MEMORANDUM

TO: Jim Well, Ducks Unlimited
FROM: Dai Thomas, PE, and Mike Harvey, PhD., PG
SUBJECT: **May 8, 2013 Resurvey of M&T/Llano Seco Pumping Plant and City of Chico Outfall Reach of the Sacramento River
M&T/Llano Seco Fish Screen Facility Long-term Protection Project, Phase IV, Project No. US-CA-62-6**
DATE: June 11, 2013

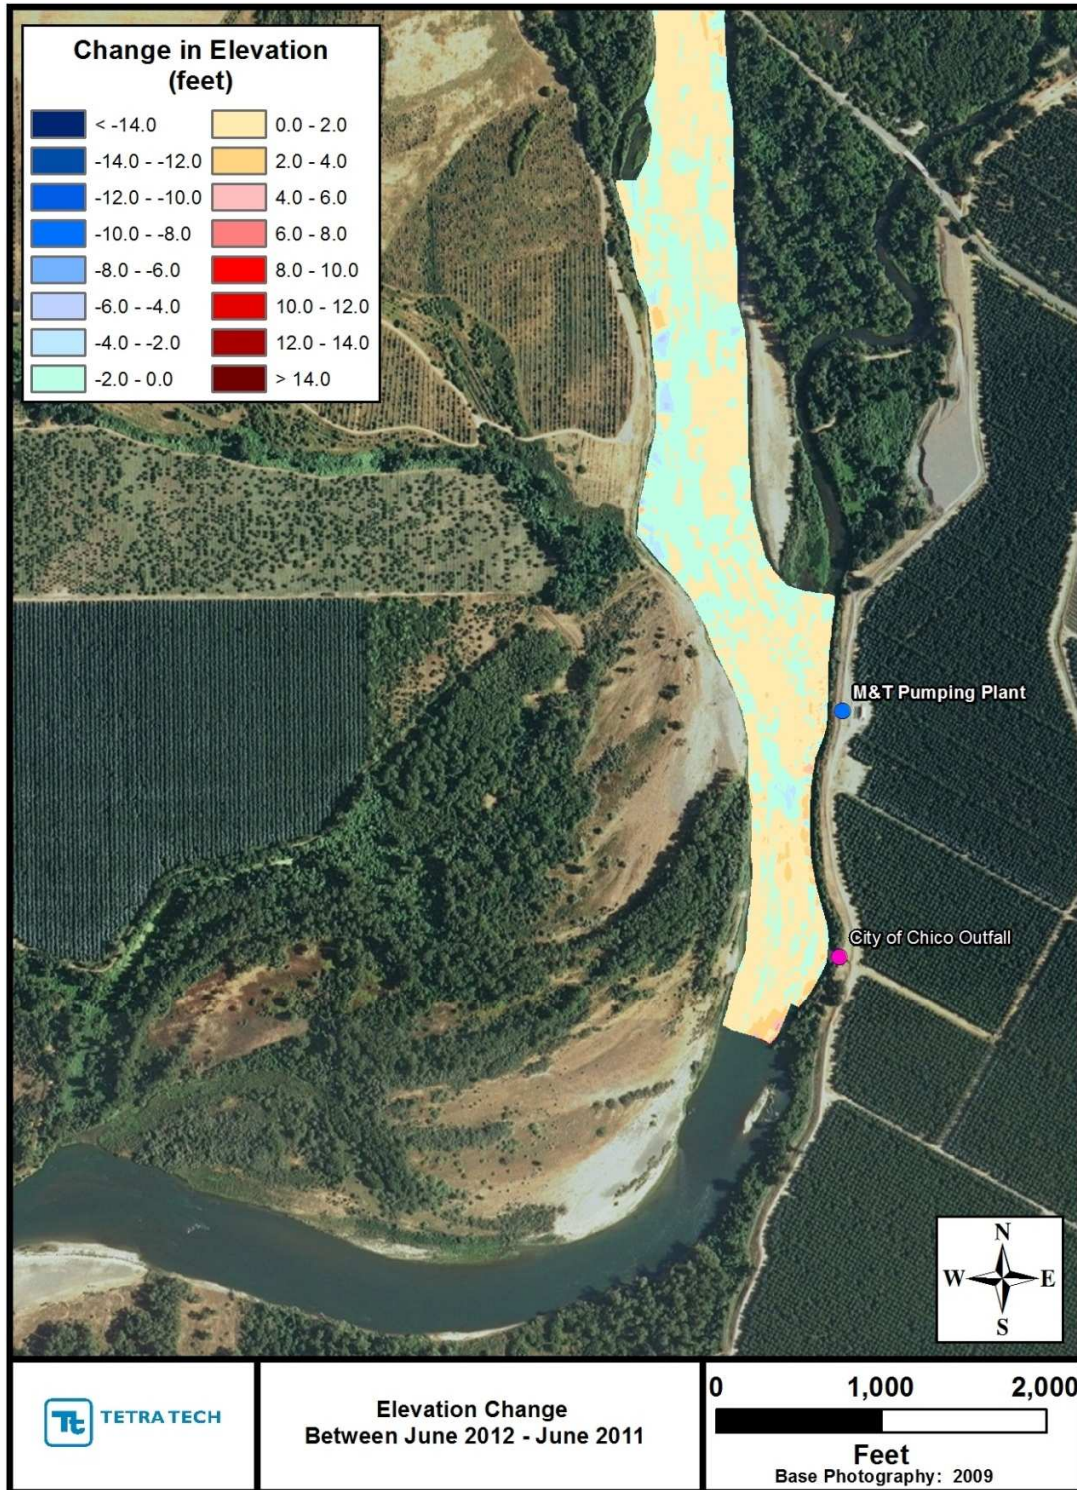
Figure 5 presents the changes in bed elevation between the 2011 survey and the 2012 surveys. The data indicate that there was some additional aggradation in the vicinity of the pump intake as compared to the 2011 survey, which was likely due to the lack of significant peak flows during the 2012 spring runoff period (peak flow at Hamilton City was about 44,000 cfs).

Figure 5. Elevation changes in the M&T/Llano Seco reach between the June 2012 and June 2011 surveys.

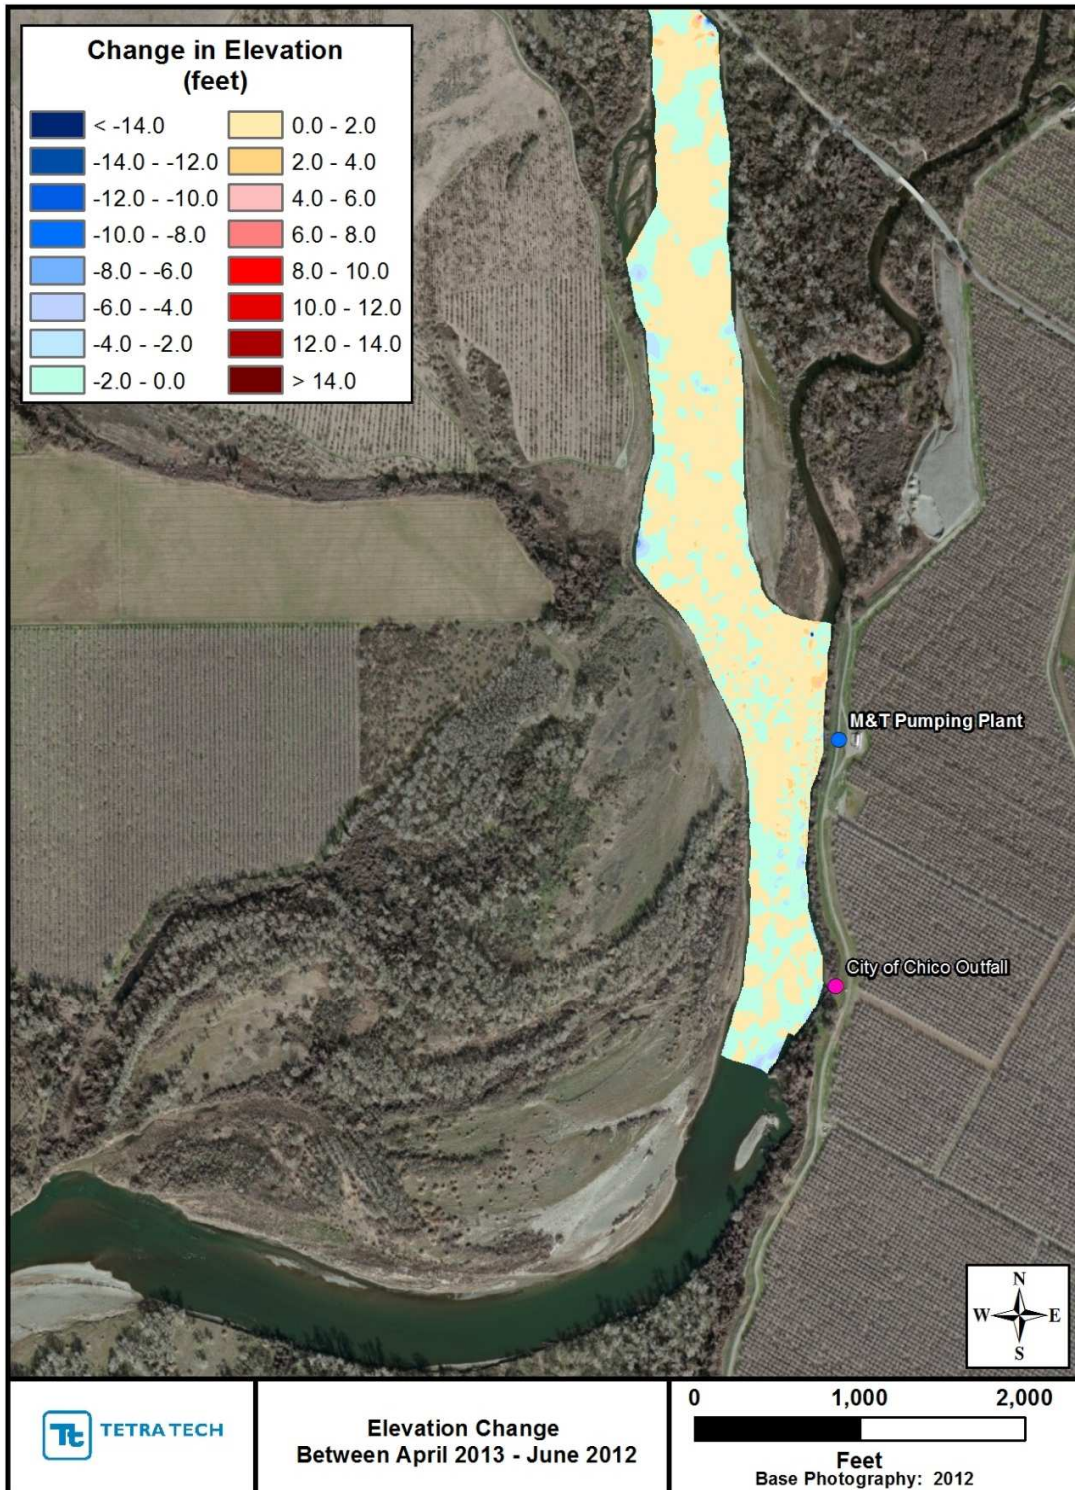
Figure 6 presents the changes in bed elevation between the 2012 survey and the 2013 surveys. The data indicate that there was very little change in bed elevation between the 2012

and 2013 surveys with the majority of the values in the -2 to 0 or the 0- to 2-foot categories. The range of these categories has been kept consistent with the previous survey report (Tetra Tech, 2012); in general, most of the values range between -0.5 and 0.5 feet, which represents little change in bed elevation. **Figure 7** presents the differences in elevation of the bed of the river between the 2013 and 2006 surveys, and demonstrates that the site is still net aggradational.

Figure 6. Elevation changes in the M&T/Llano Seco reach between the June 2012 and May 2013 surveys.

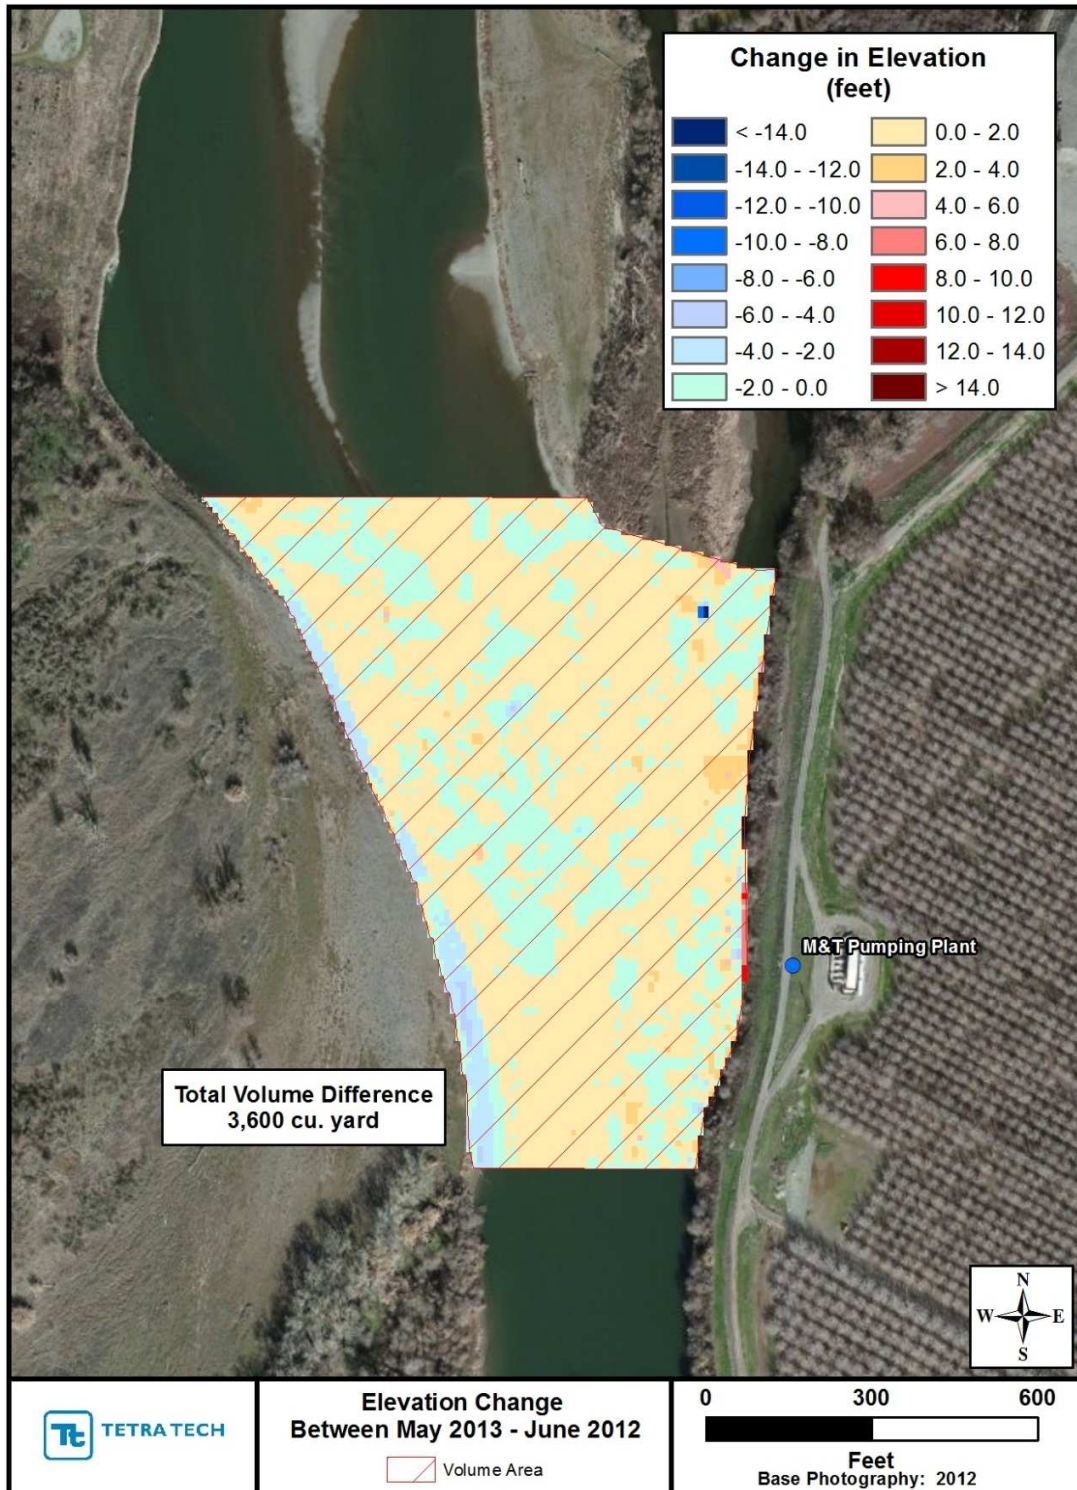
In order to further evaluate bed elevation changes between 2006 and 2013, and to determine the volume of dredge material in the vicinity of the fish screens and pump inlets, an approximately 600- by 1,200-foot area was designated and the difference in volume between surveys was determined. Between the 2006 and 2010 surveys, about 89,000 cu.yd. (~120,000 tons) of material accumulated (**Figure 8**). Between the 2011 and 2006 surveys, the volume of material that accumulated was reduced to about 54,400 cu.yd. (~72,900 tons) (**Figure 9**). Between 2010 and 2011, there was net loss of about 34,800 cu.yd. (~47,000 tons) of material (**Figure 10**). Between the 2012 and 2006 surveys, there was a net accumulation of about 61,300 cu.yd (~82,800 tons) (**Figure 11**). From 2011 to 2012, there was slight aggradation in the delineated area and a net gain of about 6,700 cu.yd (~9,000 tons) of material (**Figure 12**). Between the 2013 and 2006 surveys, there was a net accumulation of about 66,000 cu.yd (~89,100 tons) (**Figure 13**). From 2012 to 2013, there was slight aggradation in the delineated area and a net gain of about 3,600 cu.yd (~4,860 tons) of material (**Figure 14**)

Figure 14. Volumetric calculation of the deposition in the 600- by 1,200-foot segment in the vicinity of the fish screens and pump inlets between the May 2013 and June 2012 surveys.

The 2011 peak flow event exceeded bankfull conditions and eroded the previously deposited material in the vicinity of the fish screens and pump inlets, leaving the area relatively clear of deposition. The 2012 and 2013 surveys indicated relatively little deposition in this area, and therefore, dredging is not recommended at this time.

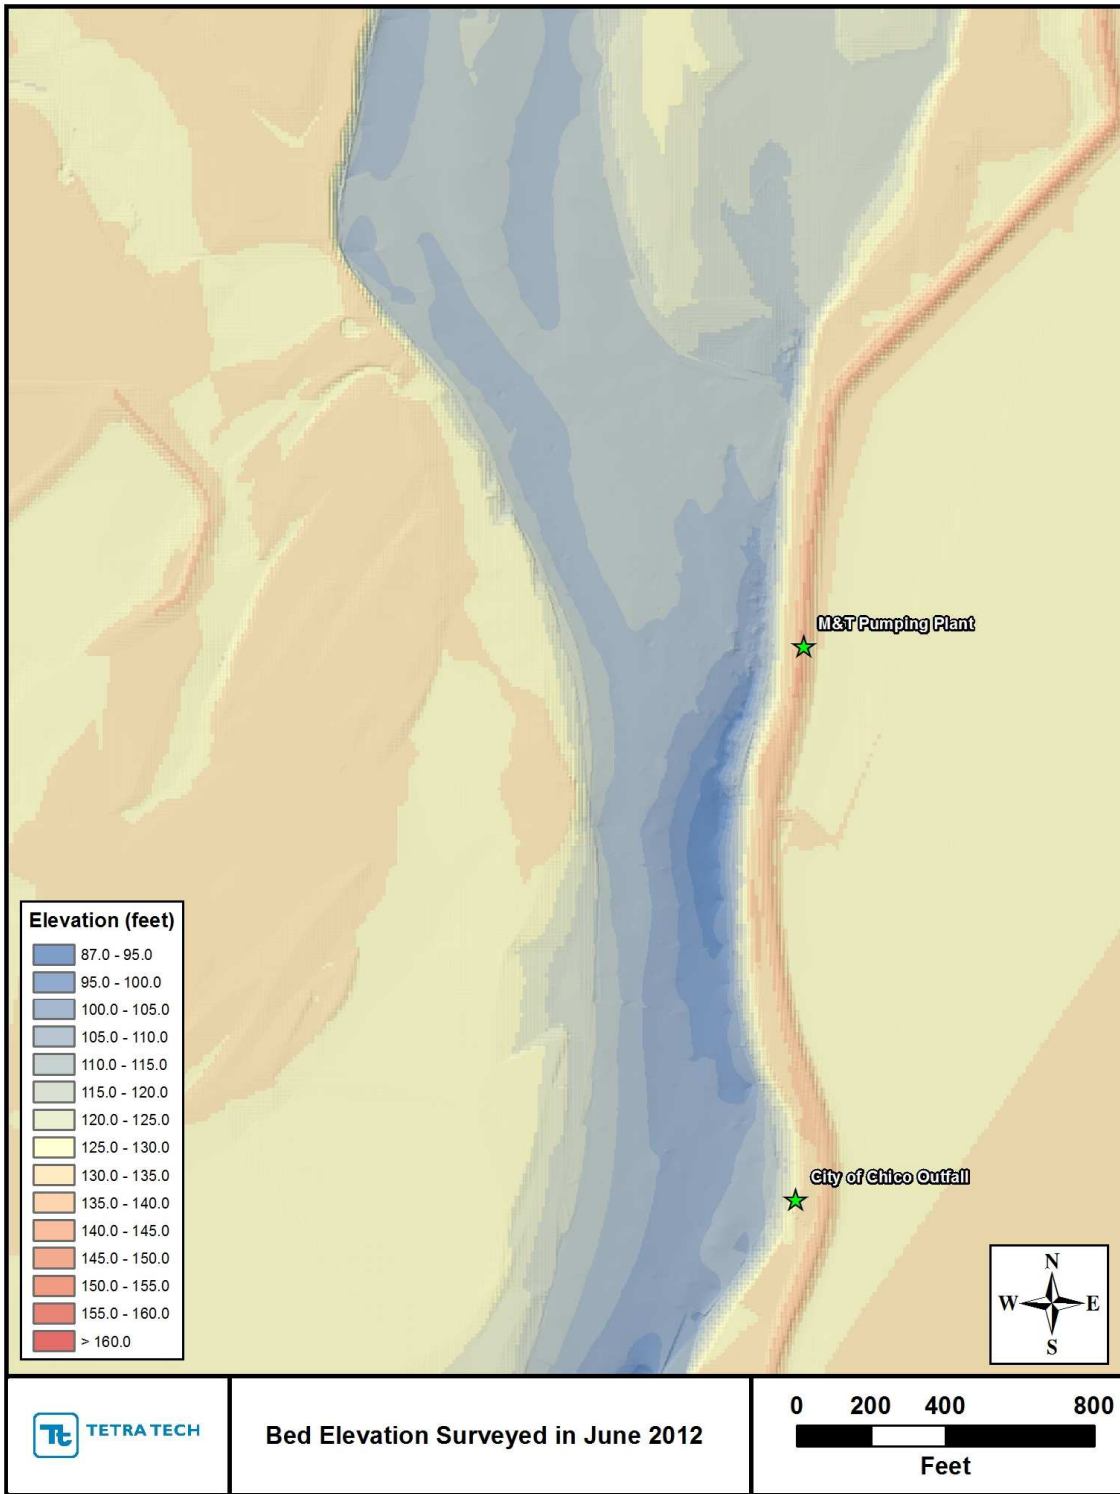
Aggradation and degradation within the M&T/Llano Seco reach appears to be tied to the peak flow hydrology. With the exception of WY2004, the peak flows in the six years prior to 2005 were less than the bankfull (~90,000 cfs) in the M&T/Llano Seco reach and this sequence of flows appears to be responsible for the aggradation in the channel (Figure 1). In WY2006, the peak flow was about 135,000 cfs and clearly there was some degradation in the reach, especially in the vicinity of the fish screens and pump inlets (**Figure 15**). Between WY2006 and WY2010, the peak flows were again less than the bankfull and aggradation occurred in the vicinity of the fish screens and pumps (**Figure 16**). Peak flow in WY2011 was about 102,500 cfs and this flow appears to have caused degradation in the vicinity of the fish screens and pump inlets (**Figure 17**). Between 2011 and 2012, the peak flows during the spring 2012 runoff period was about 44,000 cfs (approximately half of the bankfull flow) and there was a relatively small amount of deposition in the vicinity of the fish screens and pump inlets but the general problem of deposition during low flow years was observed (**Figure 18**).

Figure 18. Color gradient plot showing the bed topography in the vicinity of the M&T/Llano Seco Pumping Plant and the relocated City of Chico Outfall in June 2012.

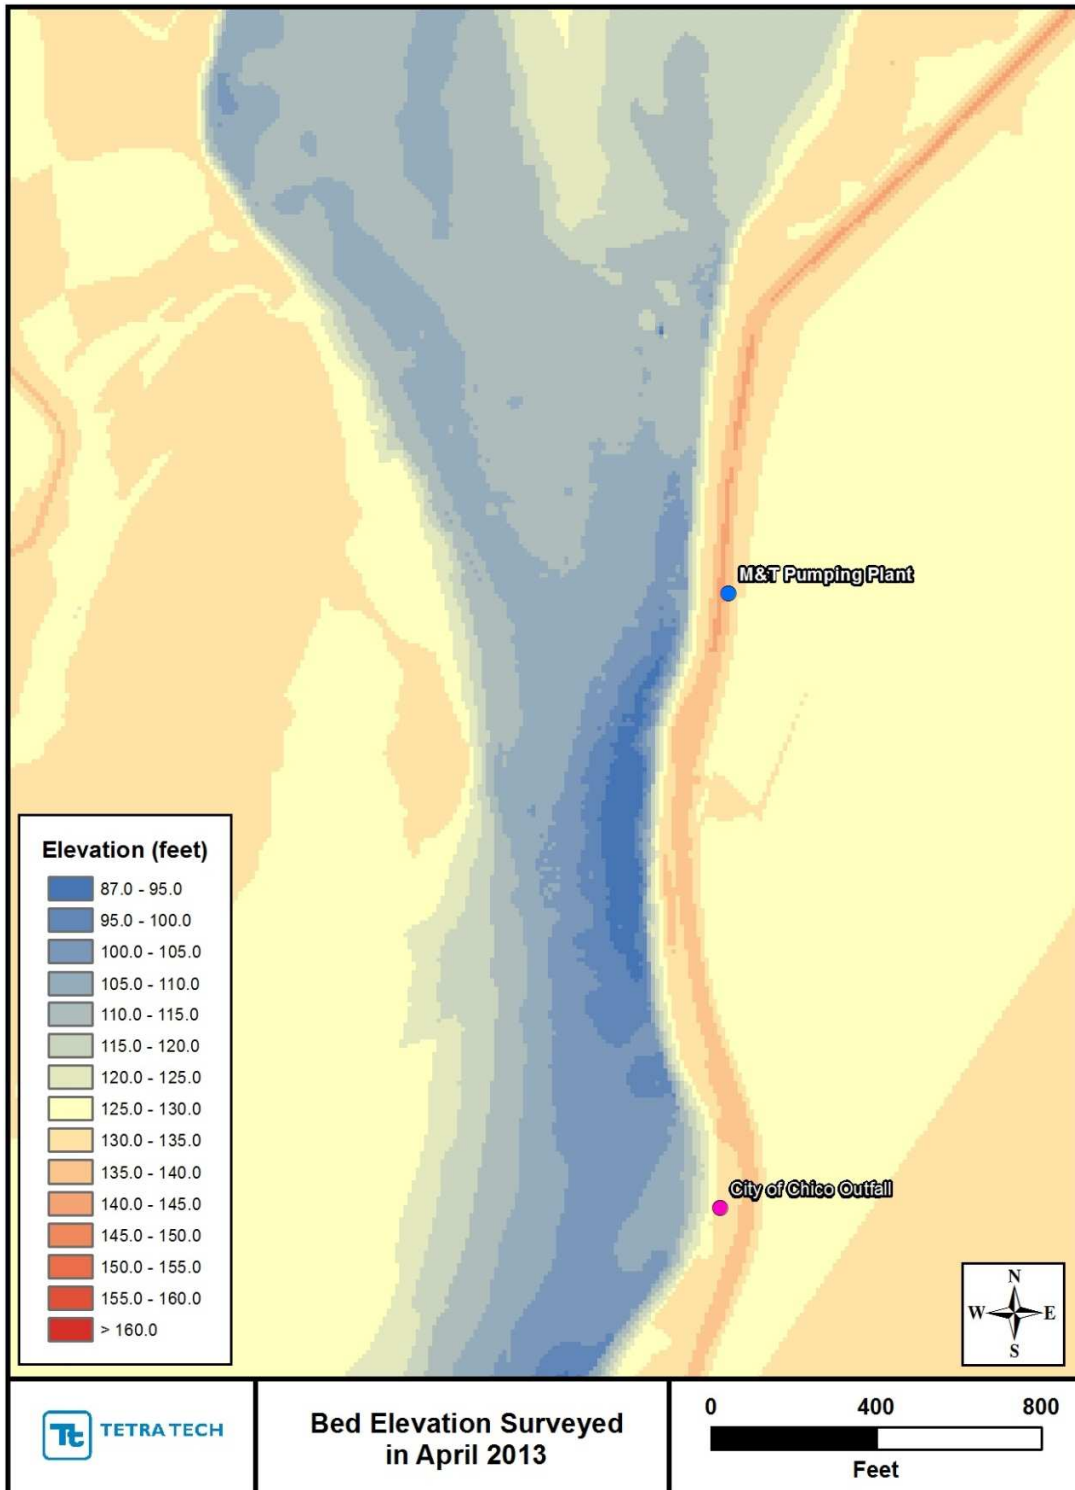
As mentioned previously, the peak flow between the 2012 and 2013 surveys was about 85,600 cfs, which is slightly less than the bankfull discharge of 90,000 cfs, and the duration of the peak flow event was less than one day. Between 2012 and 2013, there was a relatively small amount of deposition in the vicinity of the fish screens and pump inlets, but the general pattern of deposition at less than bankfull discharges was observed (**Figure 19**).

Figure 19. Color gradient plot showing the bed topography in the vicinity of the M&T/Llano Seco Pumping Plant and the relocated City of Chico Outfall in May 2013.

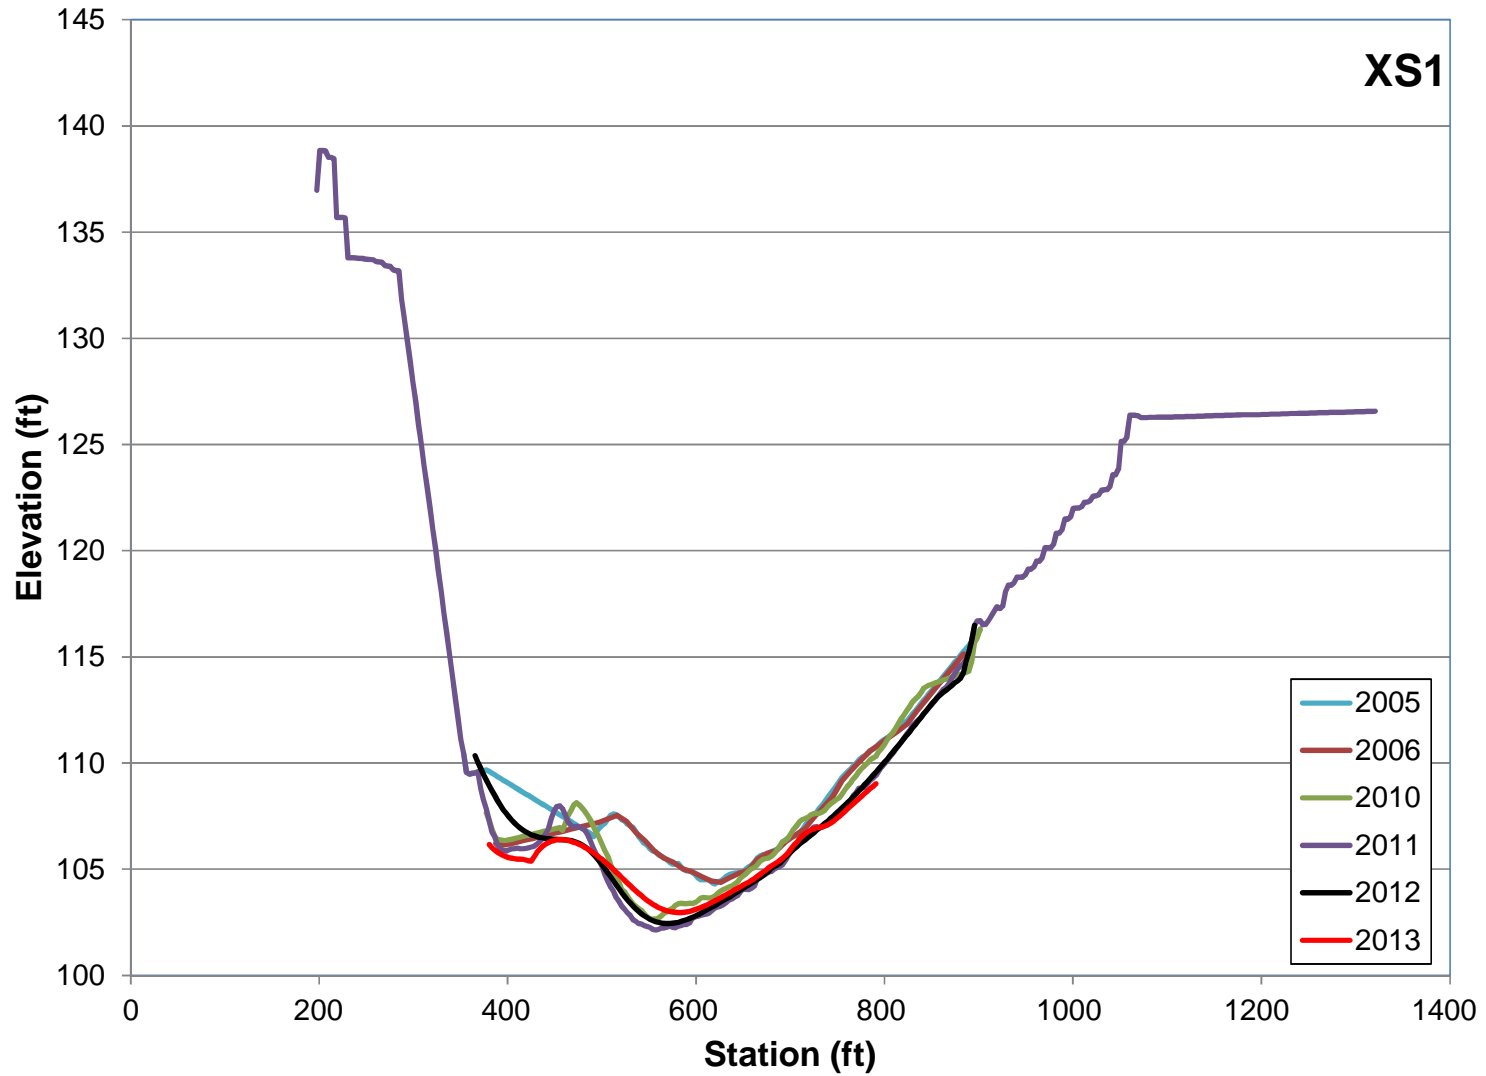
At the City of Chico's outfall (**Figure 21**), the cross sections indicate that there was some aggradation on the left (east) side of the channel in 2005 but the 2006, 2010 and 2011 surveys show that the local aggradation was removed. The 2012 survey shows a small amount of aggradation near the left bank in the vicinity of Sta 440 and degradation in the vicinity of Sta 450 the 2013 survey shows slight degradation along the left side of the channel from near the left bank (east) to approximately Station 430. The 2013 survey also shows no change from the location of the thalweg (~Sta 560) to Sta 890 compared to the 2012 survey.

Figure 21. Comparative cross-section plots, 2005 to 2012 at the relocated City of Chico outfall.

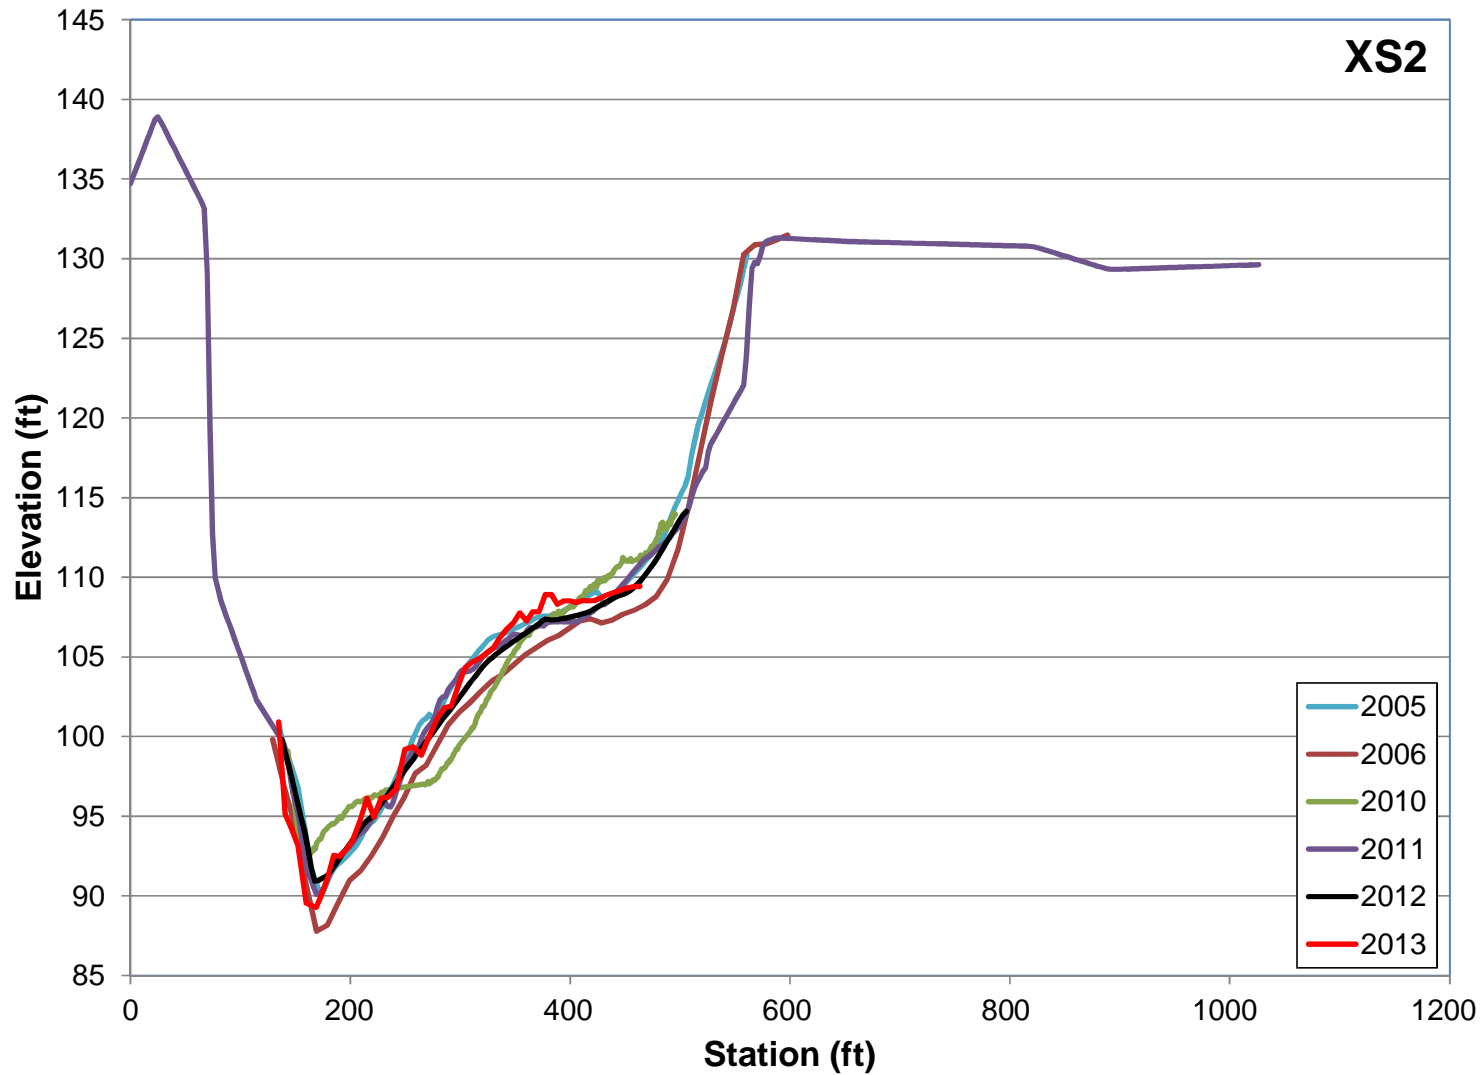
At the location of the City's prior outfall (**Figure 22**), it is apparent that the aggradation in 2010 was removed by the flows in 2011 and that the depth of scour probably depends on the magnitude of the high flows since the bed elevation in 2006 is the lowest. The 2012 survey shows there was very little change along the cross section compared to 2011 conditions. The 2013 survey shows approximately 1.5 feet of degradation at the channel thalweg (~Sta 170) compared to the 2012 survey. The 2013 survey also shows slight aggradation along the right side of the channel from Sta 290 to Sta 450.

Figure 22. Comparative cross-section plots, 2005 to 2012 at the original City of Chico outfall.

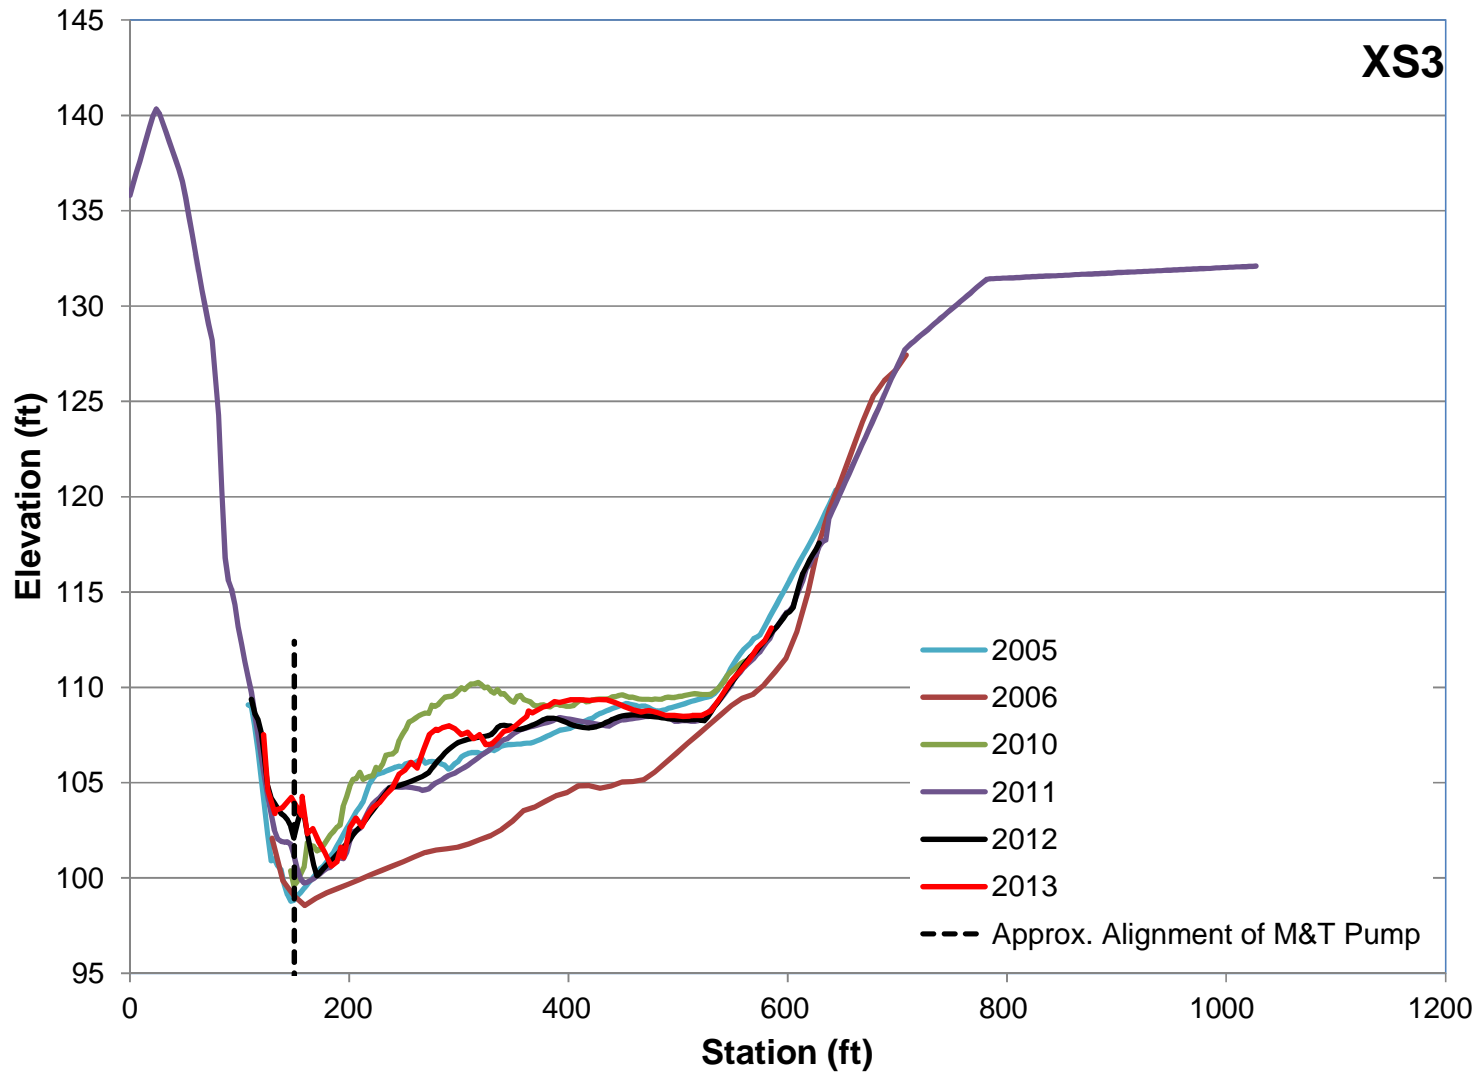
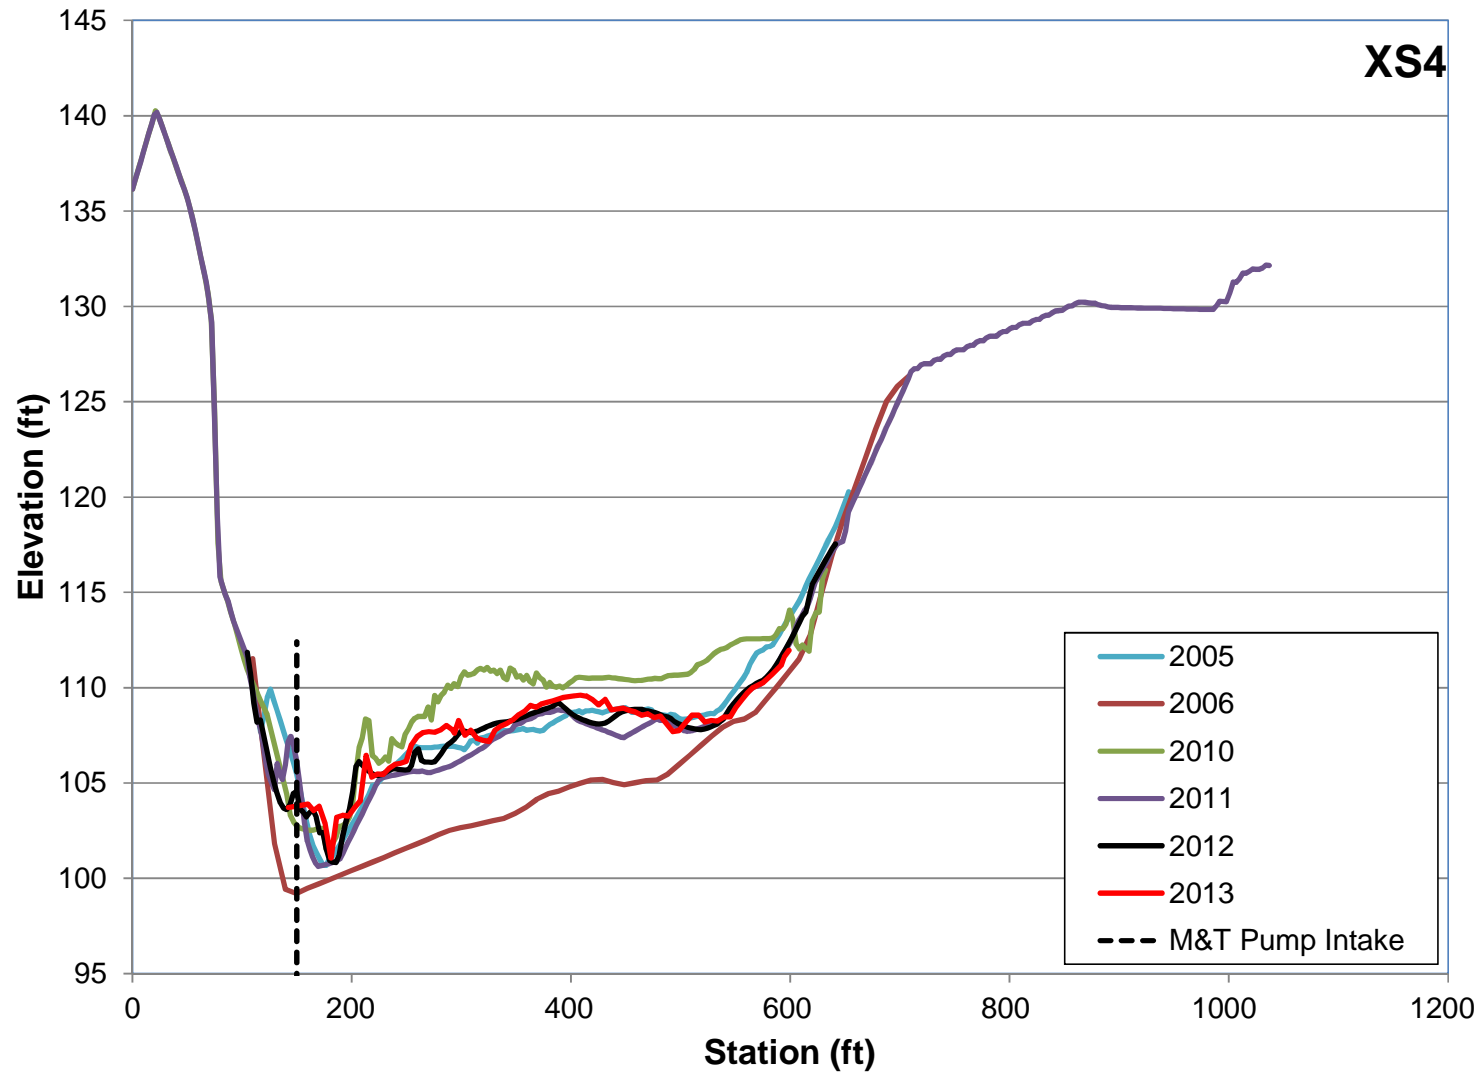
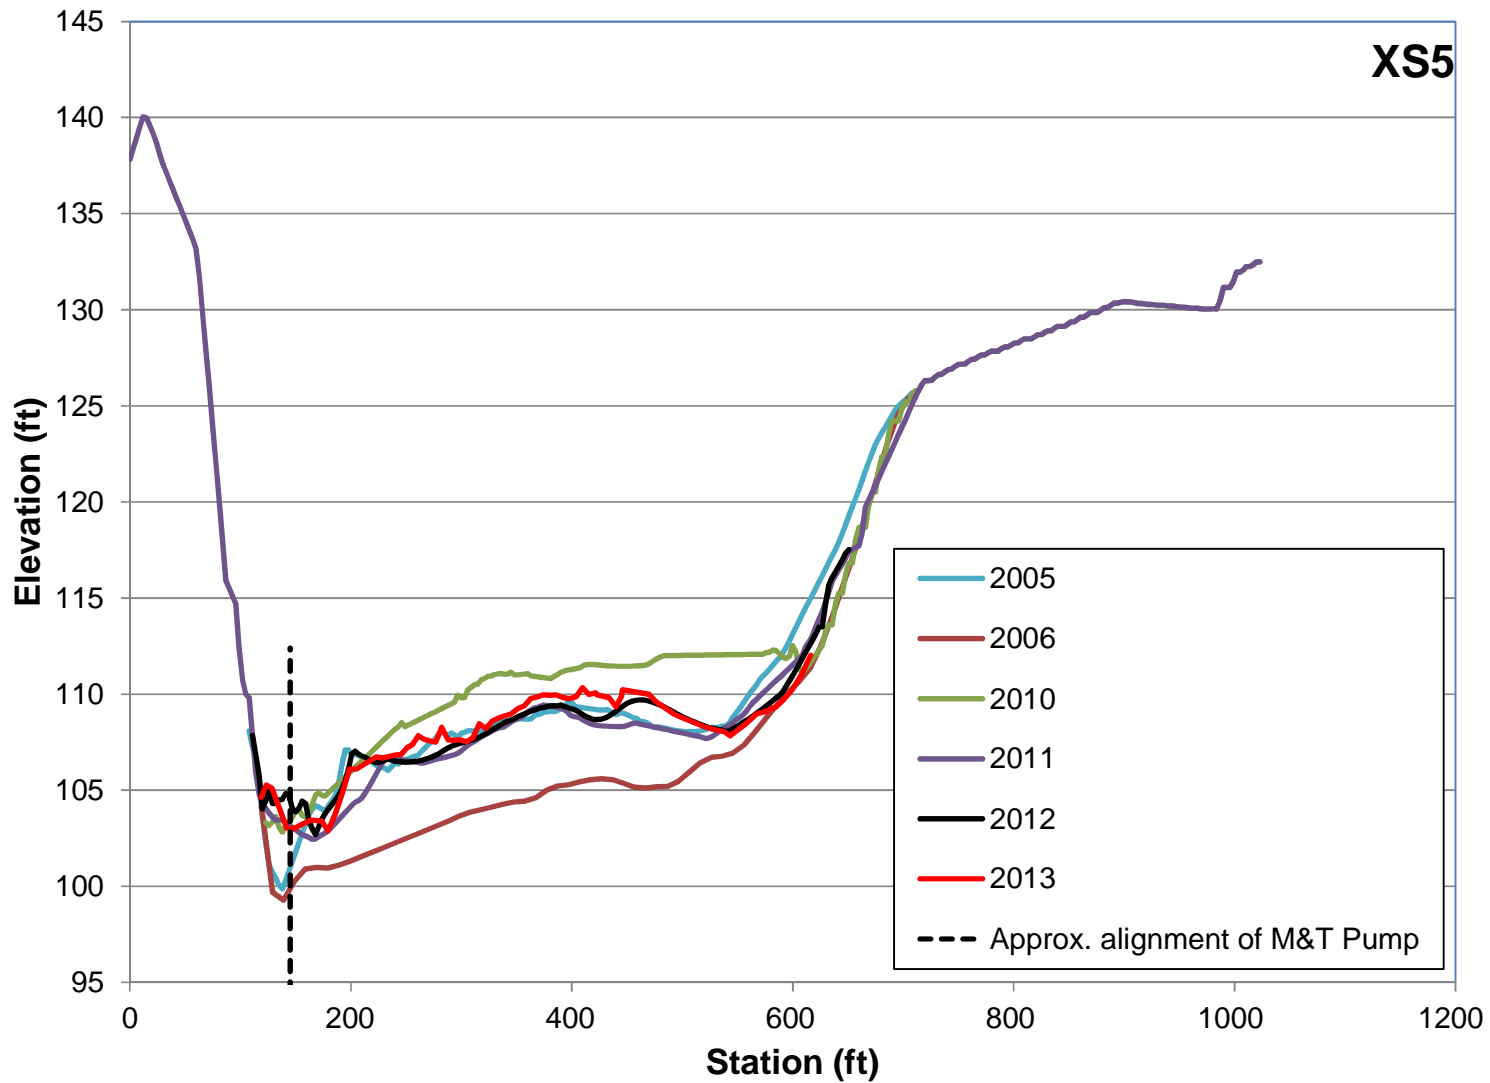
At the location of the fish screens and pump inlets (**Figures 23 through 25**) it is clear that during the lower peak flow years the deposition approaches the inlets and fish screens, and it is eroded during the higher-flow years. At XS3 (located slightly downstream from the fish screen), the 2013 survey shows there was approximately 1 foot of aggradation around the pump intake and up to 1.5 feet of aggradation to the right of the thalweg between Sta 245 and Sta 450 compared to 2012 (Figure 23). At the M&T intake (XS4), there was very little change in elevation compared to 2012; however, there was up to 1.5 feet of aggradation along the right side of the channel between Sta 230 and Sta 450, compared to 2012 (Figure 24). At XS5, which is located slightly upstream of the M&T pump intakes, the 2013 survey shows there was approximately 1 foot of degradation along the alignment of the intake compared to 2012; similar to XS3 and XS4, there was up to 1.5 feet of aggradation along the right side of the channel between Sta 230 and Sta 470, compared to 2012.

Figure 23. Comparative cross-section plots, 2005 to 2012 immediately downstream of the M&T/Llano Seco fish screens and pump inlets.

Figure 24. Comparative cross-section plots, 2005 to 2012 at the M&T/Llano Seco fish screens and pump inlets.

Figure 25. Comparative cross-section plots, 2005 to 2012 immediately upstream of the M&T/Llano Seco fish screens and pump inlets.

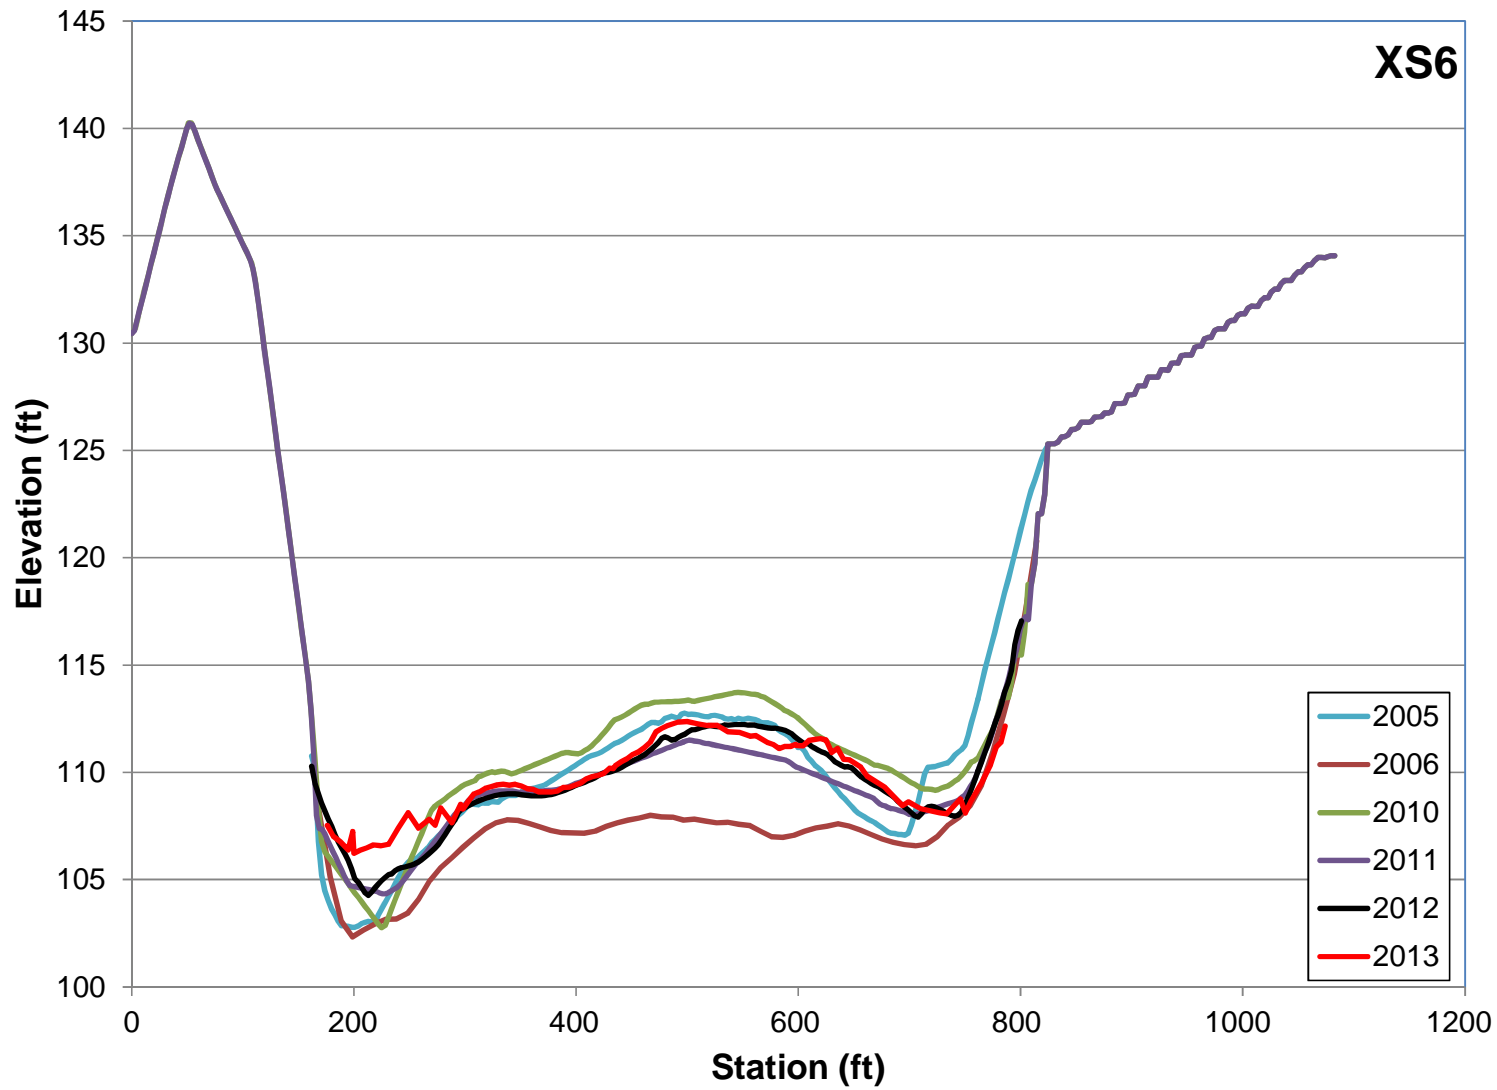
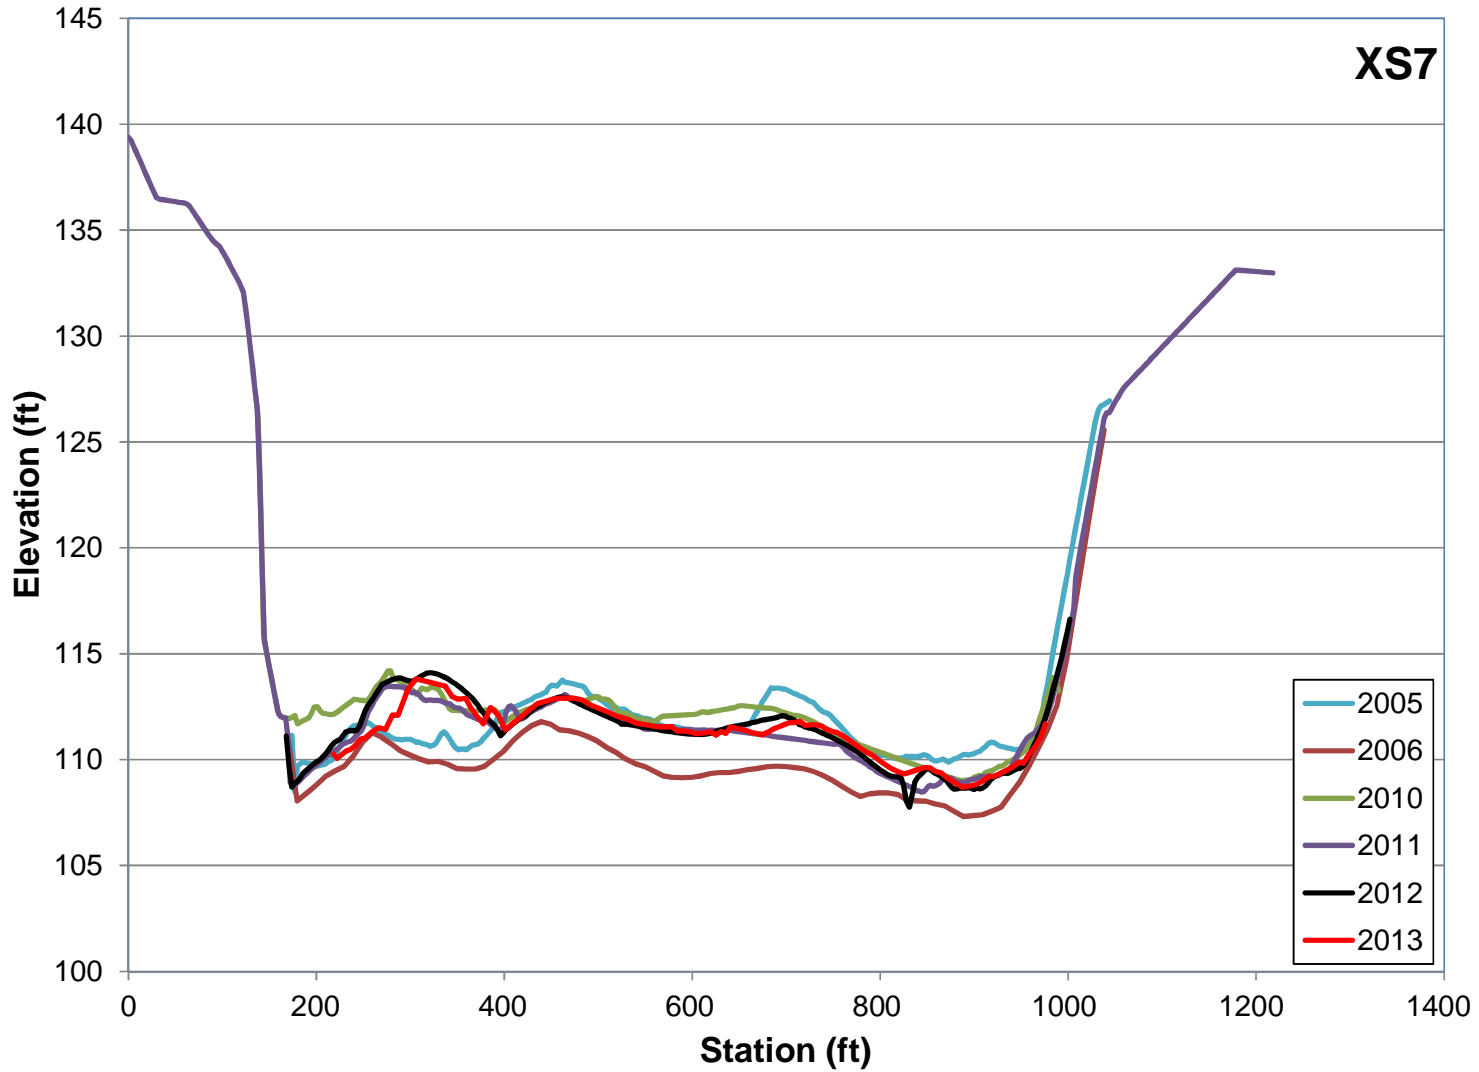
The same general trend is seen on the upper part of the migrating bar (**Figures 26 and 27**). Aggradation occurs during the lower peak flow years (2005, 2010, and 2012) and there is scour in the higher peak flow years (2006 and 2011). The 2013 survey shows there was aggradation of up to 2 feet near the left bank of XS6 and localized differences (aggradation and degradation) of up to 1 foot in the main channel, but in general, between Sta 290 and the right bank, the 2013 survey is very similar to the 2012 survey. At XS7, there was approximately 1 foot of aggradation downstream from the bank attached bar.

Figure 26. Comparative cross-section plots, 2005 to 2012 upstream of the M&T/Llano Seco fish screens and pump inlets on the lower part of the migrating bar.

Figure 27. Comparative cross-section plots, 2005 to 2012 upstream of the M&T/Llano Seco fish screens and pump inlets on the upper part of the migrating bar.

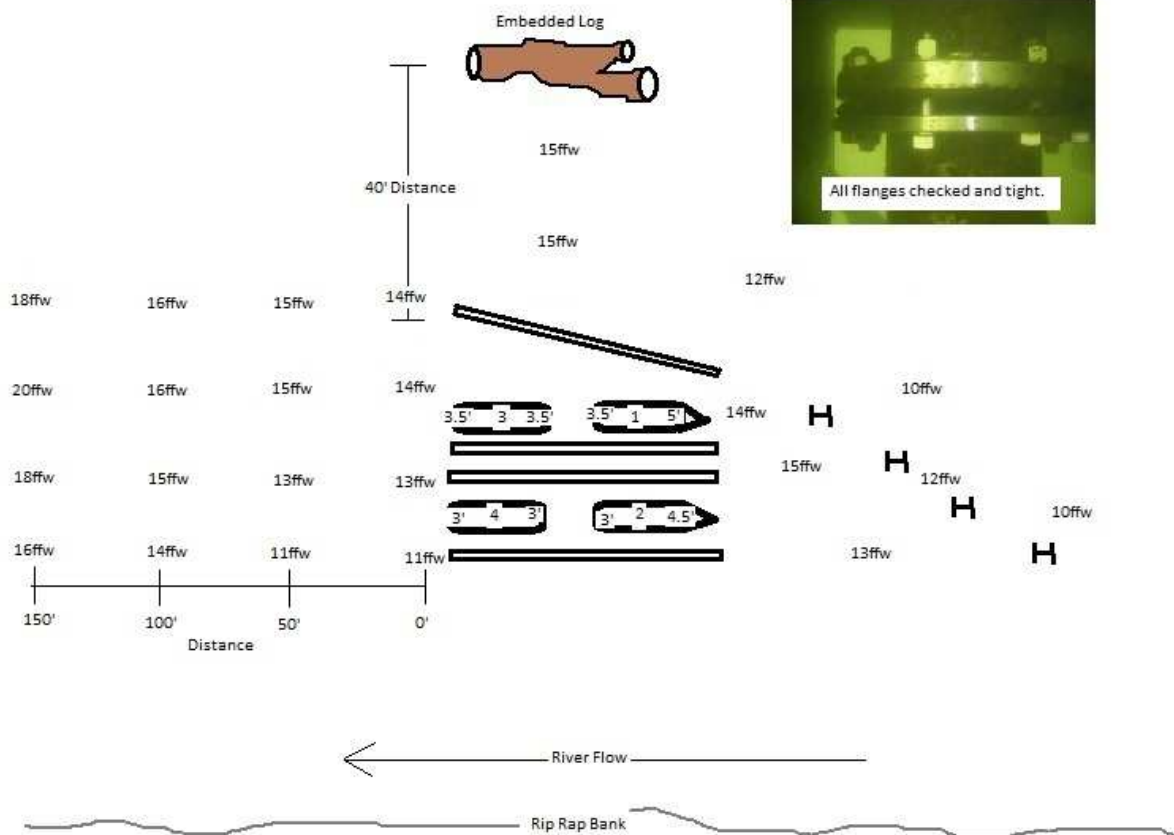
Ord Ferry 3-20-13 River Stage 97.1

- Screen #1 - Flanges and bolts tight. Small dent, no gap. Screen cleaned.
4.25' Average under screen to sand and gravel bottom.
- Screen #2 - Flanges and bolts tight. No Damage. Screen cleaned.
3.75' Average under screen to sand and silt bottom.
- Screen #3 - Flanges and bolts tight. Small dent, no gap. Screen cleaned.
3.5' Average under screen to sand and gravel bottom.
- Screen #4 - Flanges and bolts tight. No Damage. Screen cleaned.
3' Average under screen to sand and silt bottom.
