MEMORANDUM

TO: Jim Well, Ducks Unlimited
FROM: Dai Thomas, PE, and Mike Harvey, PhD., PG
SUBJECT: **May 8, 2013 Resurvey of M&T/Llano Seco Pumping Plant and City of Chico Outfall Reach of the Sacramento River
M&T/Llano Seco Fish Screen Facility Long-term Protection Project, Phase IV, Project No. US-CA-62-6**
DATE: June 11, 2013

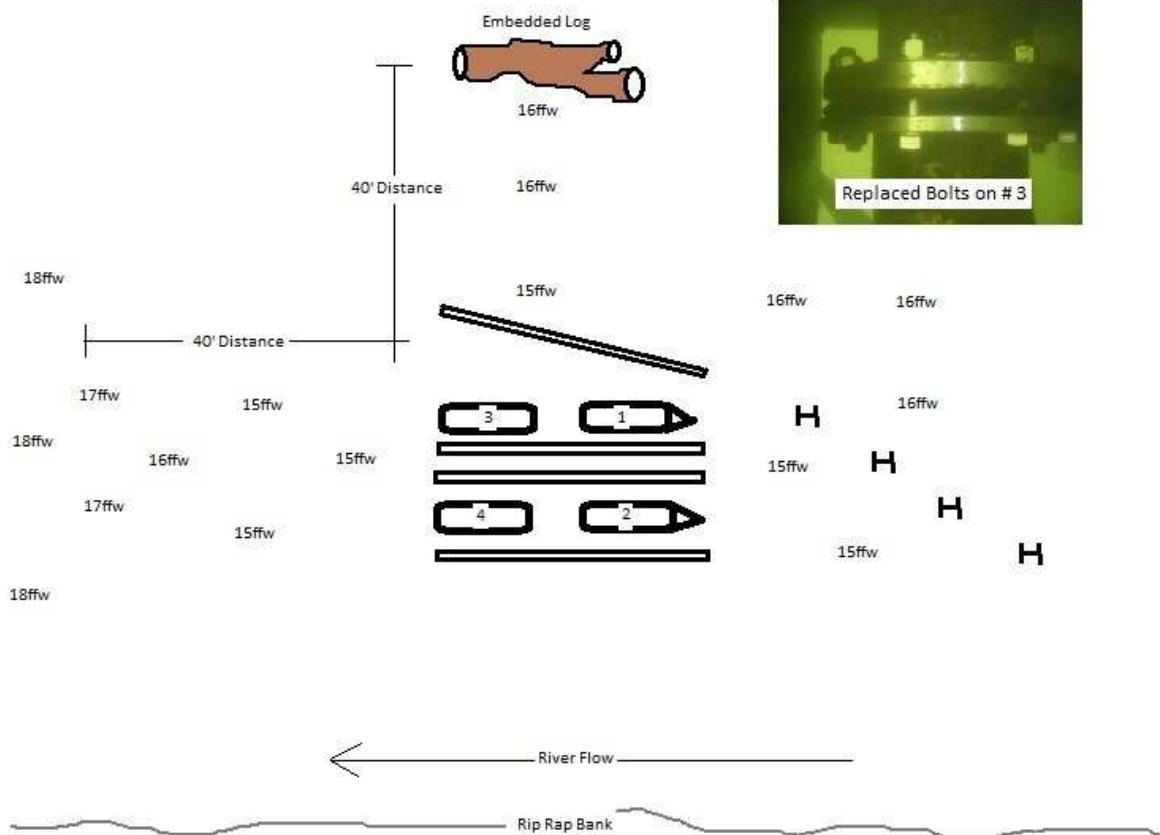
Ord Ferry 5-17-12 River Stage 97.75

Screen #1 - Flanges and bolts tight. Air test = No leaks. Screen cleaned. No dents.

6' from bottom of screen to sandy bottom.

Screen #2 - Flanges and bolts tight. Air test = No leaks. Screen cleaned. No dents.

5' From bottom of screen to sandy bottom.

Screen #3 - Flanges and bolts checked. 2 Galled Stainless Steel bolts found. Bolts removed and replaced.

Bolts tightened. Air test = Small leak at beginning of air burst. Determined leak is workable and not to be repaired but will monitor. Screen cleaned. Two dents found. Diver able to rebend wedge wire back to operational status and closed up small gap. 4' From bottom of screen to sandy bottom.

Screen #4 - Flanges and bolts tight. Air test = No leaks. Screen cleaned. No dents.

3' From bottom of screens to sandy bottom.

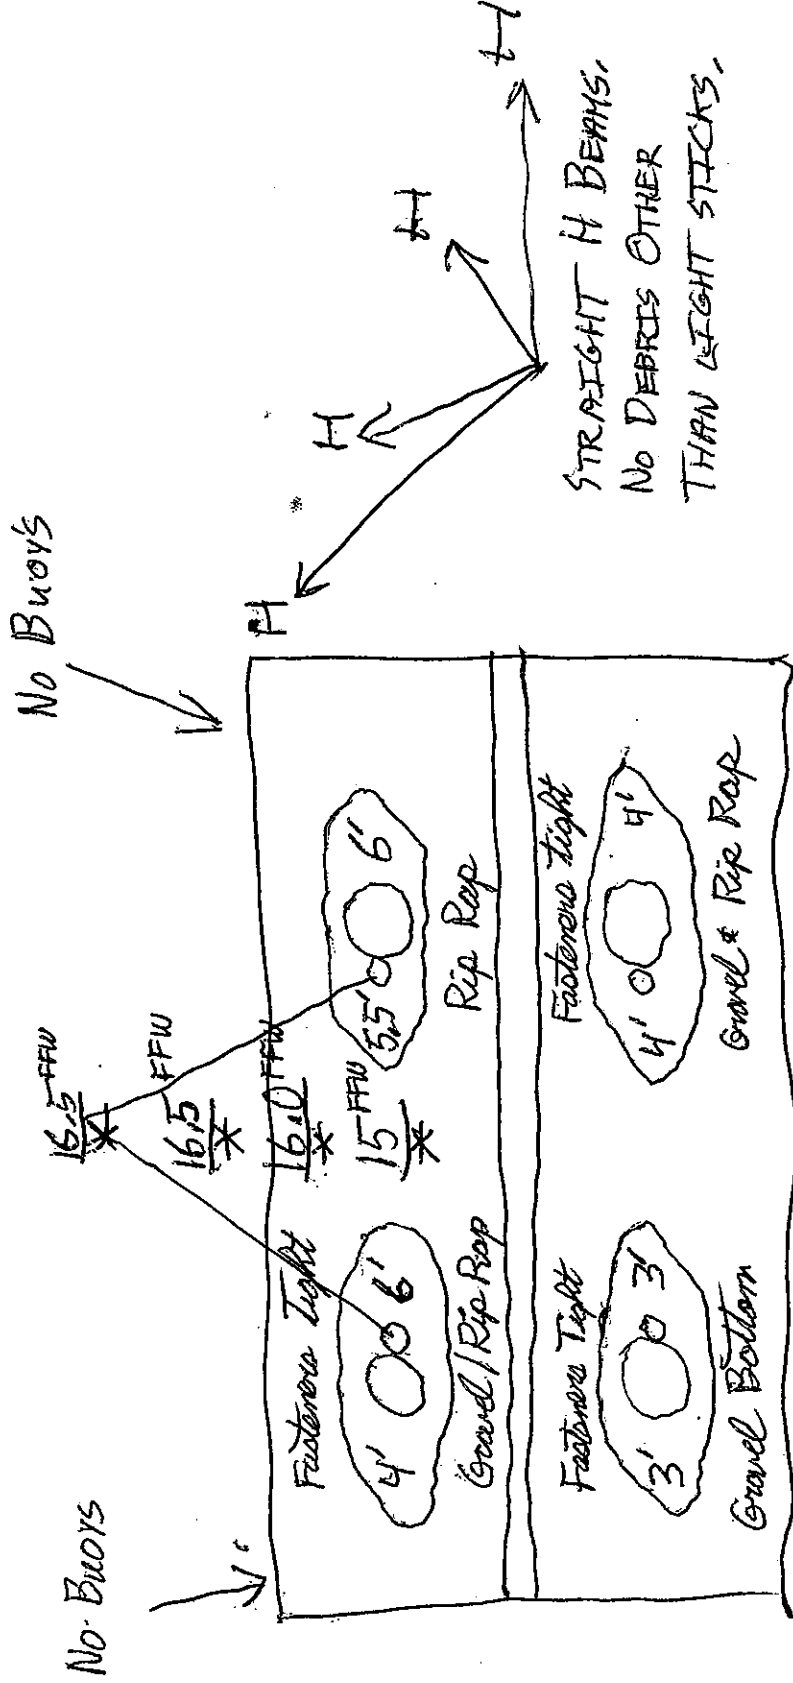
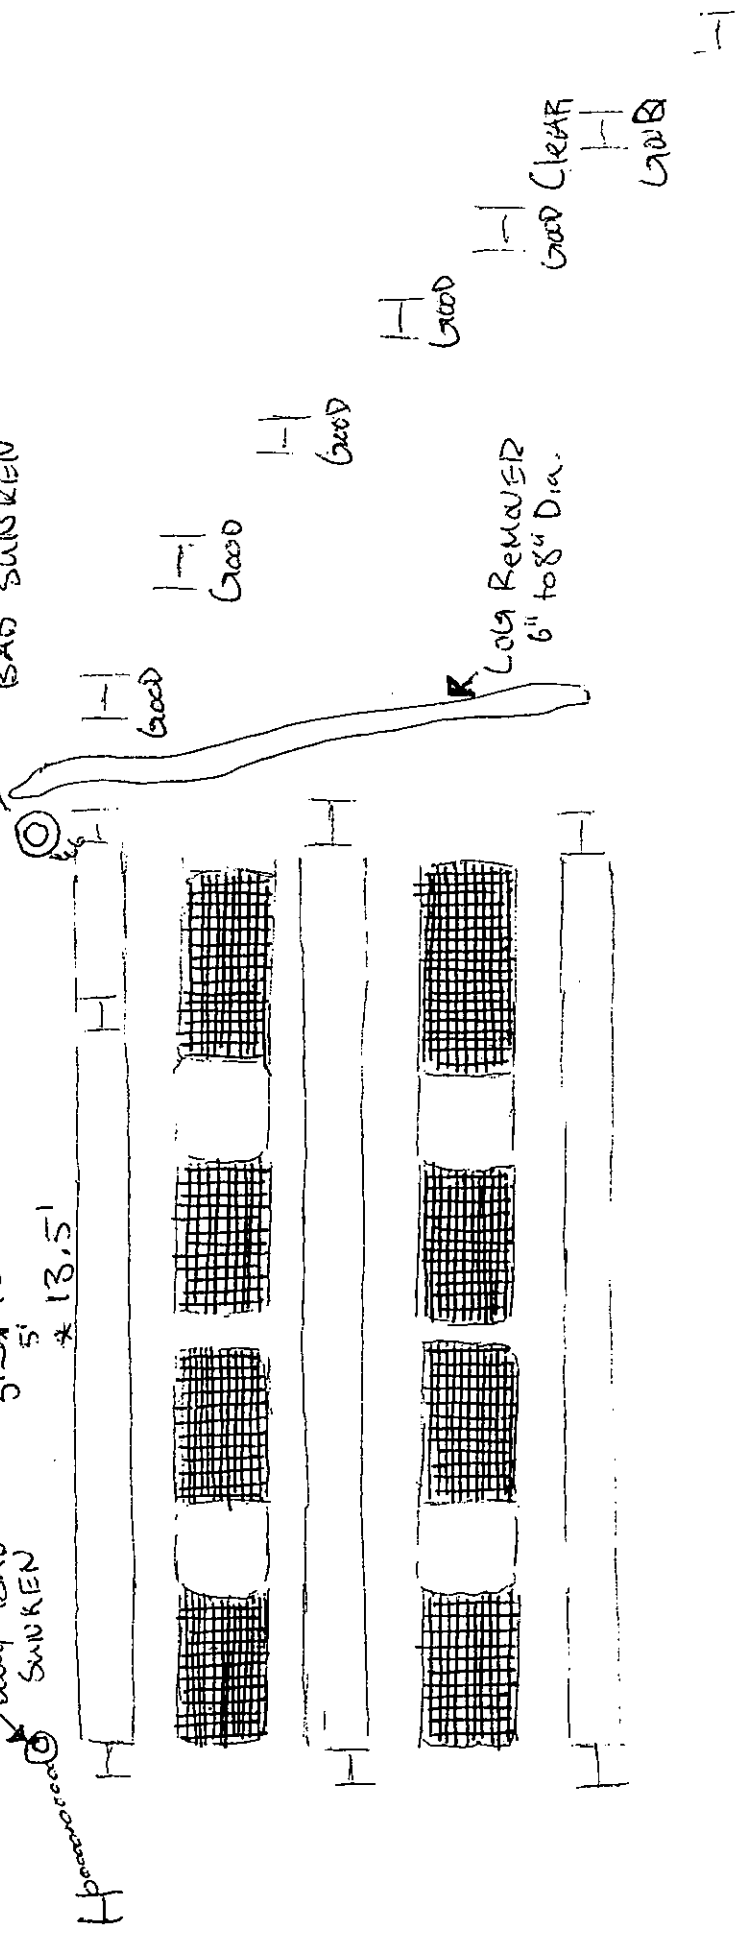
4/14/08
INSPECTION

- NOTES:
- UPSTREAM-INNER: UPST. 3' FROM SCREEN TO BOTTOM DOWN: 5' FROM SCREEN TO BOTTOM RIP RAP Bottom Bolts GOOD/AIR BLAST GOOD
 - DOWN STREAM-INNER: UPST. 2' TO RIP RAP Bott. DOWN: 3' TO SANDY Bolts GOOD/AIR BLAST GOOD
 - DOWN STREAM-OUTER: UPST. 5' TO GRAVEL Bott. DOWN: 4' TO RIP RAP Bolt Bolts GOOD/AIR BLAST GOOD
 - UPSTREAM-OUTER: UPST. 6' TO RIP-RAP/GRAVEL Bott. DOWN: 6' TO GRAVEL Bottom, Bolts GOOD/AIR BLAST GOOD

DOWN STREAM
 BOUY BAD
 SUNKEN

UPSTREAM BOUY
 BAD SUNKEN

- 5' = 15'
 - 10' = 14'
 - 15' = 15'
 - 20' = 15'
 - 25' = 15'
 - 30' = 14'
- * PAST 30' SLOPES UP GRADUALLY
 * BOTH BOUY'S SUNKEN
 * REMOVED LOG FROM STRUCTURE
 * ALL H-BEAMS GOOD
