MEMORANDUM

TO: Jim Well, Ducks Unlimited
FROM: Mike Harvey, Ph.D., P.G.
SUBJECT: **M&T/ Llano Seco Fish Screen Facility Short-Term/Long-Term Protection Project (Project No. US-CA-62-2)**
Maintenance Inspection and Reports (Subtask 14.1)
Inspection Report No.1

Cc:
DATE: November 29, 2010

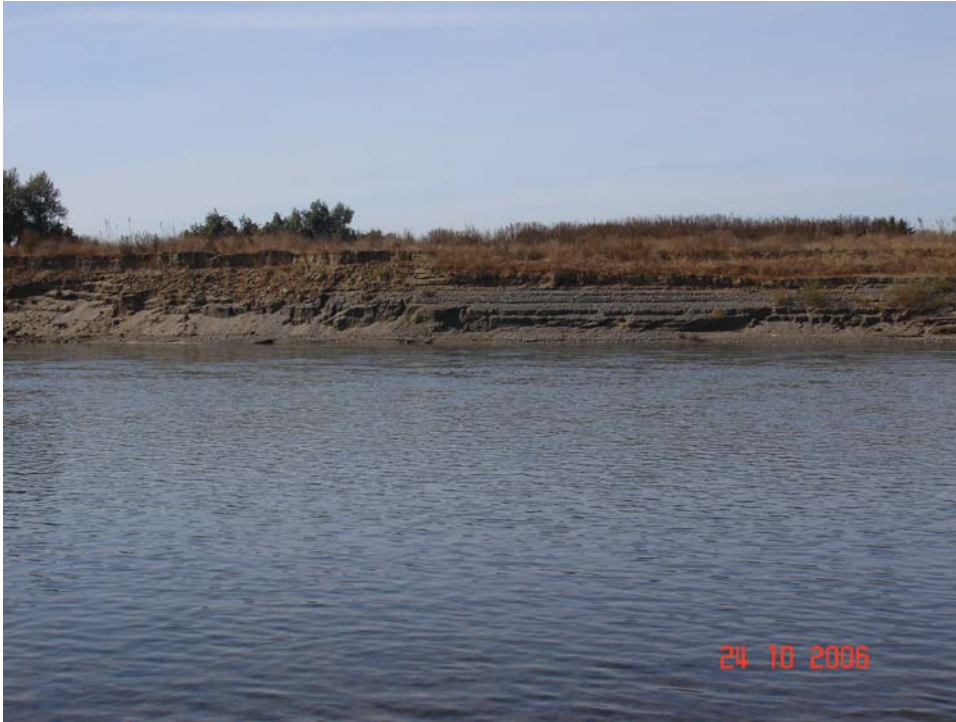
Figure 1. Photograph of the upstream end of the site prior to construction of the rock-toe/brush revetment (Photo taken on 10/24/2006).

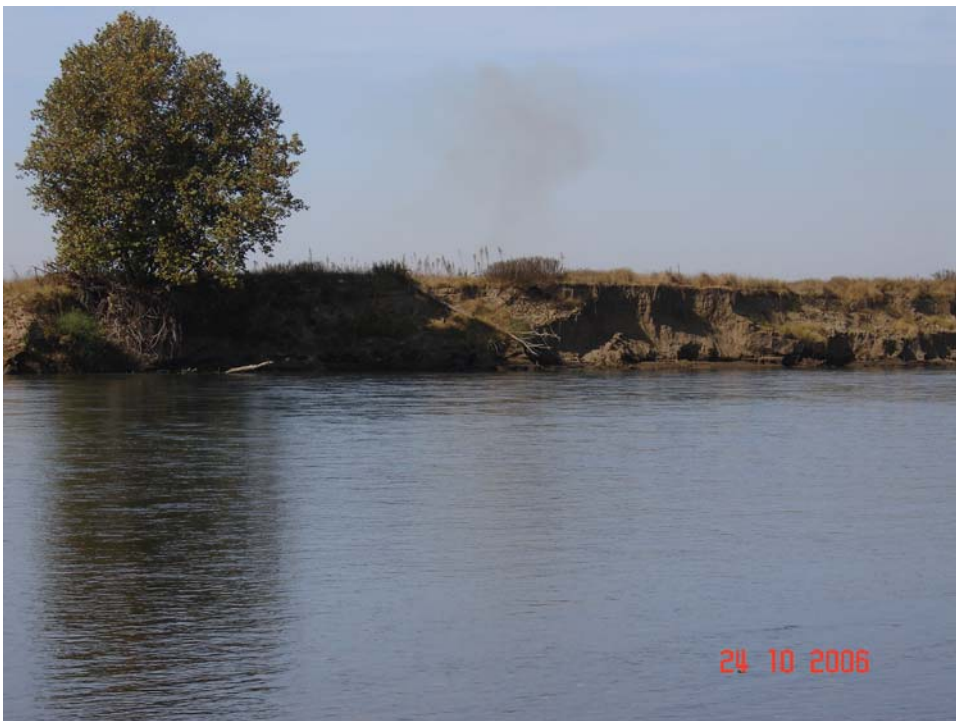
Figure 2. Photograph of the middle part of the site prior to construction of the rock-toe/brush revetment (Photo taken on 10/24/2006).

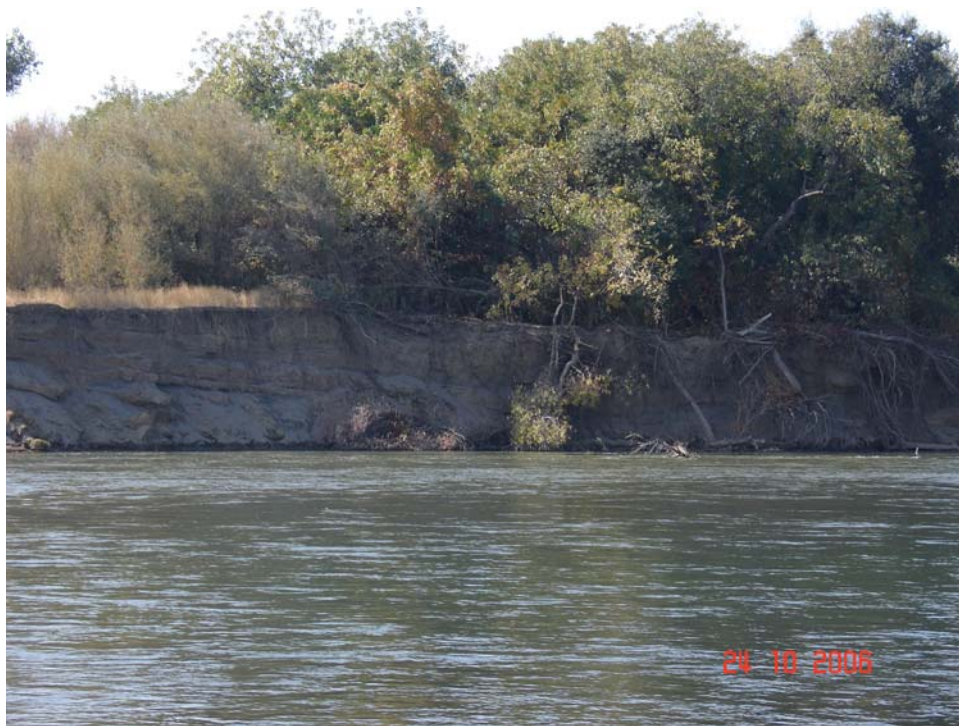
Figure 3. Photograph of the apex of the eroding bend prior to construction of the rock-toe/brush revetment (Photo taken on 10/24/2006).

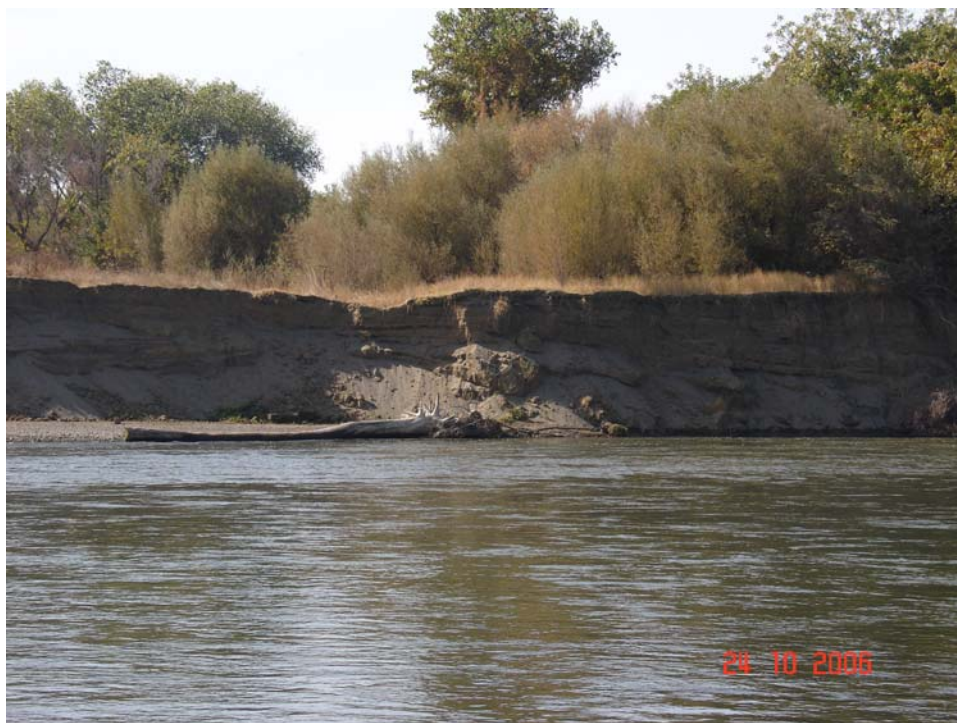
Figure 4. Photograph of the middle part of the downstream part of the site prior to construction of the rock-toe/brush revetment (Photo taken on 10/24/2006).

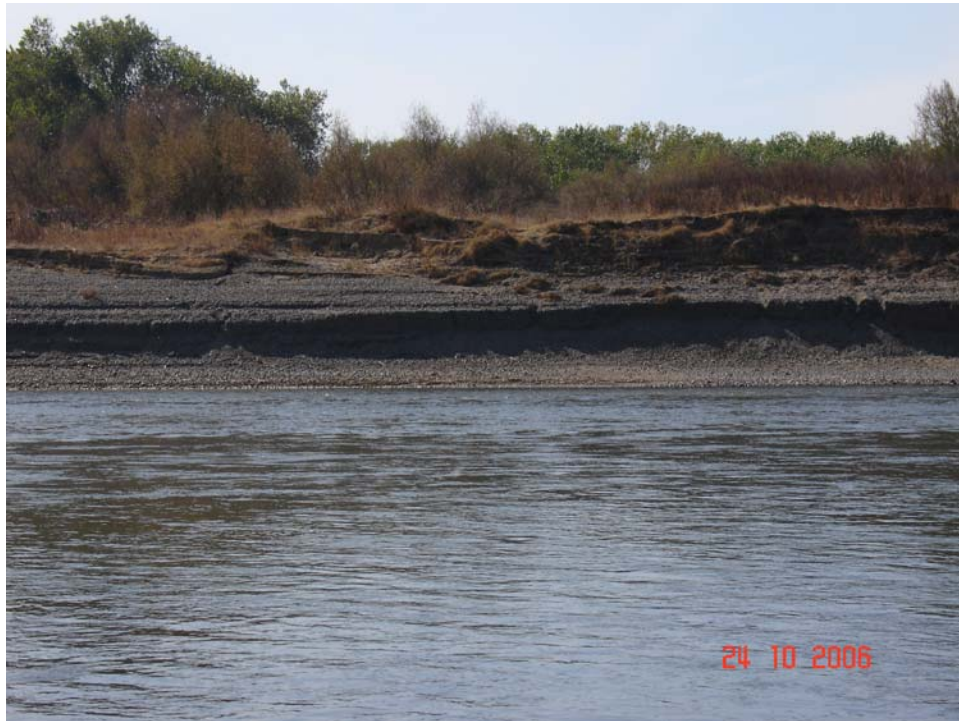
Figure 5. Photograph of the downstream end of the site prior to construction of the rock-toe/brush revetment (Photo taken on 10/24/2006).

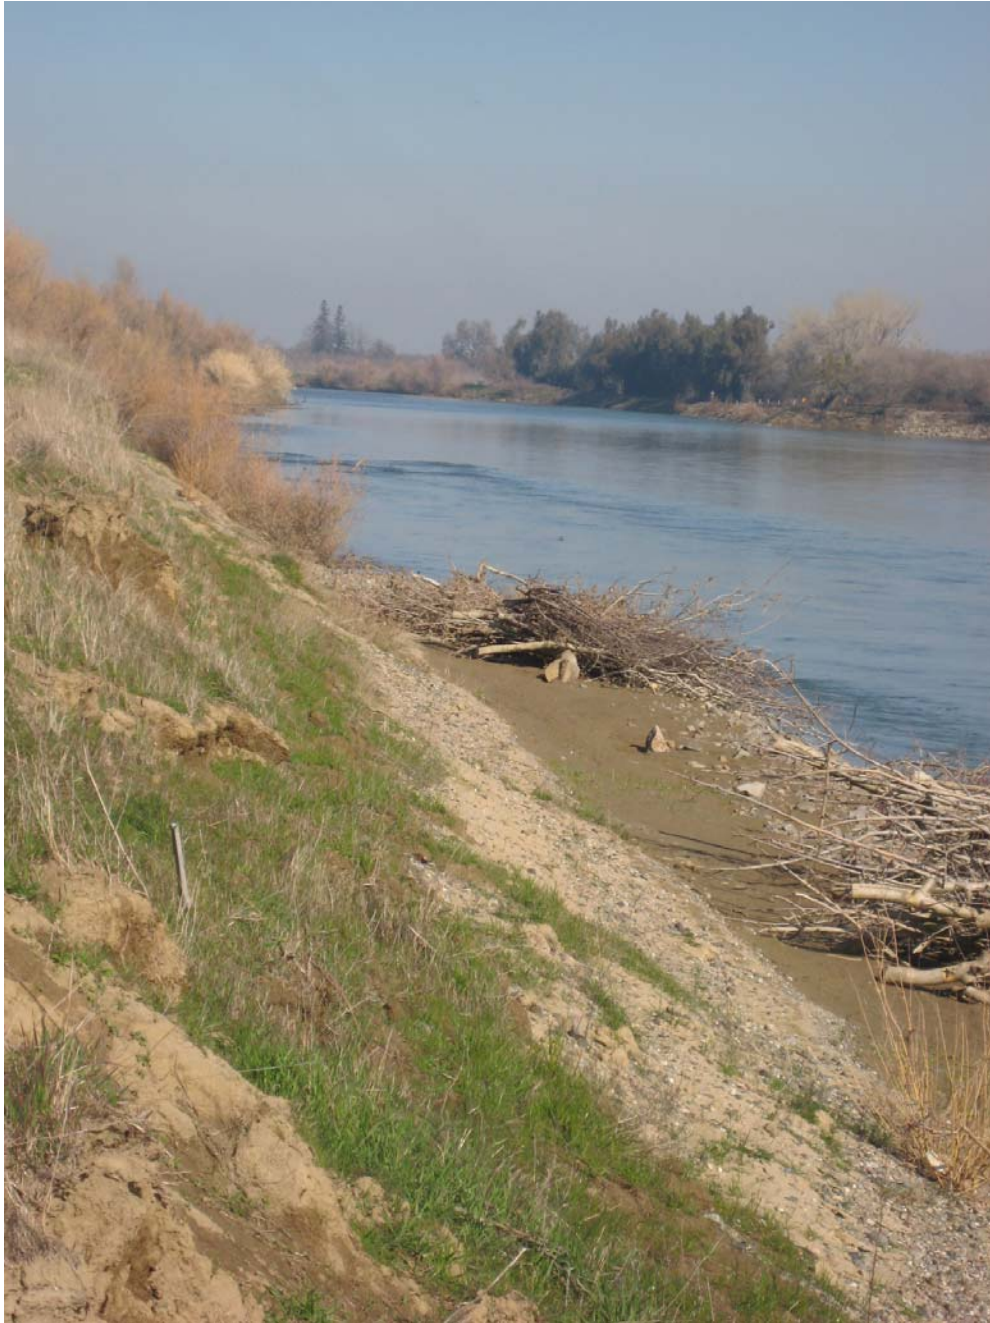
Photographs of the structure taken in March 2008 after the first period of high flows following construction are provided for reference purposes. **Figure 11** shows that the upstream end of the structure and pre-existing bank vegetation are intact. **Figure 12** shows that the woody vegetation emplaced on the top of the revetment is still in place and that there had been deposition of sediment (primarily fine sands and silts) on top of and within the upper layer of the rock. **Figure 13** shows that there was erosion and retreat of the unprotected portion of the bank, but there was no evidence of scour behind the rock. **Figure 14** shows that the within-rock woody material was still in place.

Figure 11. View upstream of the upstream end of the revetment showing the presence of the pre-construction vegetation on the upstream bank (Photo taken on 03/12/2008).

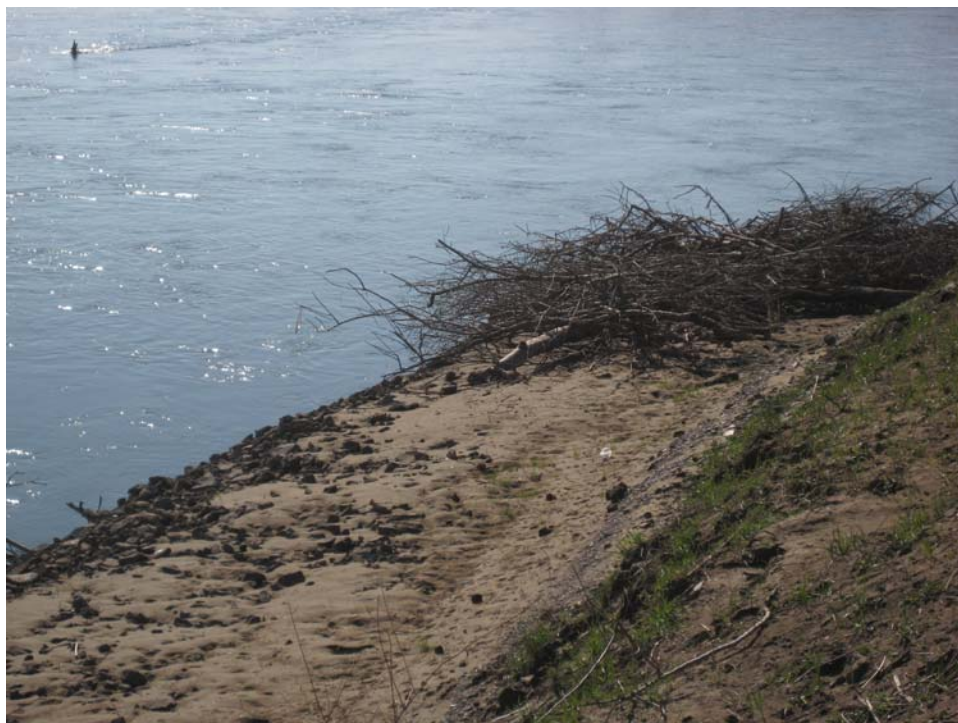
Figure 12. View of intact woody debris on top of the revetment as well as sediment deposition on top of the rock following the first higher winter flows after construction (Photo taken on 03/12/2008).

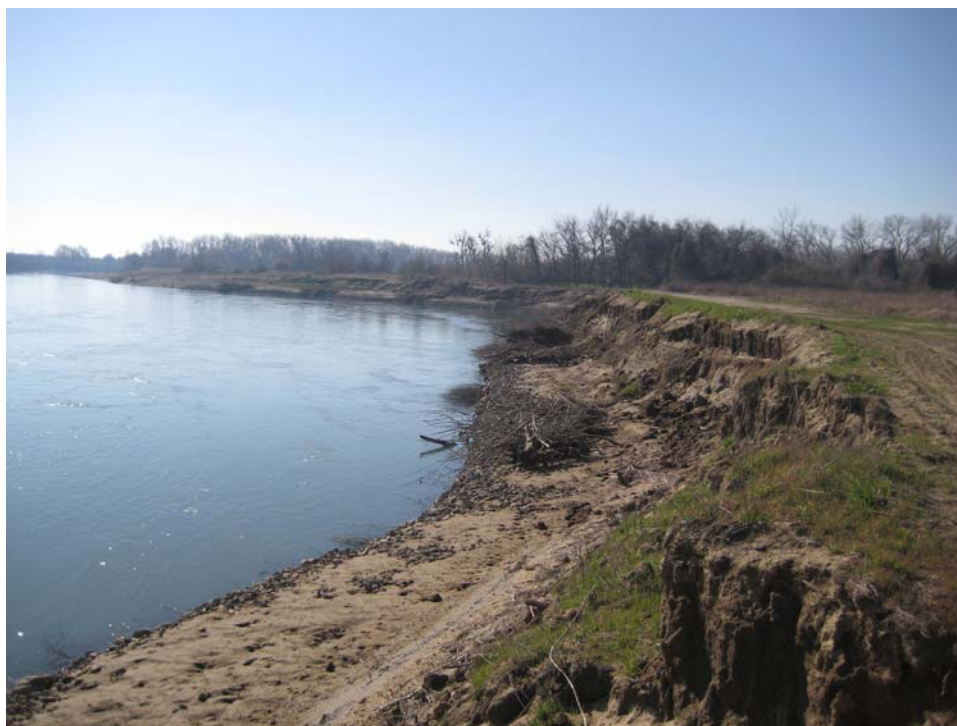
Figure 13. View downstream of bank erosion caused by the first higher winter flows after construction (Photo taken on 03/12/2008).

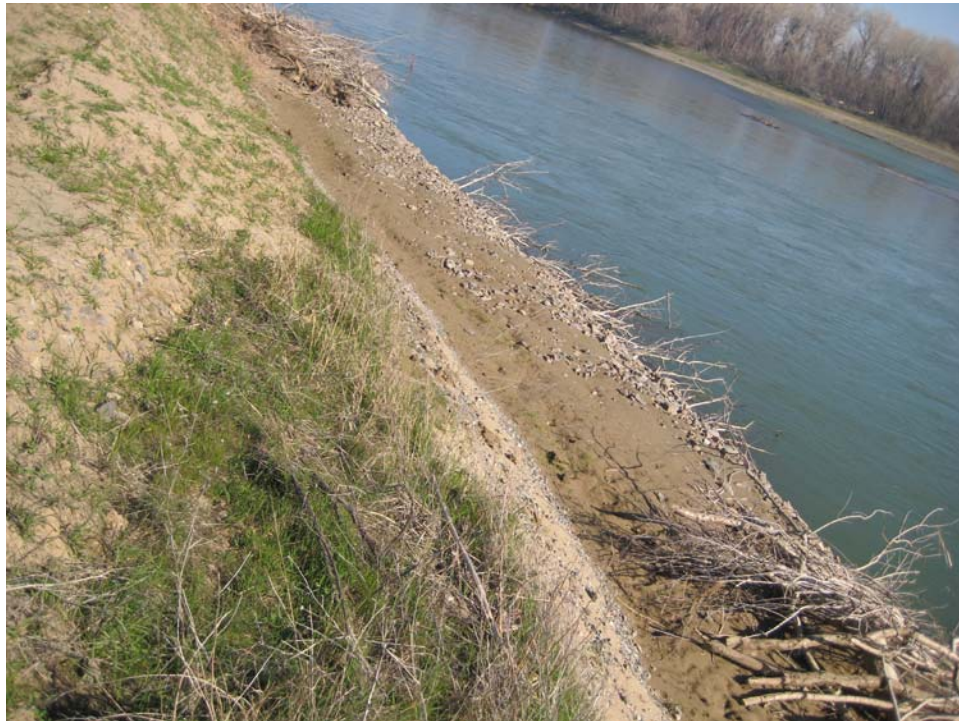
Figure 14. View of top of revetment showing the presence of woody material both on top of the revetment and encased within the structure following the first higher winter flows after construction (Photo taken on 03/12/2008).

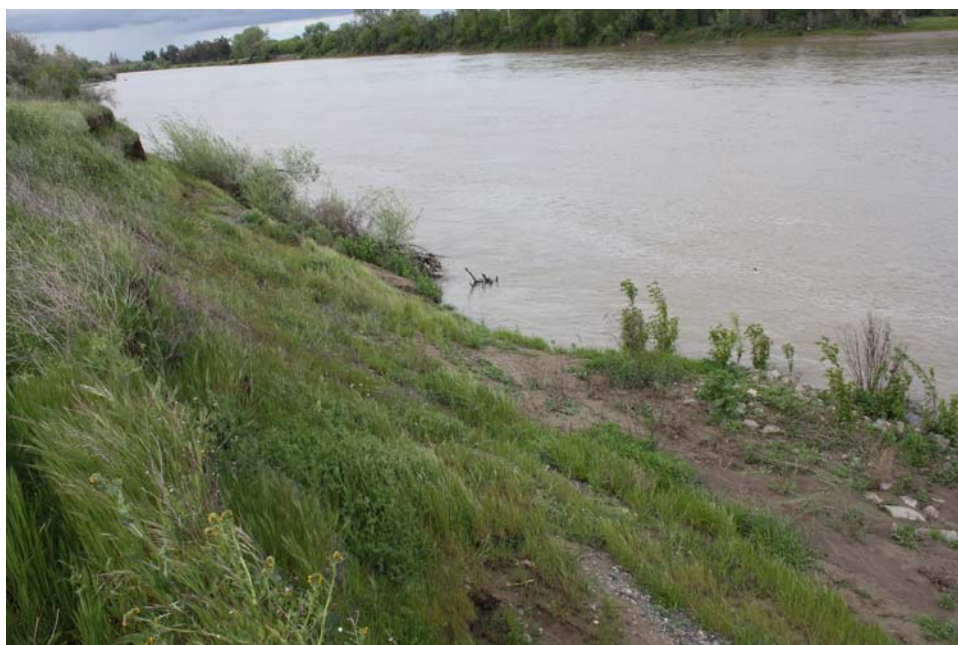
1. **Upstream Flanking** – There is no evidence that there has been any erosion at the upstream end of the structure (**Figure 15**). Comparison with Figure 11 indicates that there has been little or no change at the upstream end of the site since construction.

Figure 15. View of the upstream end of the revetment and the pre-construction riparian vegetation growing on the bank upstream of the structure. Flow in the river was about 11,000 cfs (Photo taken on 04/12/2010).

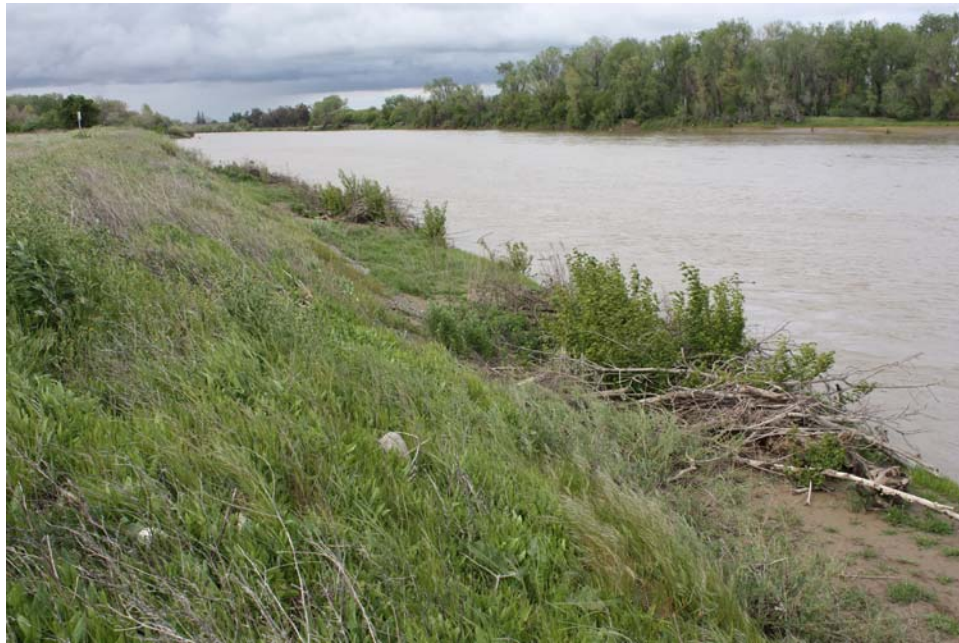
2. **Loss of Rock** – There was no evidence of loss of rock at any location along the entire 1,500 feet of the structure (**Figure 16**). The crest of the rock was sharp along the entire revetment and there was no evidence of erosion scarps.

Figure 16. View upstream of the revetment showing the presence of the woody debris piles that were constructed on top of the structure. Flow in the river was about 11,000 cfs (Photo taken on 04/12/2010).

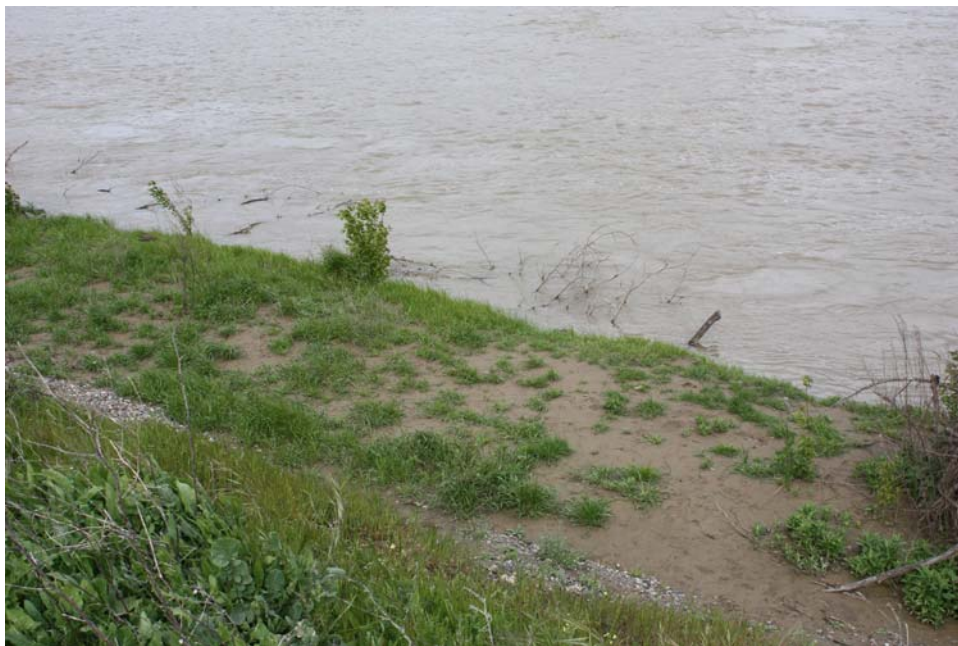
3. **Loss of Woody Material** – Although the water surface was generally above the elevation of the woody debris included within the structure, there was evidence of its presence at a number of locations (**Figure 17**). The fact that the woody material was located below the water surface at a discharge (11,000 cfs) below the design discharge (12,000 cfs) suggests there may have been some bed scour along the revetment, but it could also easily be within the margin of error for the rating curve that was used for design purposes. From a biological perspective, the woody debris is being inundated and thus providing habitat for more than the designed 50 percent of the time. Woody debris piles placed on the top of the revetment are intact (**Figure 18**) and appear to be sites of preferential establishment of boxelders and other plants (**Figure 19**), probably because of their effects on local flow velocities.

Figure 17. View of the top of submerged woody material that was incorporated into the revetment at about Elevation 117 feet. Flow in the river was about 11,000 cfs (Photo taken on 04/12/2008).

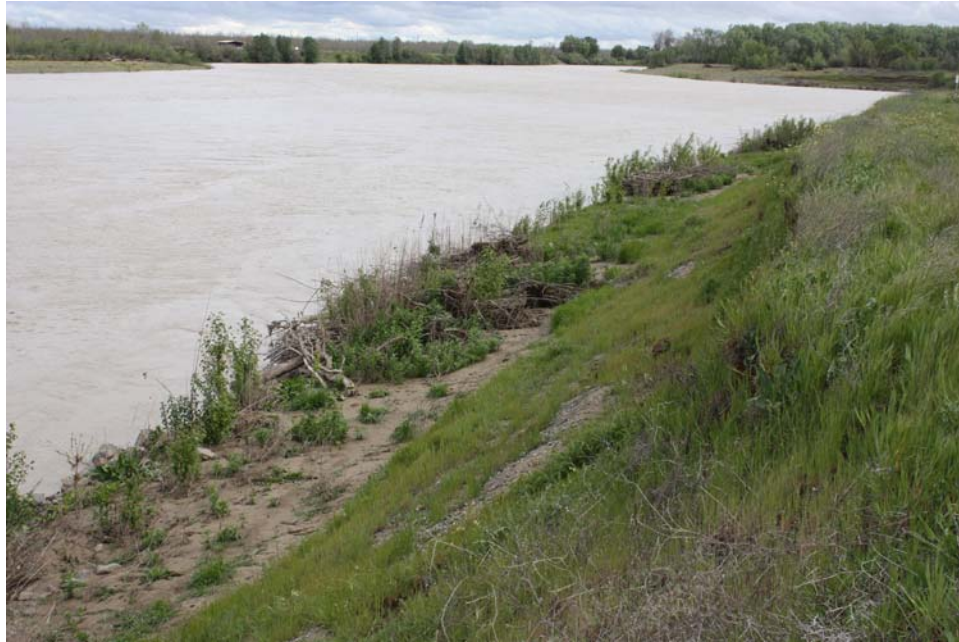
Figure 18. View downstream of the top of the revetment showing the woody debris piles that were placed and cabled onto the revetment. Flow in the river was about 11,000 cfs (Photo taken on 04/12/2008).

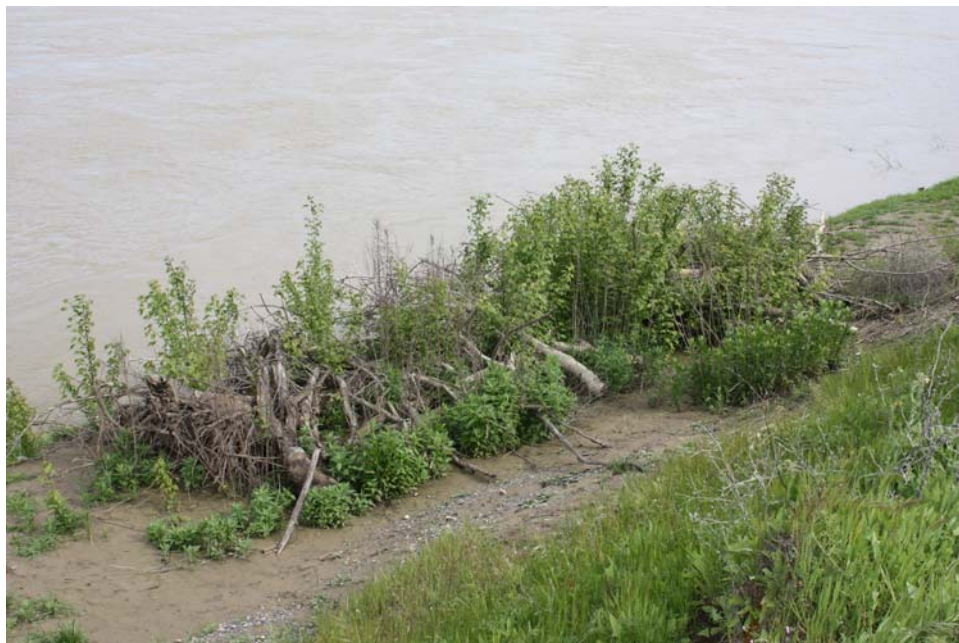
Figure 19. Close up view of a woody debris pile cabled onto the top of the revetment showing volunteer woody plants growing within and around the debris pile. Flow in the river was about 11,000 cfs (Photo taken on 04/12/2010).

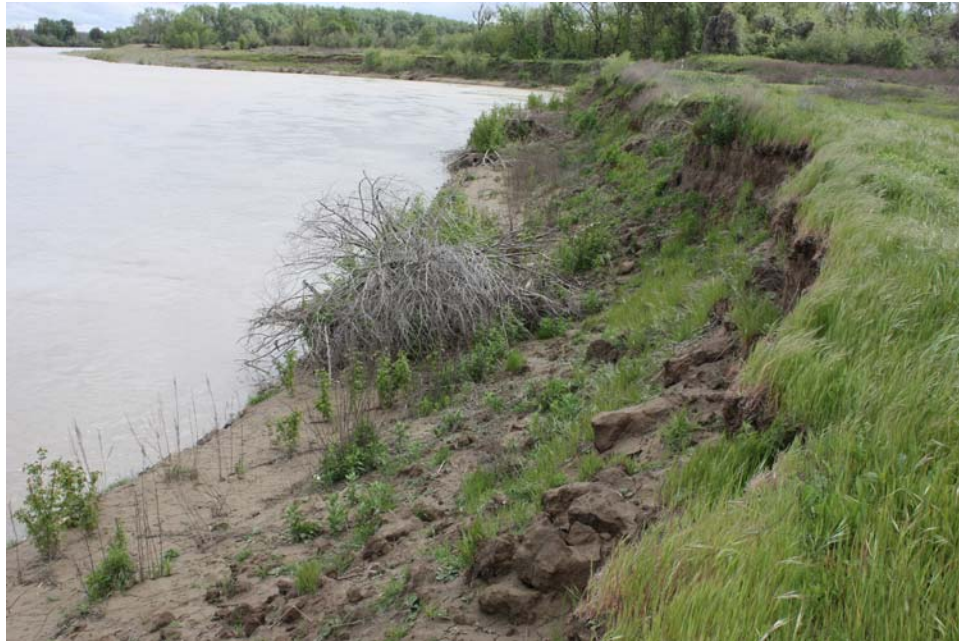
4. **Excessive Bank Erosion** – Upper bank erosion is occurring at a number of locations along the site, as expected (**Figure 20**). The ongoing erosion is lowering the bank angle as the bank rotates backwards from the armored toe. However, there is no evidence of any scour along the contact between the rock and the bank (**Figure 21**), and it is clear that woody vegetation (primarily willows) has become established at the base of the bank and on the lower angle portions of the bank (**Figure 22**).
5. **Excessive Downstream Erosion** – Observation of the downstream end of the revetment did not indicate that there had been any significant erosion of the bank downstream of the revetment (**Figure 23**) and there does not appear to have been any loss of rock (**Figure 24**).

Figure 20. View downstream of eroding upper bank above the top of the revetment that is causing the bank angle to be reduced. Flow in the river was about 11,000 cfs (Photo taken on 04/12/2010).

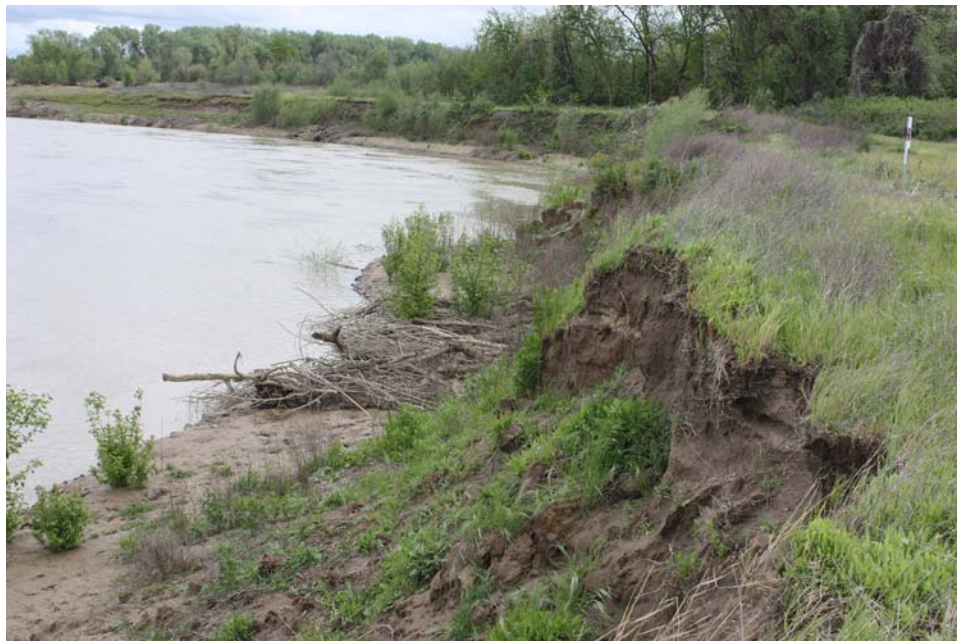
Figure 21. View downstream showing eroding upper bank but no evidence of any scour of the backfill material at the base of the bank. Flow in the river was about 11,000 cfs (Photo taken on 04/12/2008).

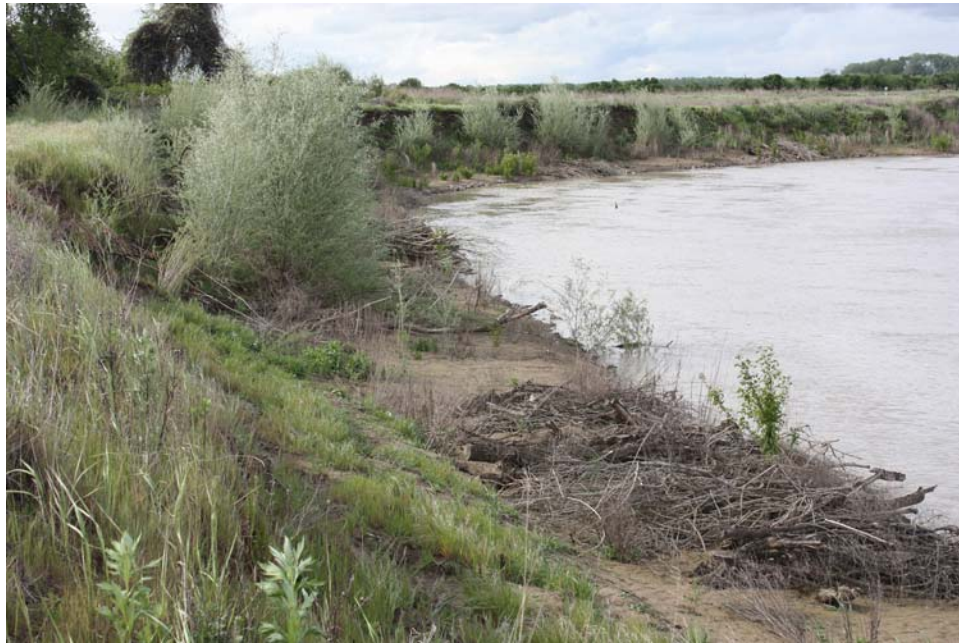
Figure 22. View upstream of willow growth along the top of the revetment and at the base of the eroding bank. Flow in the river was about 11,000 cfs (Photo taken on 04/12/2010).

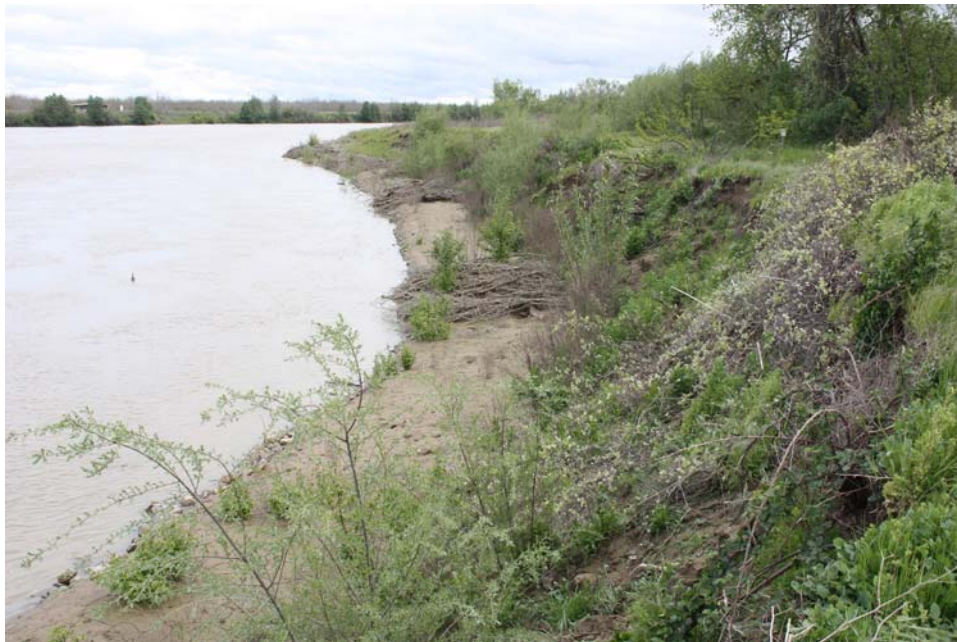
Figure 23. View downstream of the downstream part of the revetment with vegetation growing at the toe of the bank and on the top of the revetment. Flow in the river was about 11,000 cfs (Photo taken on 04/12/2010).

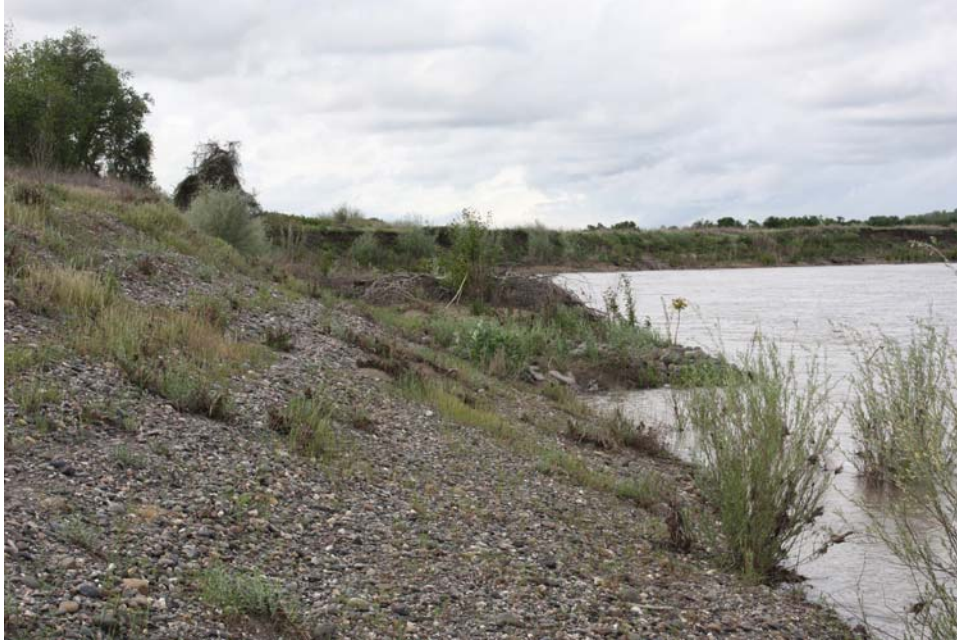
Figure 24. View upstream of the downstream end of the revetment and the downstream tie back. Flow in the river was about 11,000 cfs (Photo taken on 04/12/2010).
