TO: Jim Well, Ducks Unlimited
FROM: Mike Harvey, PhD, PG
SUBJECT: **M&T/ Llano Seco Fish Screen Facility Short-Term/Long-Term Protection Project (Project No. US-CA-62-2)**
Maintenance Inspection and Reports (Subtask 14.1)
Inspection Report No.2

DATE: May 8, 2012

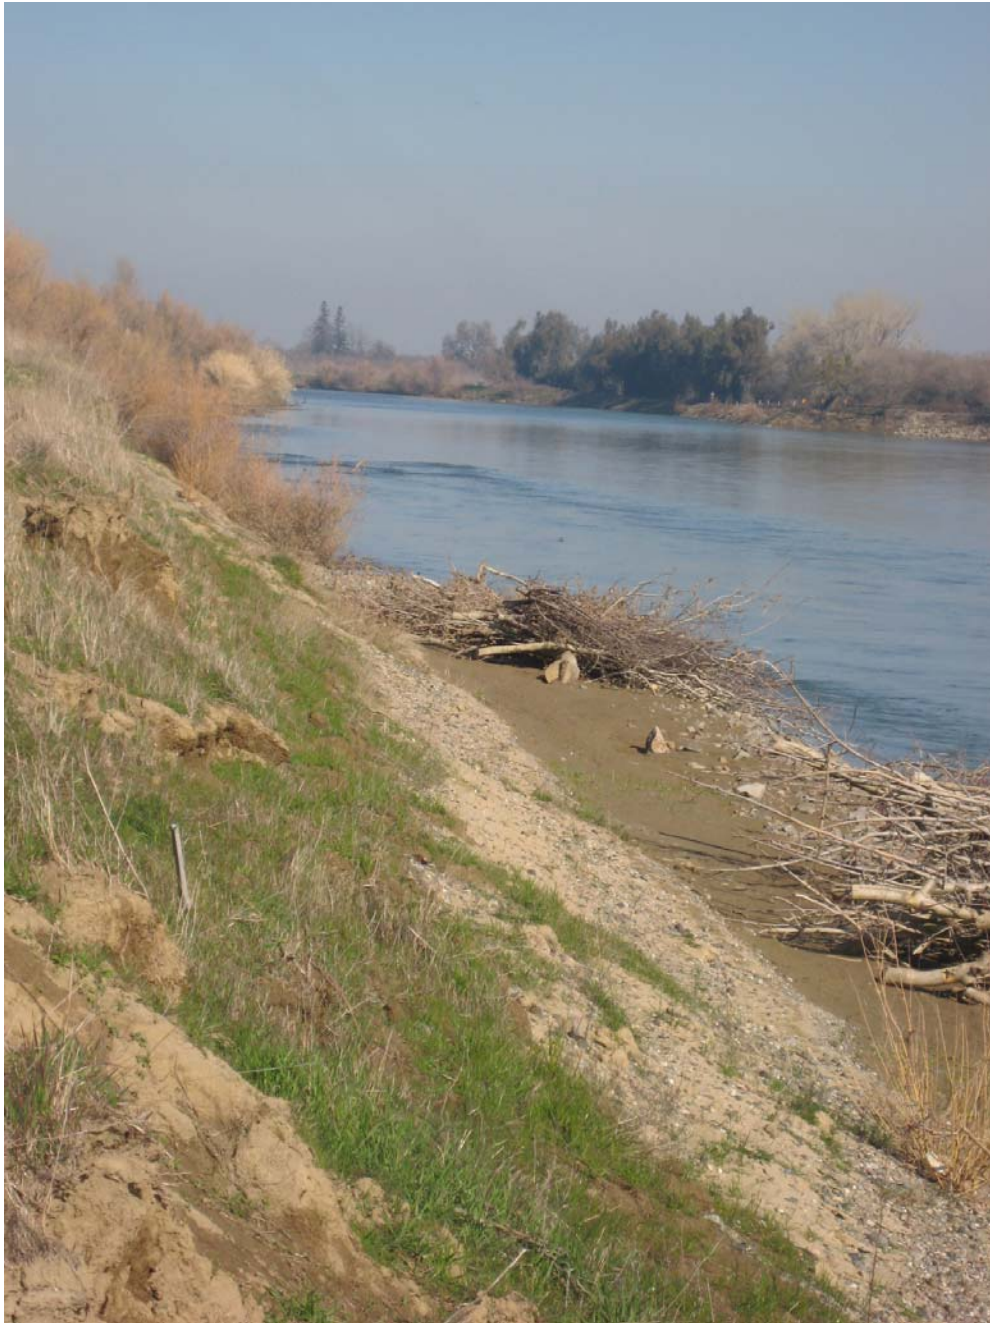
Photographs of the structure taken in March 2008 after the first period of high flows following construction are provided for reference purposes. **Figure 11** shows that the upstream end of the structure and pre-existing bank vegetation are intact. **Figure 12** shows that the woody vegetation emplaced on the top of the revetment is still in place and that there had been

Figure 11. View upstream of the upstream end of the revetment showing the presence of the pre-construction vegetation on the upstream bank (Photo taken on 03/12/2008).

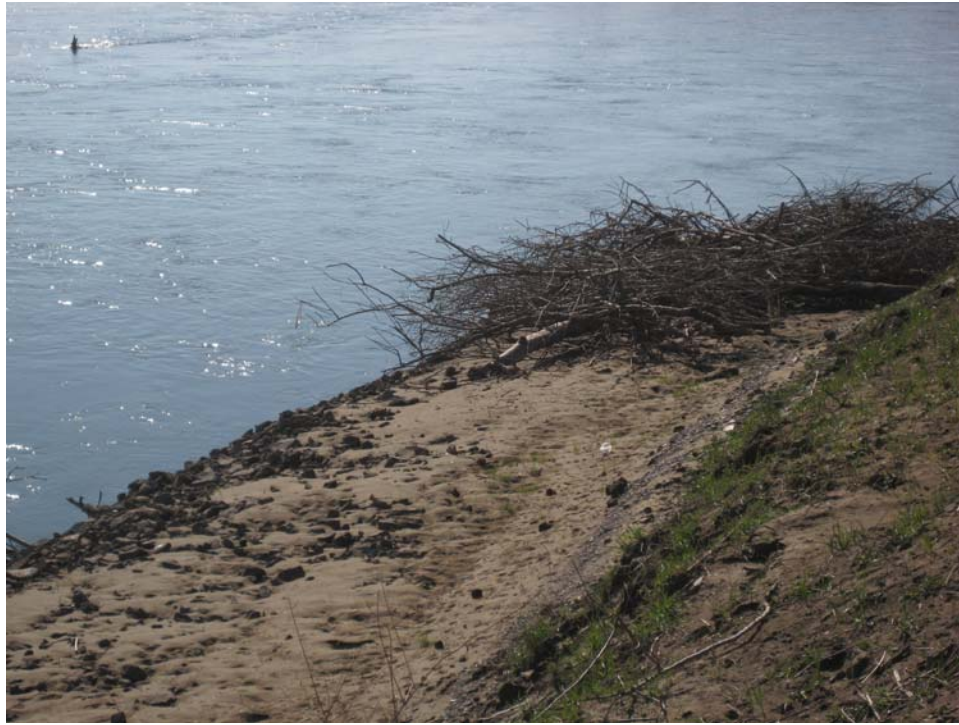
deposition of sediment (primarily fine sands and silts) on top of and within the upper layer of the rock. **Figure 13** shows that there was erosion and retreat of the unprotected portion of the bank, but there was no evidence of scour behind the rock. **Figure 14** shows that the within-rock woody material was still in place.

Figure 12. View of intact woody debris on top of the revetment as well as sediment deposition on top of the rock following the first higher winter flows after construction (Photo taken on 03/12/2008).

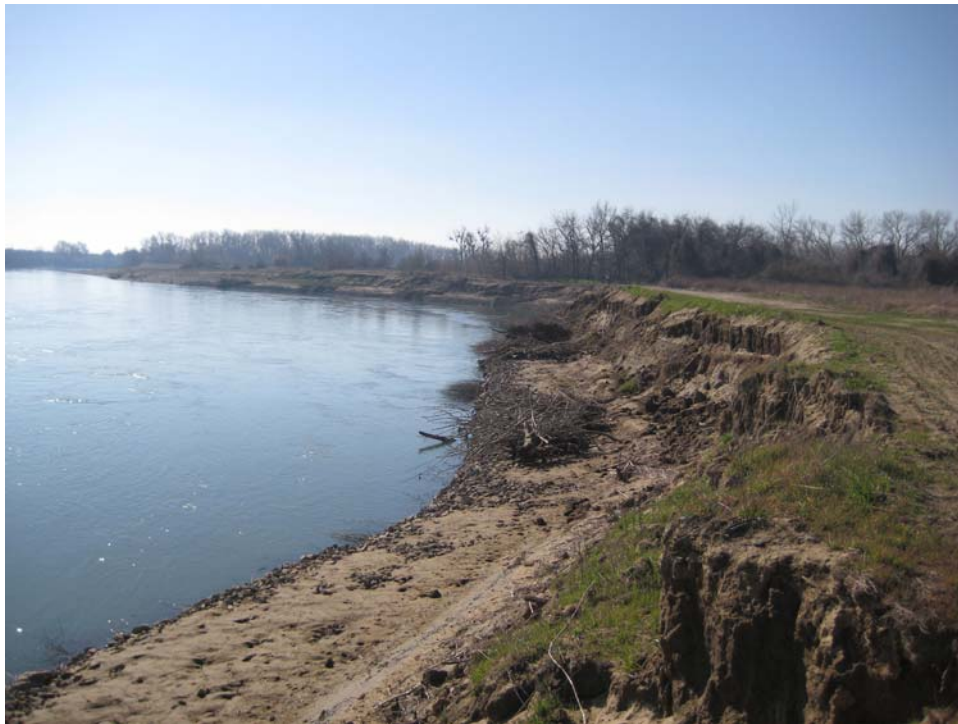
Figure 13. View downstream of bank erosion caused by the first higher winter flows after construction (Photo taken on 03/12/2008).

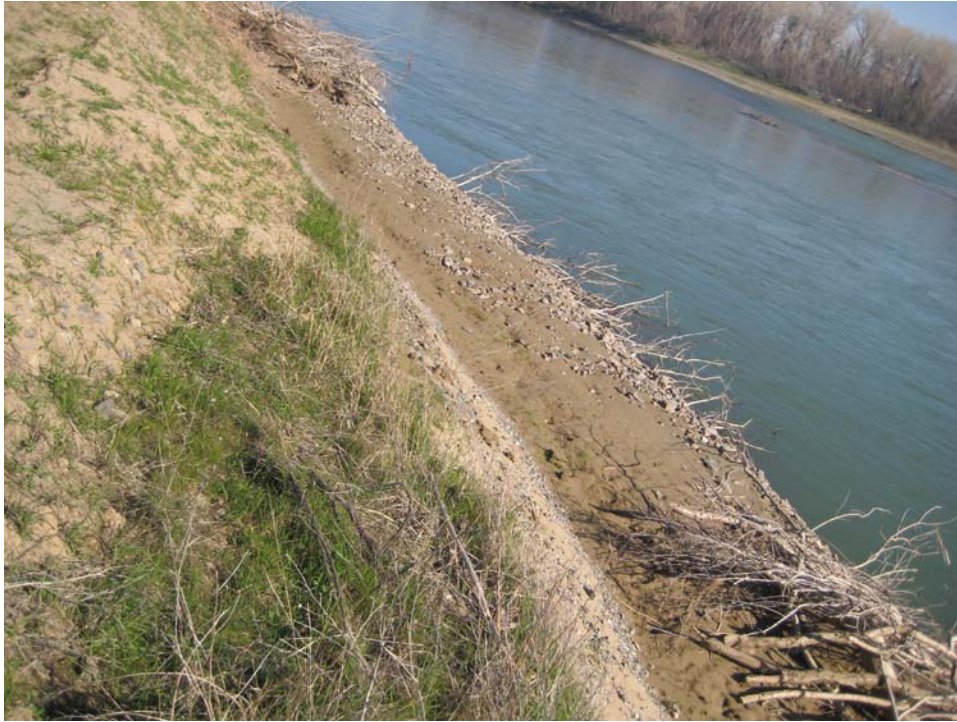
Figure 14. View of top of revetment showing the presence of woody material both on top of the revetment and encased within the structure following the first higher winter flows after construction (Photo taken on 03/12/2008).

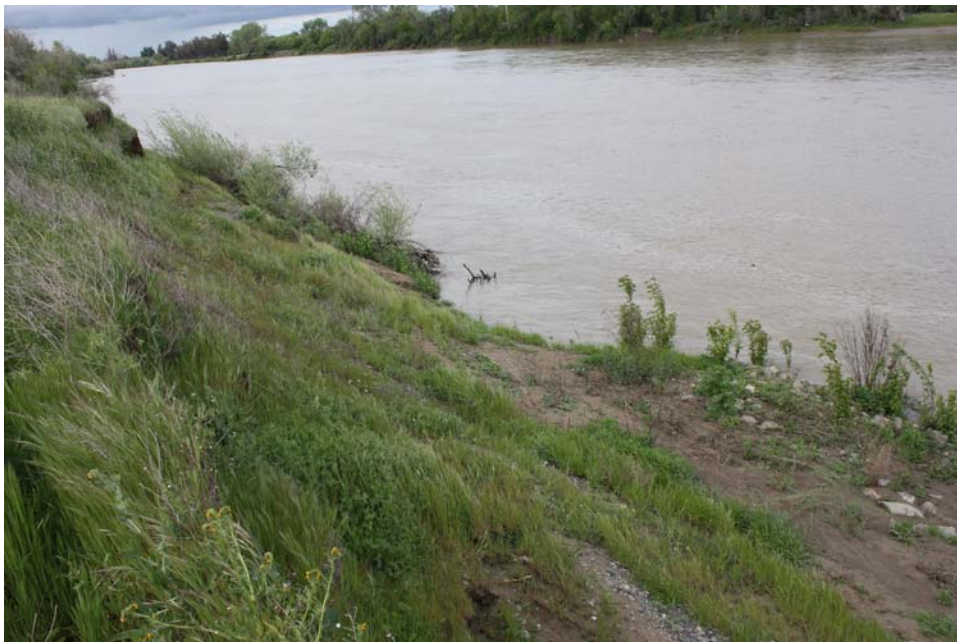
1. **Upstream Flanking** – There was no evidence that there has been any erosion at the upstream end of the structure (**Figure 15**). Comparison with Figure 11 indicates that there has been little or no change at the upstream end of the site since construction.

Figure 15. View of the upstream end of the revetment and the pre-construction riparian vegetation growing on the bank upstream of the structure. Flow in the river was about 11,000 cfs (Photo taken on 04/12/2010).

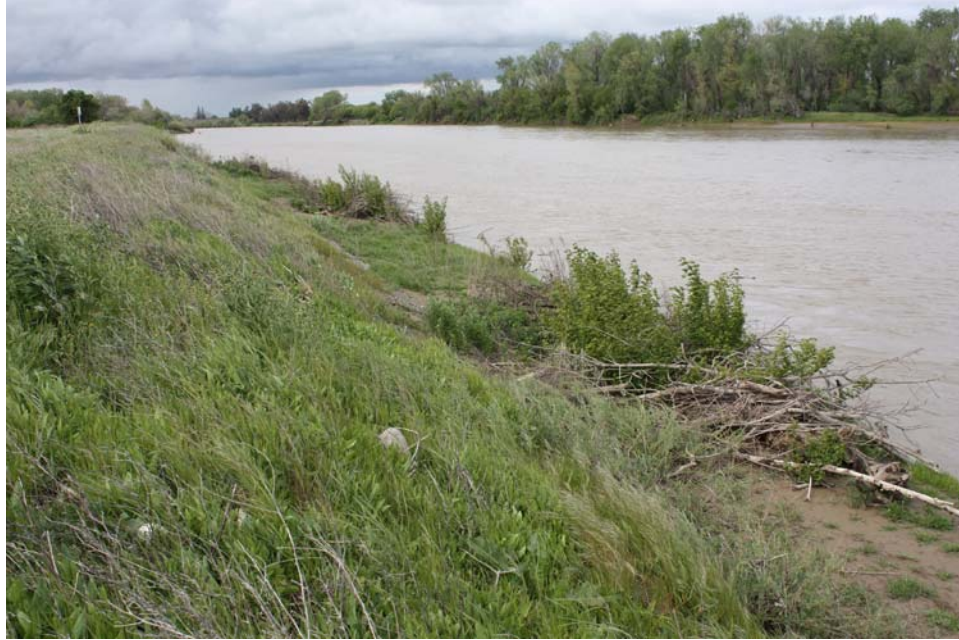
2. **Loss of Rock** – There was no evidence of loss of rock at any location along the entire 1,500 feet of the structure (**Figure 16**). The crest of the rock was sharp along the entire revetment and there was no evidence of erosion scarps.

Figure 16. View upstream of the revetment showing the presence of the woody debris piles that were constructed on top of the structure. Flow in the river was about 11,000 cfs (Photo taken on 04/12/2010).

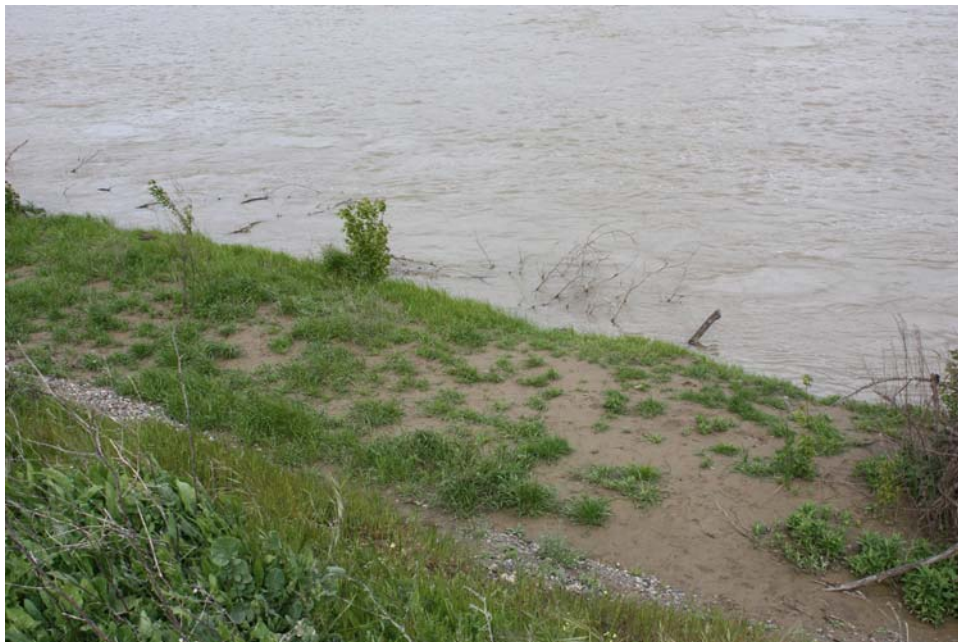
3. **Loss of Woody Material** – Although the water surface was generally above the elevation of the woody debris included within the structure, there was evidence of its presence at a number of locations (**Figure 17**). The fact that the woody material was located below the water surface at a discharge (11,000 cfs) below the design discharge (12,000 cfs) suggests there may have been some bed scour along the revetment, but it could also easily be within the margin of error for the rating curve that was used for design purposes. From a biological perspective, the woody debris is being inundated and thus providing habitat for more than the designed 50 percent of the time. Woody debris piles placed on the top of the revetment were intact (**Figure 18**) and appear to be sites of preferential establishment of boxelders and other plants (**Figure 19**), probably because of their effects on local flow velocities.

Figure 17. View of the top of submerged woody material that was incorporated into the revetment at about Elevation 117 feet. Flow in the river was about 11,000 cfs (Photo taken on 04/12/2008).

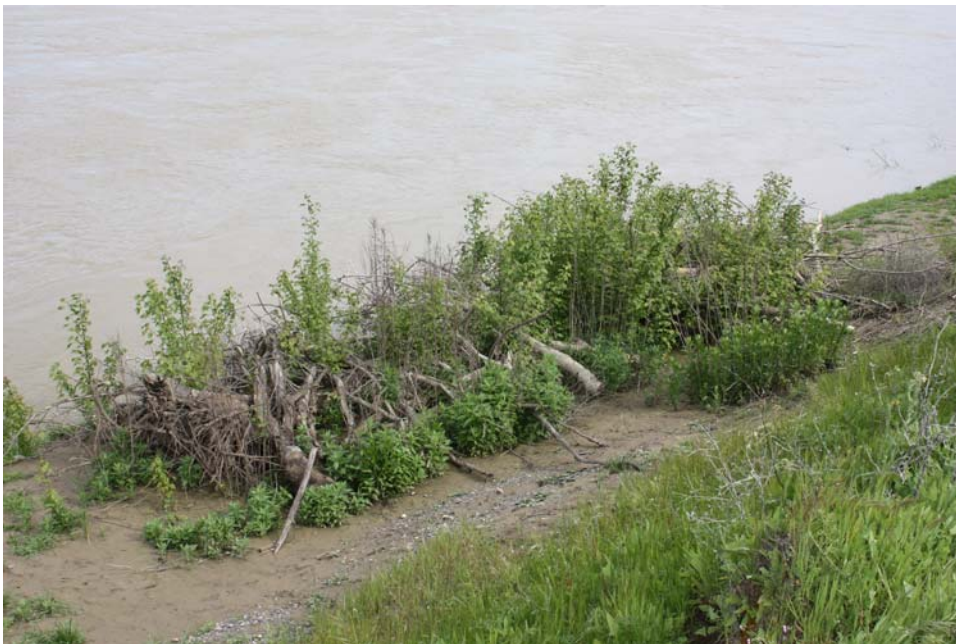
Figure 19. Close up view of a woody debris pile cabled onto the top of the revetment showing volunteer woody plants growing within and around the debris pile. Flow in the river was about 11,000 cfs (Photo taken on 04/12/2010).

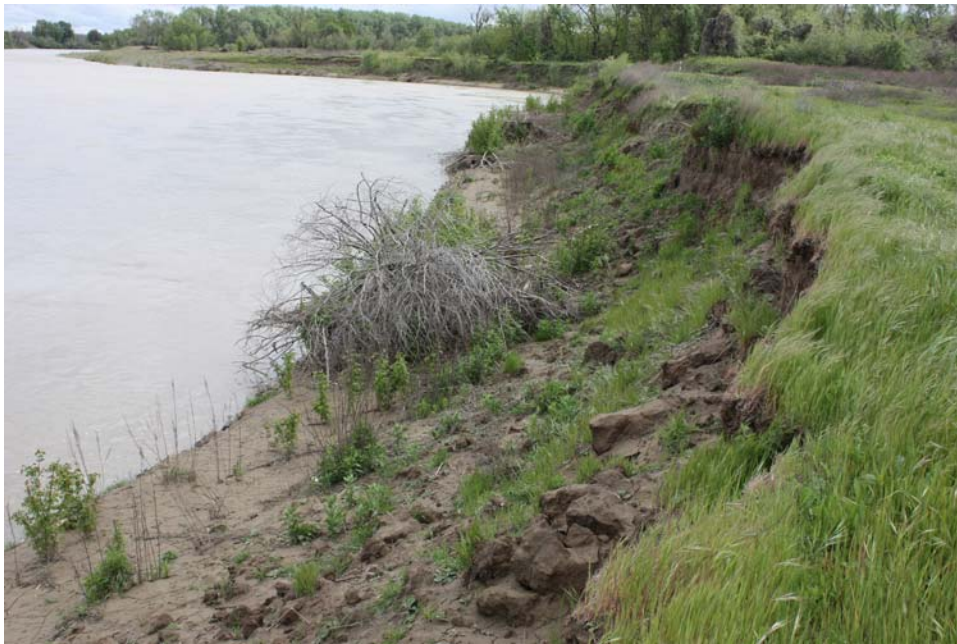
4. **Excessive Bank Erosion** – Upper bank erosion was occurring at a number of locations along the site, as expected (**Figure 20**). The ongoing erosion is lowering the bank angle as the bank rotates backwards from the armored toe. However, there was no evidence of any scour along the contact between the rock and the bank (**Figure 21**), and it is clear that

4. **Excessive Bank Erosion** – Upper bank erosion continues to occur at a number of locations along the site, as expected (Figures 20, 21). The ongoing erosion is lowering the bank angle as the bank rotates backwards from the armored toe. However, there was no evidence of any scour along the contact between the rock and the bank (Figure 21), and it is clear that woody vegetation (primarily willows) has become established at the base of the bank and on the lower angle portions of the bank (Figure 22).

Figure 20. View downstream of eroding upper bank above the top of the revetment that is causing the bank angle to be reduced. Flow in the river was about 11,000 cfs (Photo taken on 04/12/2010).

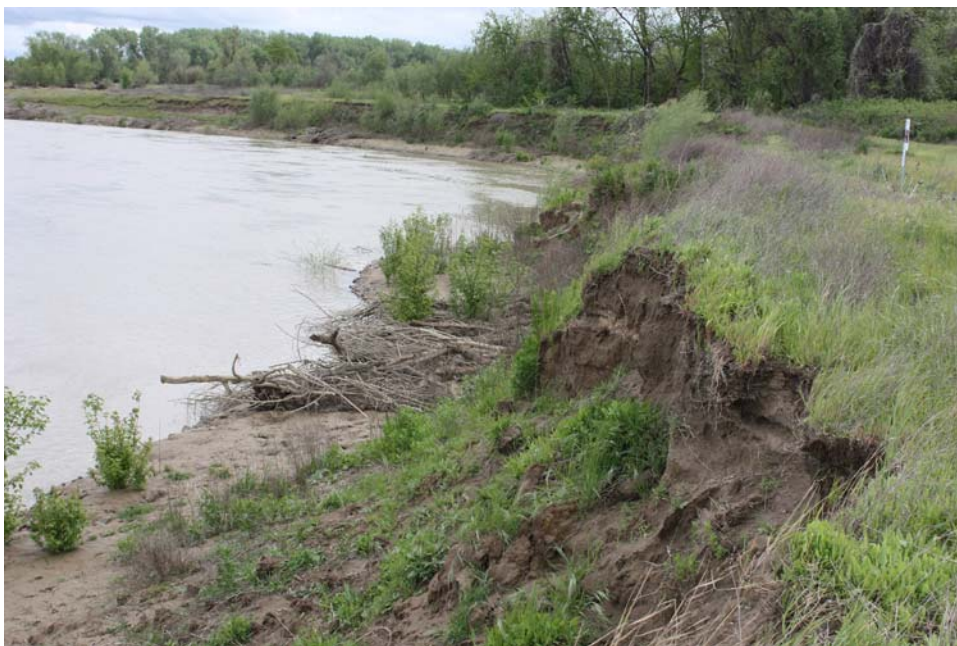
Figure 21. View downstream showing eroding upper bank but no evidence of any scour of the backfill material at the base of the bank. Flow in the river was about 11,000 cfs (Photo taken on 04/12/2010).

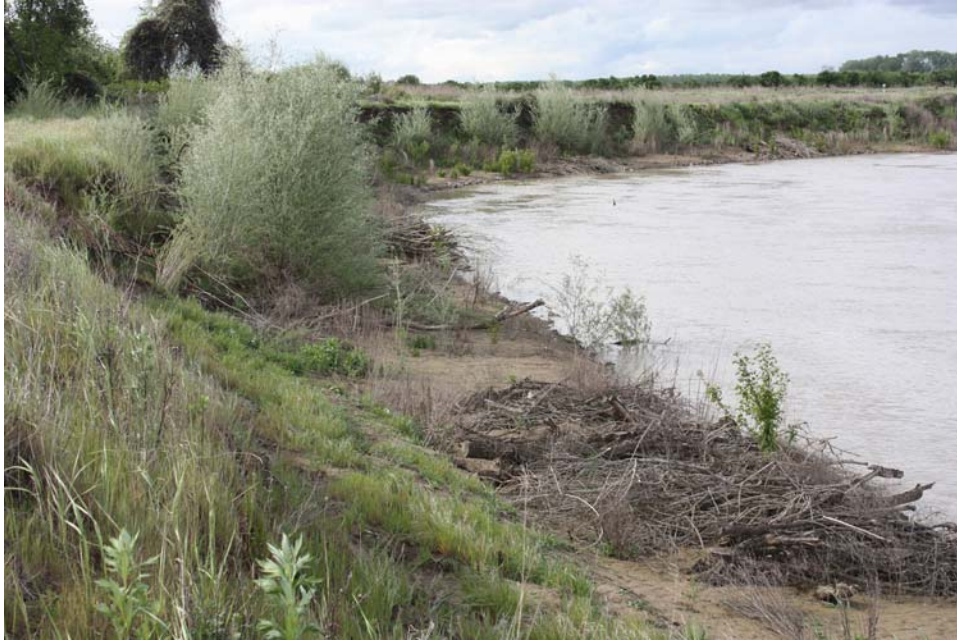
woody vegetation (primarily willows) has become established at the base of the bank and on the lower angle portions of the bank (**Figure 22**).

Figure 22. View upstream of willow growth along the top of the revetment and at the base of the eroding bank. Flow in the river was about 11,000 cfs (Photo taken on 04/12/2010).

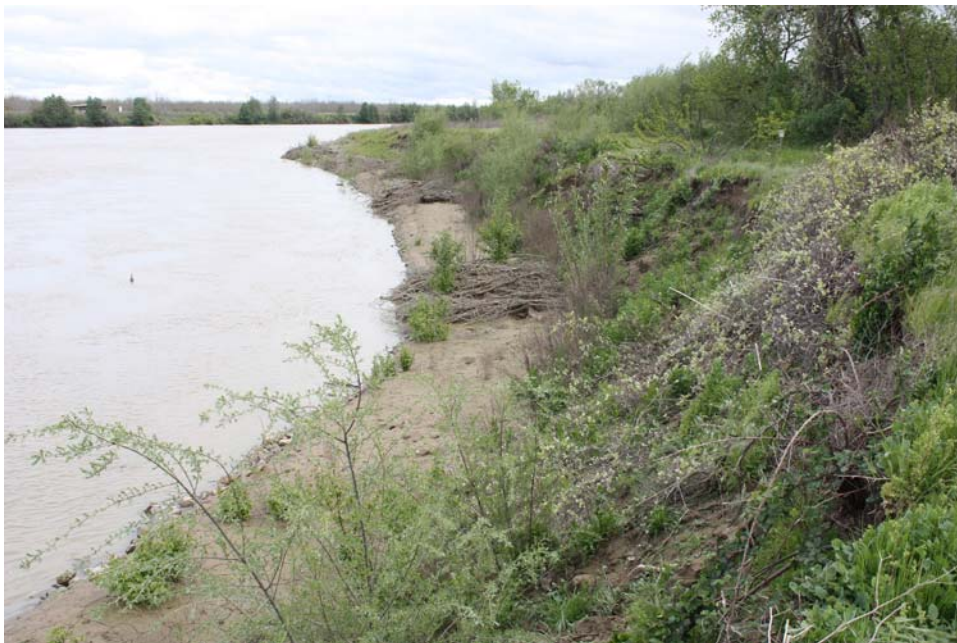
5. **Excessive Downstream Erosion** – Observation of the downstream end of the revetment did not indicate that there had been any significant erosion of the bank downstream of the revetment (**Figure 23**) and there does not appear to have been any loss of rock (**Figure 24**).

Figure 23. View downstream of the downstream part of the revetment with vegetation growing at the toe of the bank and on the top of the revetment. Flow in the river was about 11,000 cfs (Photo taken on 04/12/2010).

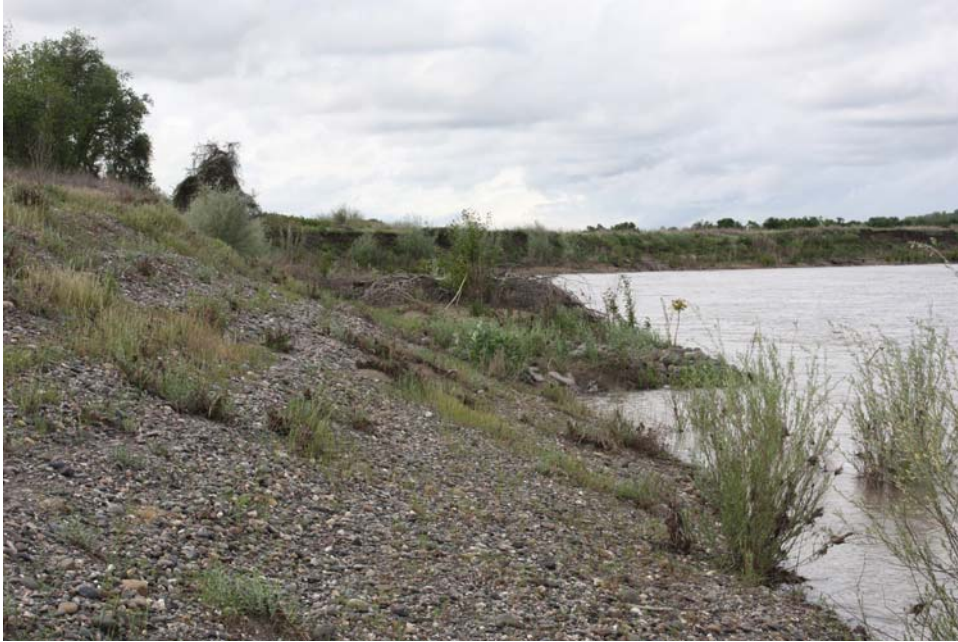
Figure 24. View upstream of the downstream end of the revetment and the downstream tie back. Flow in the river was about 11,000 cfs (Photo taken on 04/12/2010).

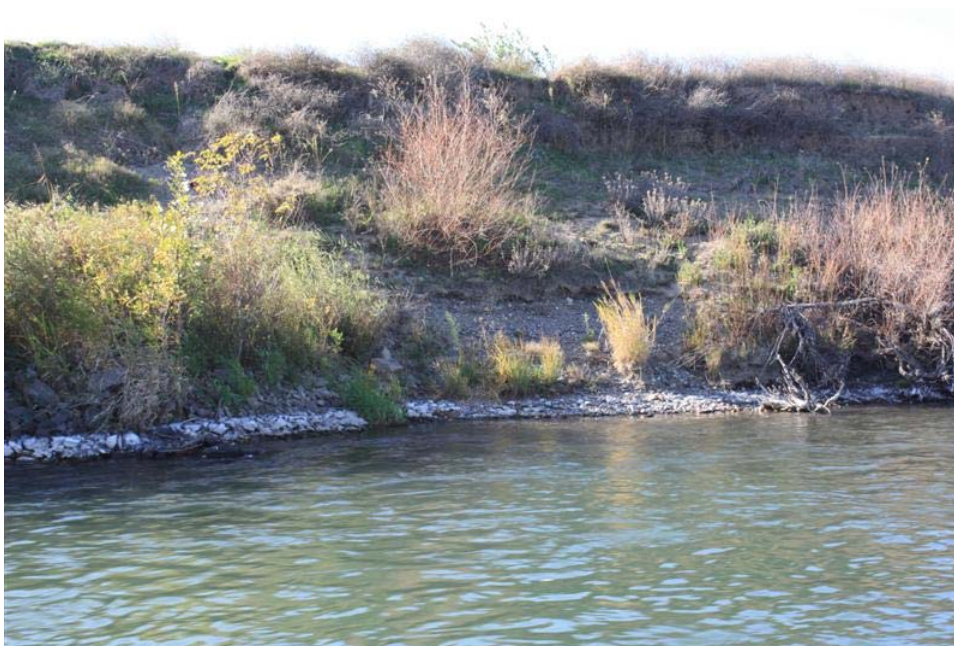
1. **Upstream Flanking** – There was no evidence that there has been any erosion at the upstream end of the structure (**Figure 25**). Comparison with Figures 11 and 15 indicates that there has been little or no change at the upstream end of the site since construction.

Figure 25. View of the upstream end of the rock revetment and transition to unprotected bank. Note the presence of the willows growing on the bank indicating that there has been little or no erosion at the upstream end of the revetment.

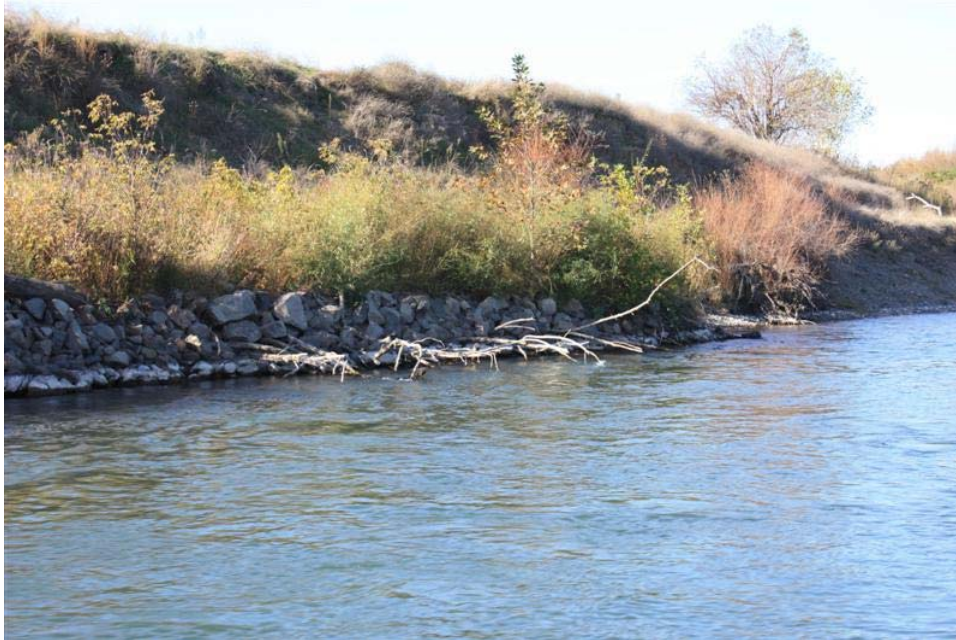
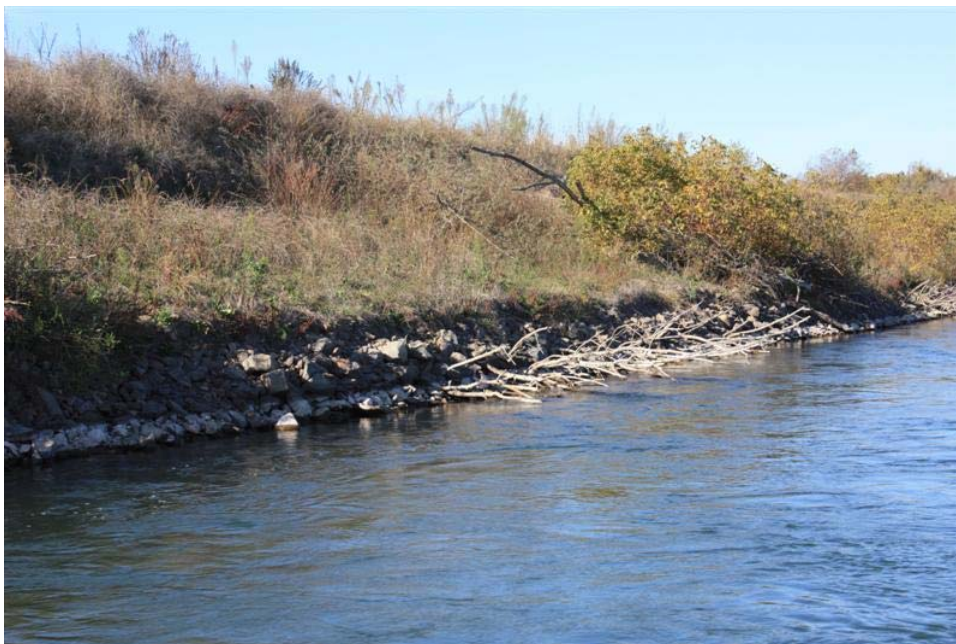
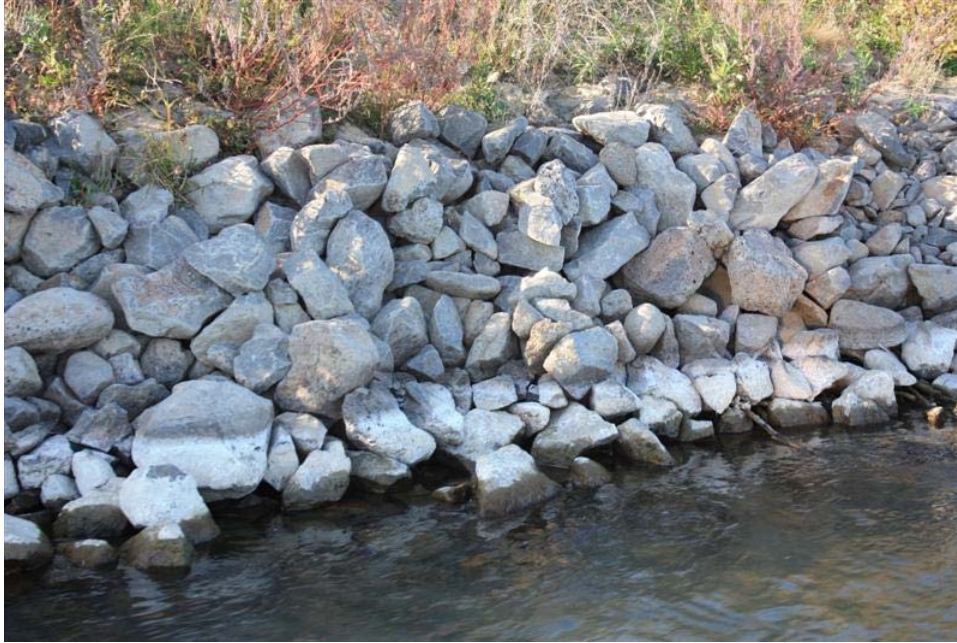
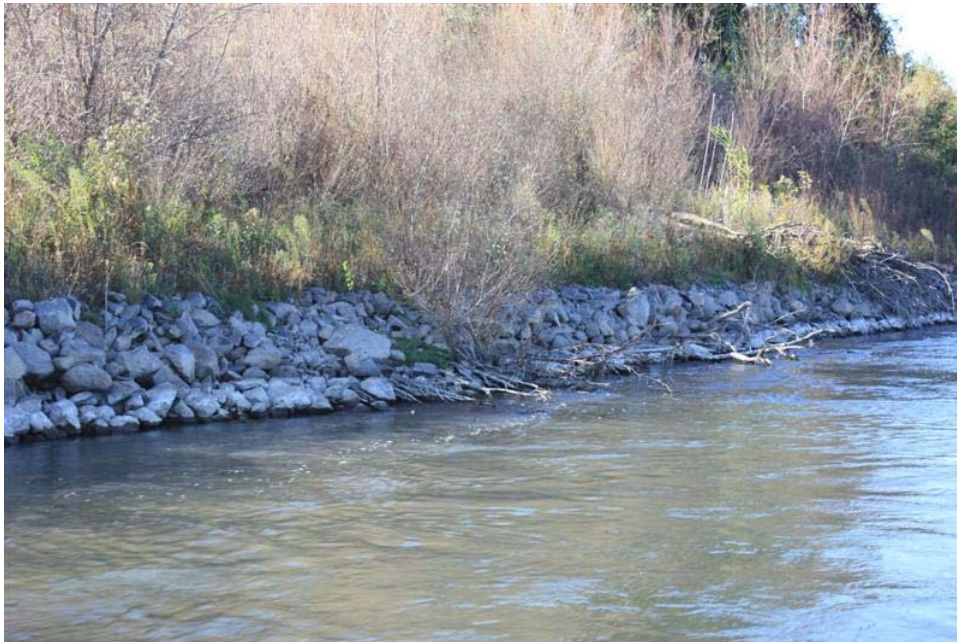
2. **Loss of Rock** – There was no evidence of loss of rock at any location along the entire 1,500 feet of the structure (**Figures 26, 27, 28, 29**). The crest of the rock was sharp along the entire revetment and there was no evidence of erosion scarps.

Figure 26. Upstream view of the upstream end of the toe rock revetment. Note presence of riparian vegetation as well as the large woody debris emplaced within the rock during construction. There is no evidence of loss of rock. Note the larger anchor boulders that were used to secure the large woody debris emplaced on the top of the revetment.

Figure 27. Upstream view of the upper section of the toe rock revetment. Note the large woody debris emplaced on the top of the rock and within the rock during construction and the riparian vegetation that has volunteered onto the top of the rock especially in the vicinity of the large woody debris placed on the top of the rock.

Figure 28. Close up view of the rock toe within the middle section of the revetment. There is no evidence of loss of rock.

Figure 29. Close up view of the rock toe within the lower end of the revetment. There is no evidence of loss of rock.

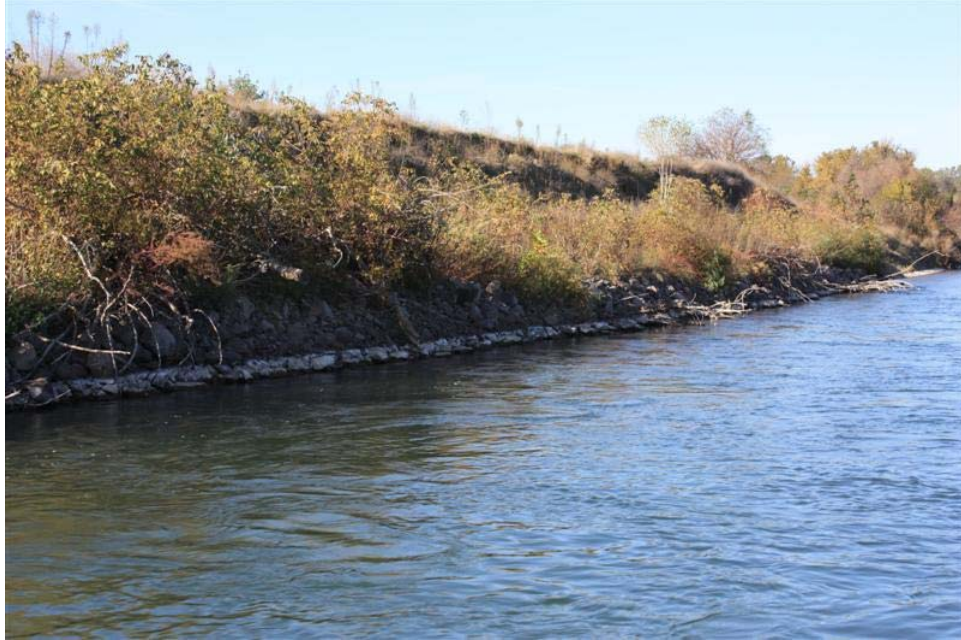
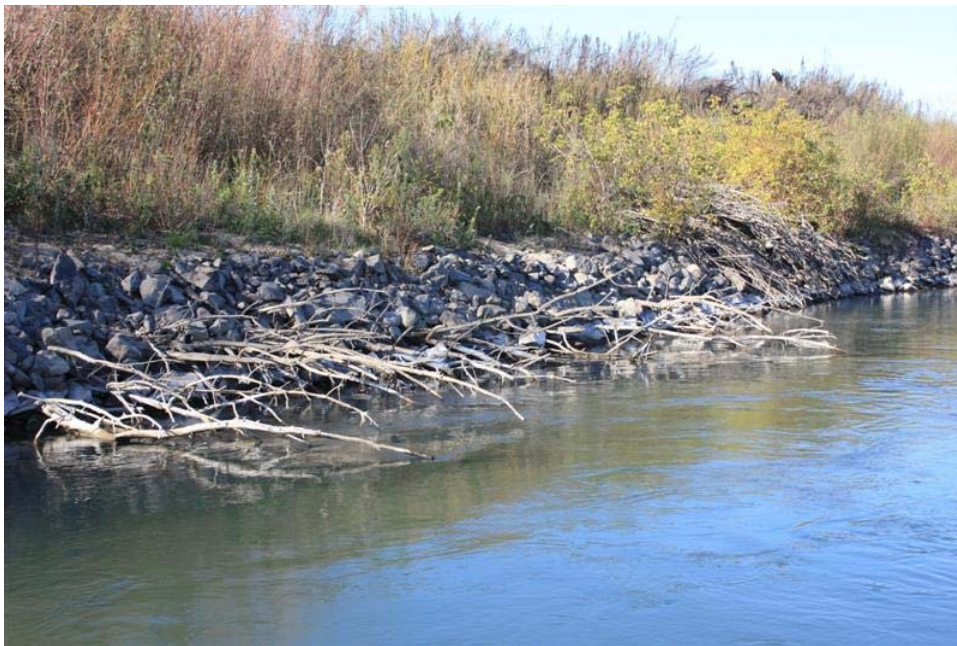
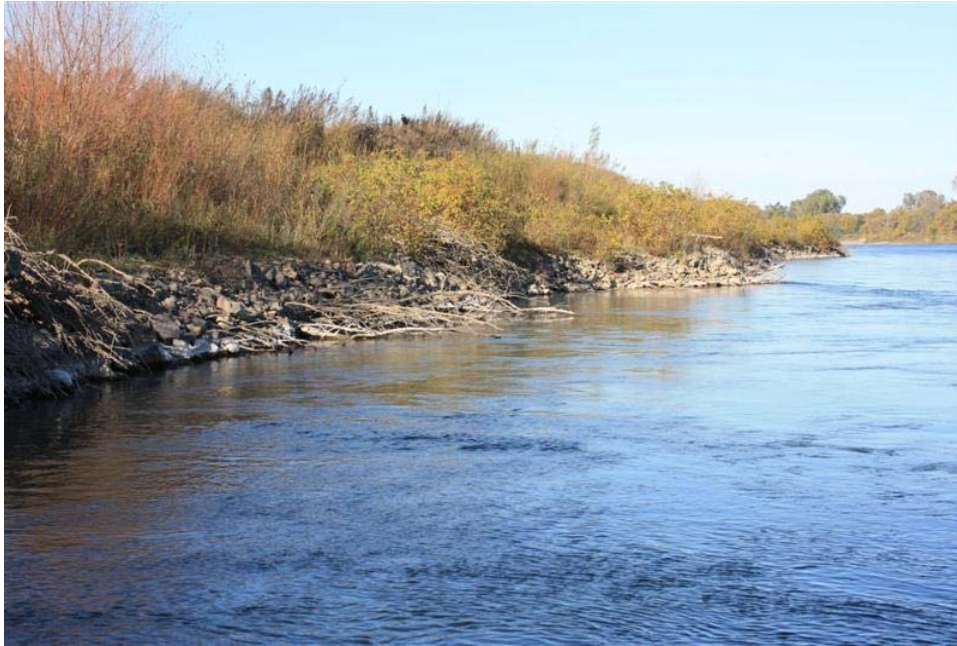
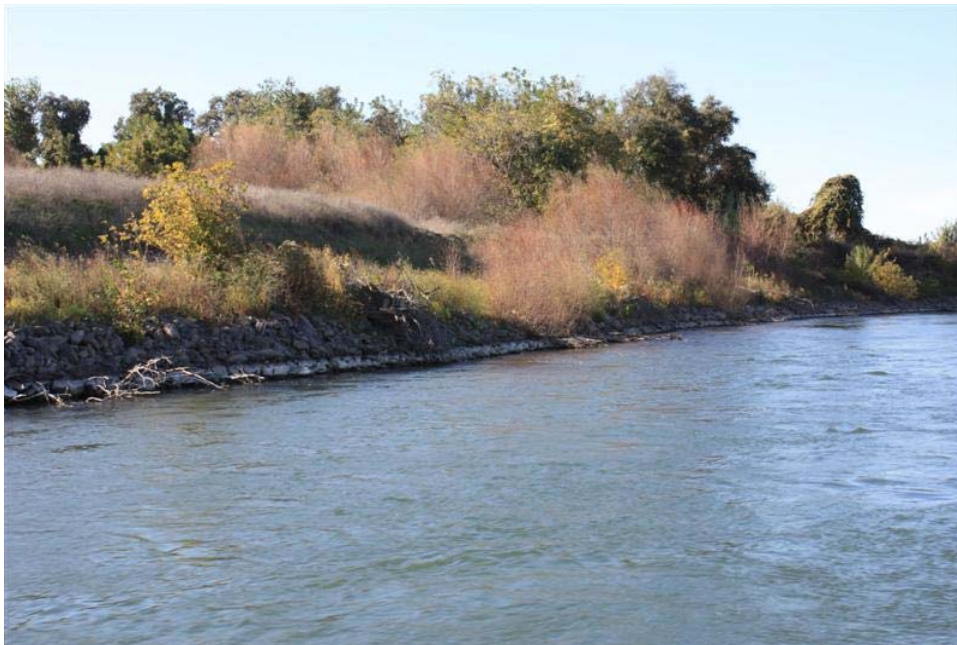
3. **Loss of Woody Material** – The water-surface elevation at a discharge of 7,190 cfs is below the large woody debris included within the structure at construction (Figure 6). Woody debris piles placed on the top of the revetment and within the revetment were intact along the entire site (**Figures 30, 31, 32, 33**). The large woody debris piles anchored on the top of the structure appears to be sites of preferential establishment of boxelders, sycamore and willows (**Figure 34**), probably because of their effects on local flow velocities.

Figure 30. Close up view of the upper section of the toe rock revetment. There is no evidence of loss of rock.

Figure 31. Upstream view of the middle section of the toe rock revetment. Note the large woody debris emplaced on the top of the rock and within the rock during construction.

Figure 32. Upstream view of the middle section of the toe rock revetment. Note the very dense volunteered riparian vegetation species growing on the top of the rock and the presence of the emplaced large woody debris on the top of the rock and within the rock.

Figure 33. Upstream view of the lower (downstream) end of the toe rock revetment. Note the presence of volunteered riparian vegetation species including sycamore, box elder and willows on the surface of the rock.

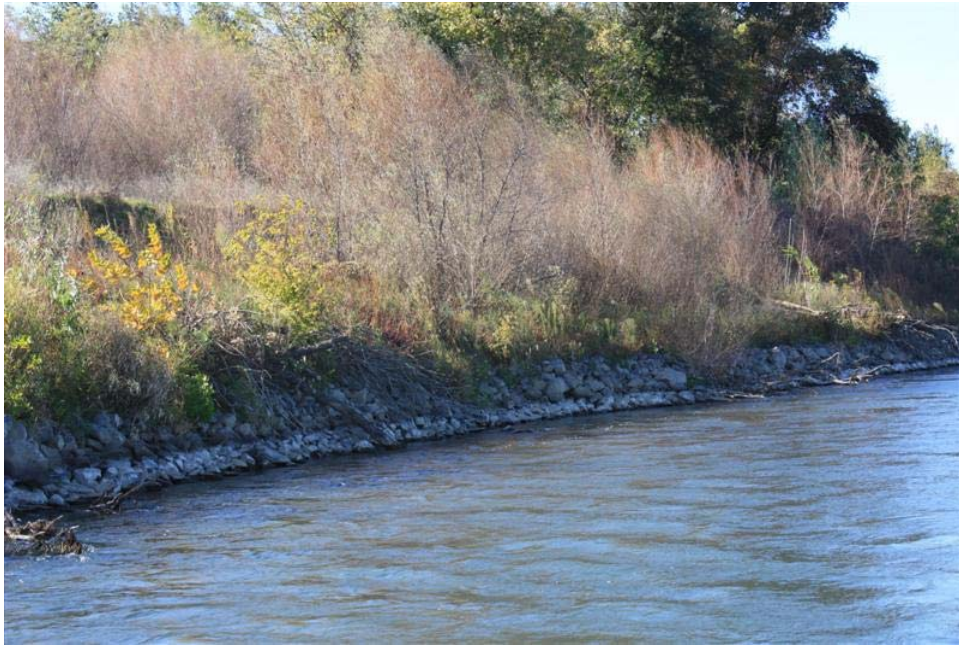
Figure 34. Upstream view of the lower end of the toe rock revetment. Note presence of volunteered riparian vegetation species as well as emplaced large woody debris on the top of the rock and within the rock. There is no evidence of loss of rock from the revetment.

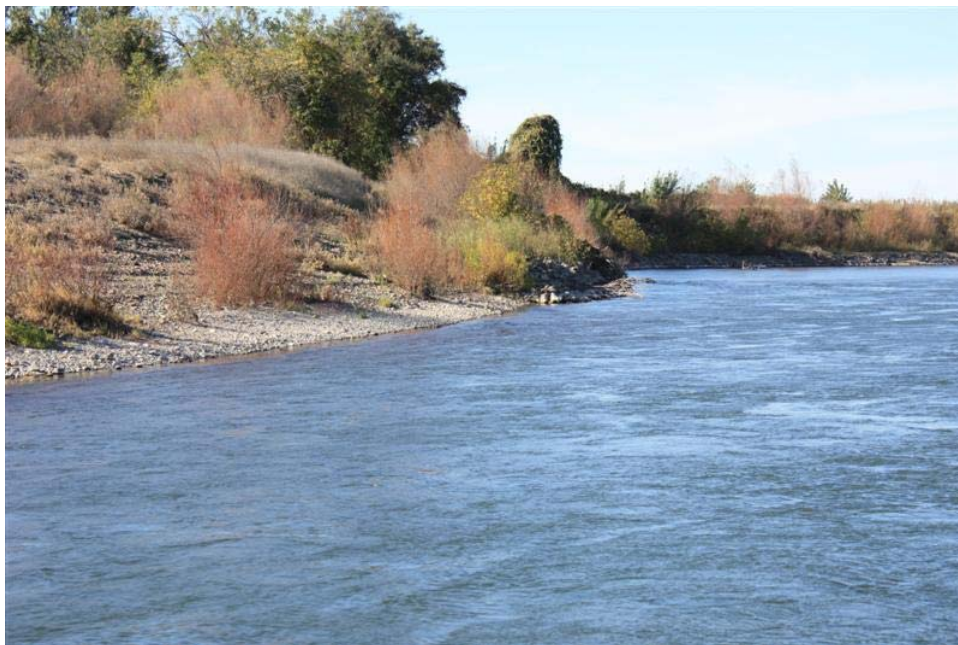
5. **Excessive Downstream Erosion** – Observation of the downstream end of the revetment did not indicate that there had been any significant erosion of the bank downstream of the revetment (Figure 35) and there does not appear to have been any loss of rock (Figure 36).

Figure 35. Downstream end of revetment. Note presence of willows growing on the bar which indicates there has been no retreat of the bank downstream of the toe rock.

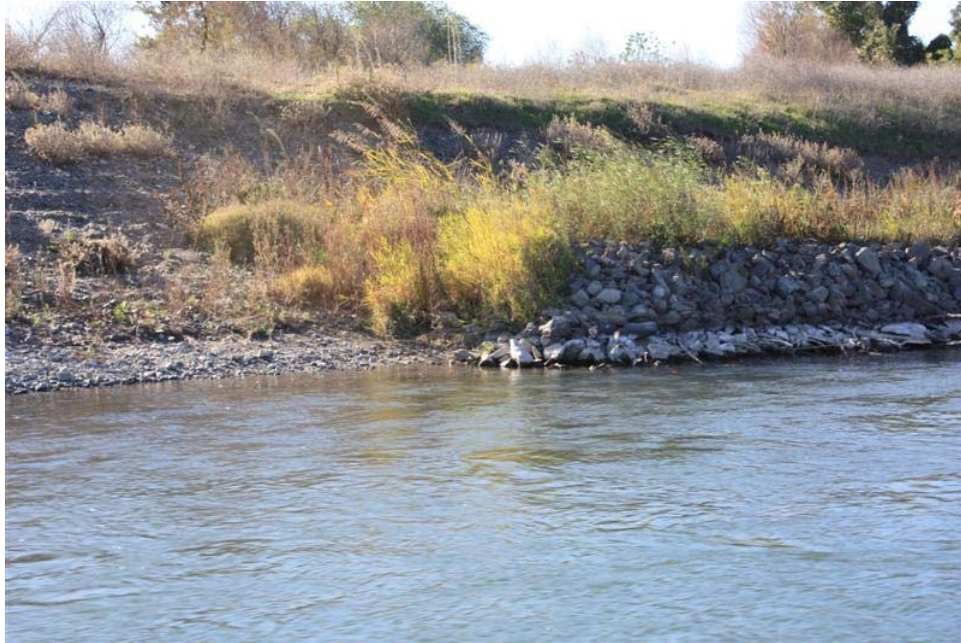
Figure 36. Close up view of the downstream end of the toe rock. Rock is intact and there appears to be little loss of rock at the downstream end.

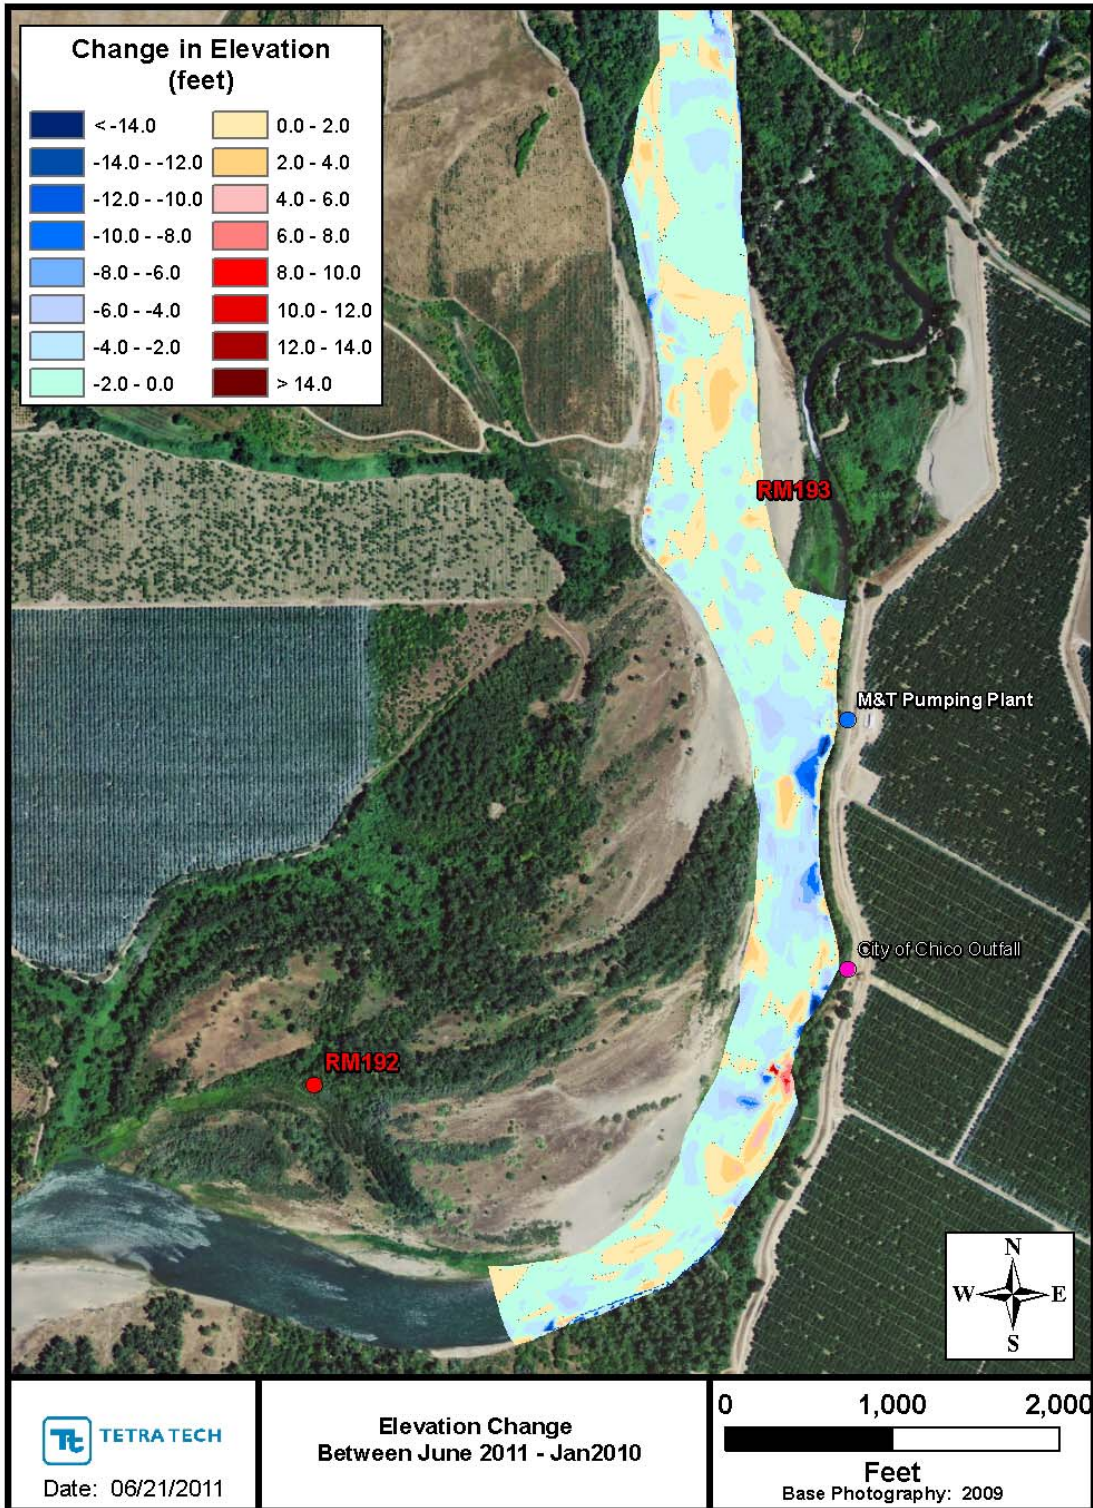
6. **Toe Scour along the Revetment** – Comparison of the January 2010 and June 2011 bathymetric surveys of the M&T reach (Figure 37) indicate that the high flows of March 2011 may have caused about 2 feet of scour along the revetment. However, the field inspection did not reveal any loss of rock resulting from the toe scour.

Figure 37. Elevation changes in the M&T/Llano Seco reach between the January 2010 and June 2011 surveys.
