TO: Jim Well, Ducks Unlimited

FROM: Mike Harvey, Ph.D., P.G.

SUBJECT: **June 7-9, 2011 Resurvey of M&T/Llano Seco Pumping Plant and City of Chico Outfall Reach of the Sacramento River**

DATE: July 11, 2011

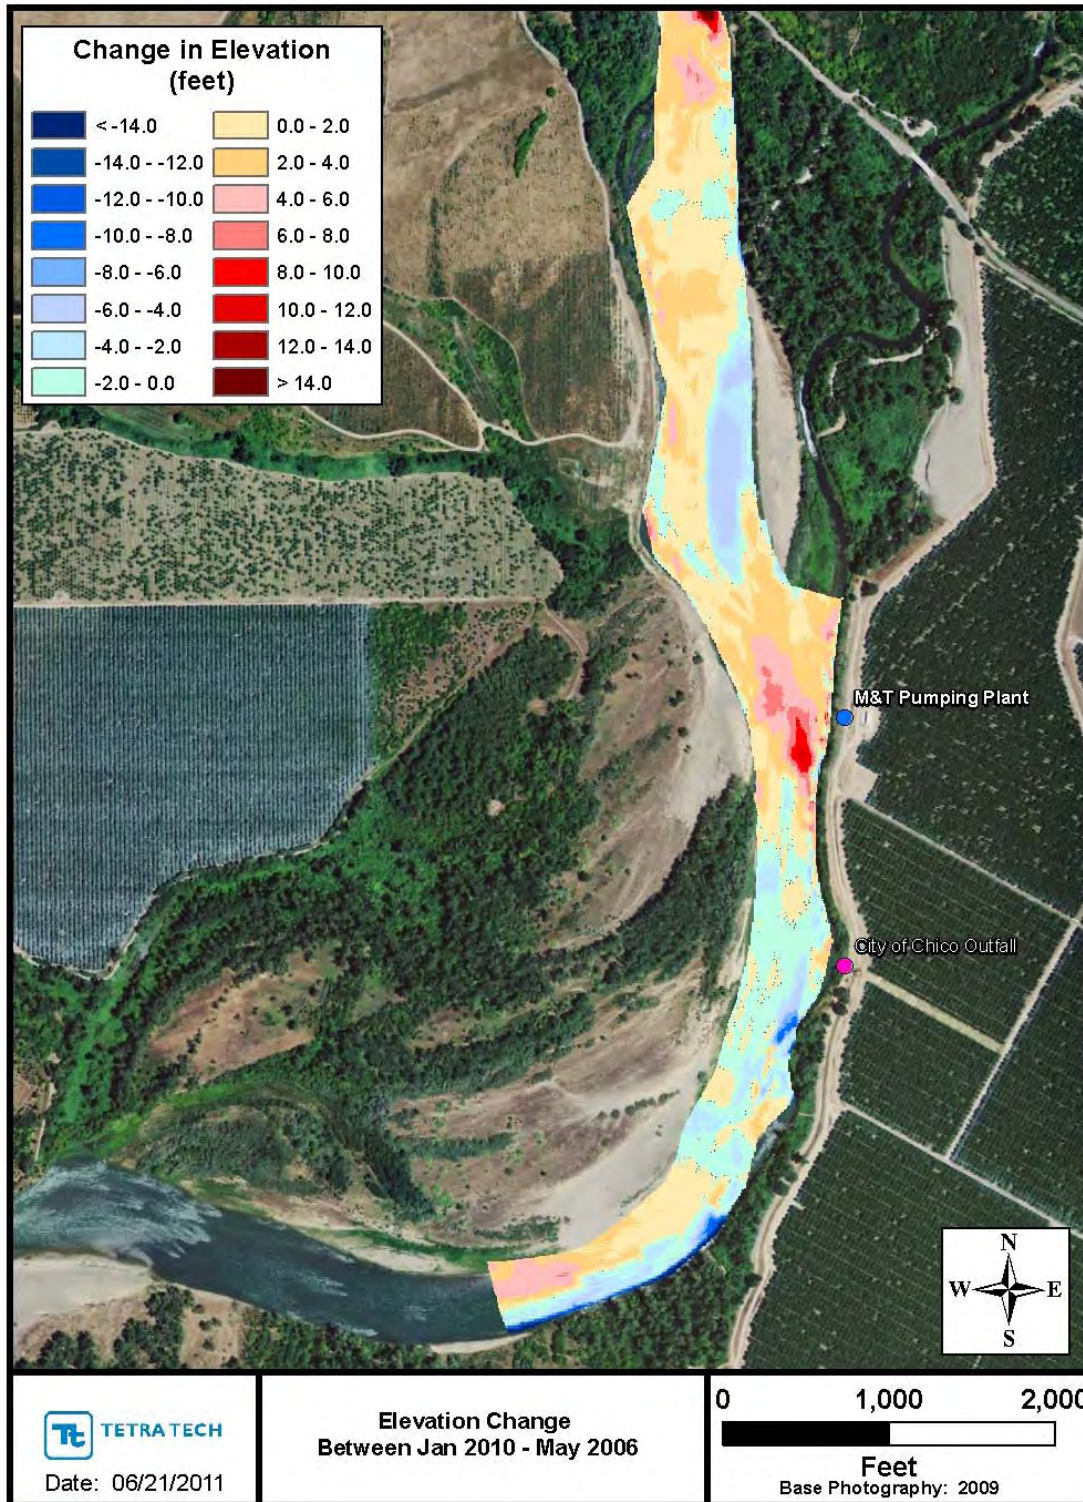
Figure 1 presents the changes in elevation of the bed of the river within the M&T/Llano Seco reach between the 2010 survey and the 2006 survey. The comparison indicates that there had been significant aggradation (4 to 10 feet) in the vicinity of the pumps which was supported by observations of the river under low-flow conditions. The location of the 2007 gravel removal is clearly visible (-4 to -6 feet) along the left (east) bank of the river upstream of the pumping plant and adjacent to Bidwell State Park. **Figure 2** presents the changes in bed elevation between the 2011 survey and the 2006 survey. It is apparent that the amount of aggradation in the vicinity of the pumping plant has been reduced following the high flows in early 2011 (peak flow at Hamilton City was about 102,000 cfs), but there is still some aggradation when compared to the 2006 survey. **Figure 3** presents the differences in elevation of the bed of the river between the 2010 and 2011 surveys.

Figure 1. Elevation changes in the M&T/Llano Seco reach between the January 2010 and May 2006 surveys.

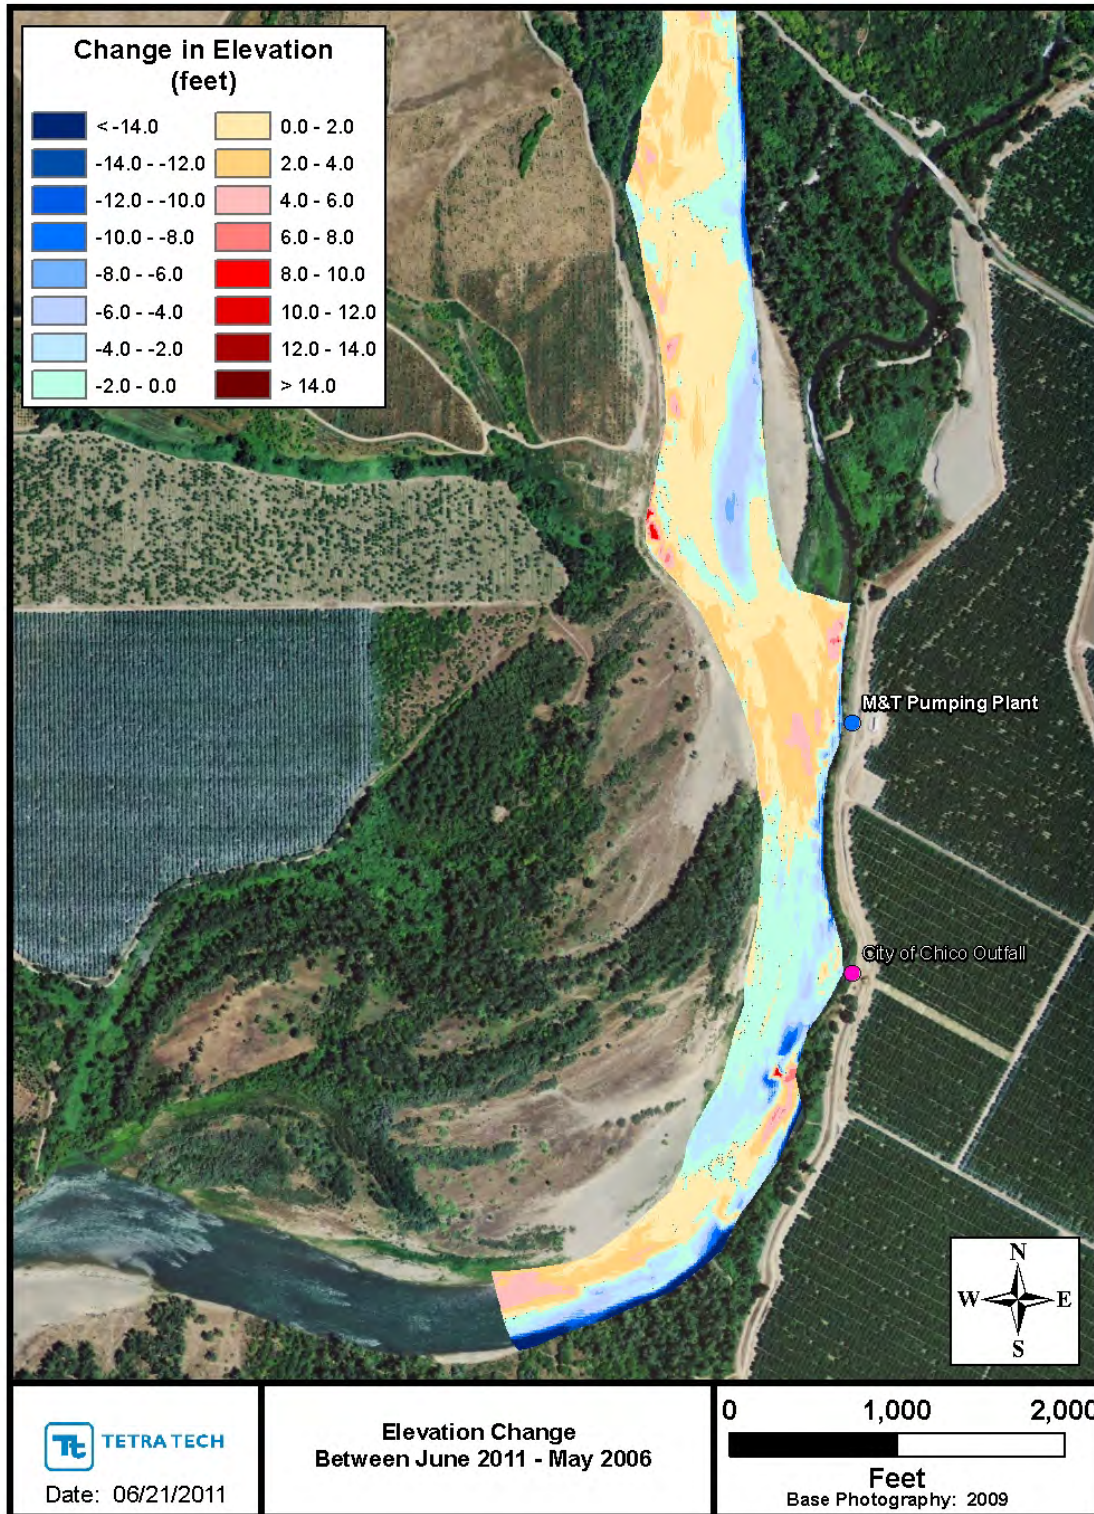
Figure 2. Elevation changes in the M&T/Llano Seco reach between the June 2011 and May 2006 surveys.

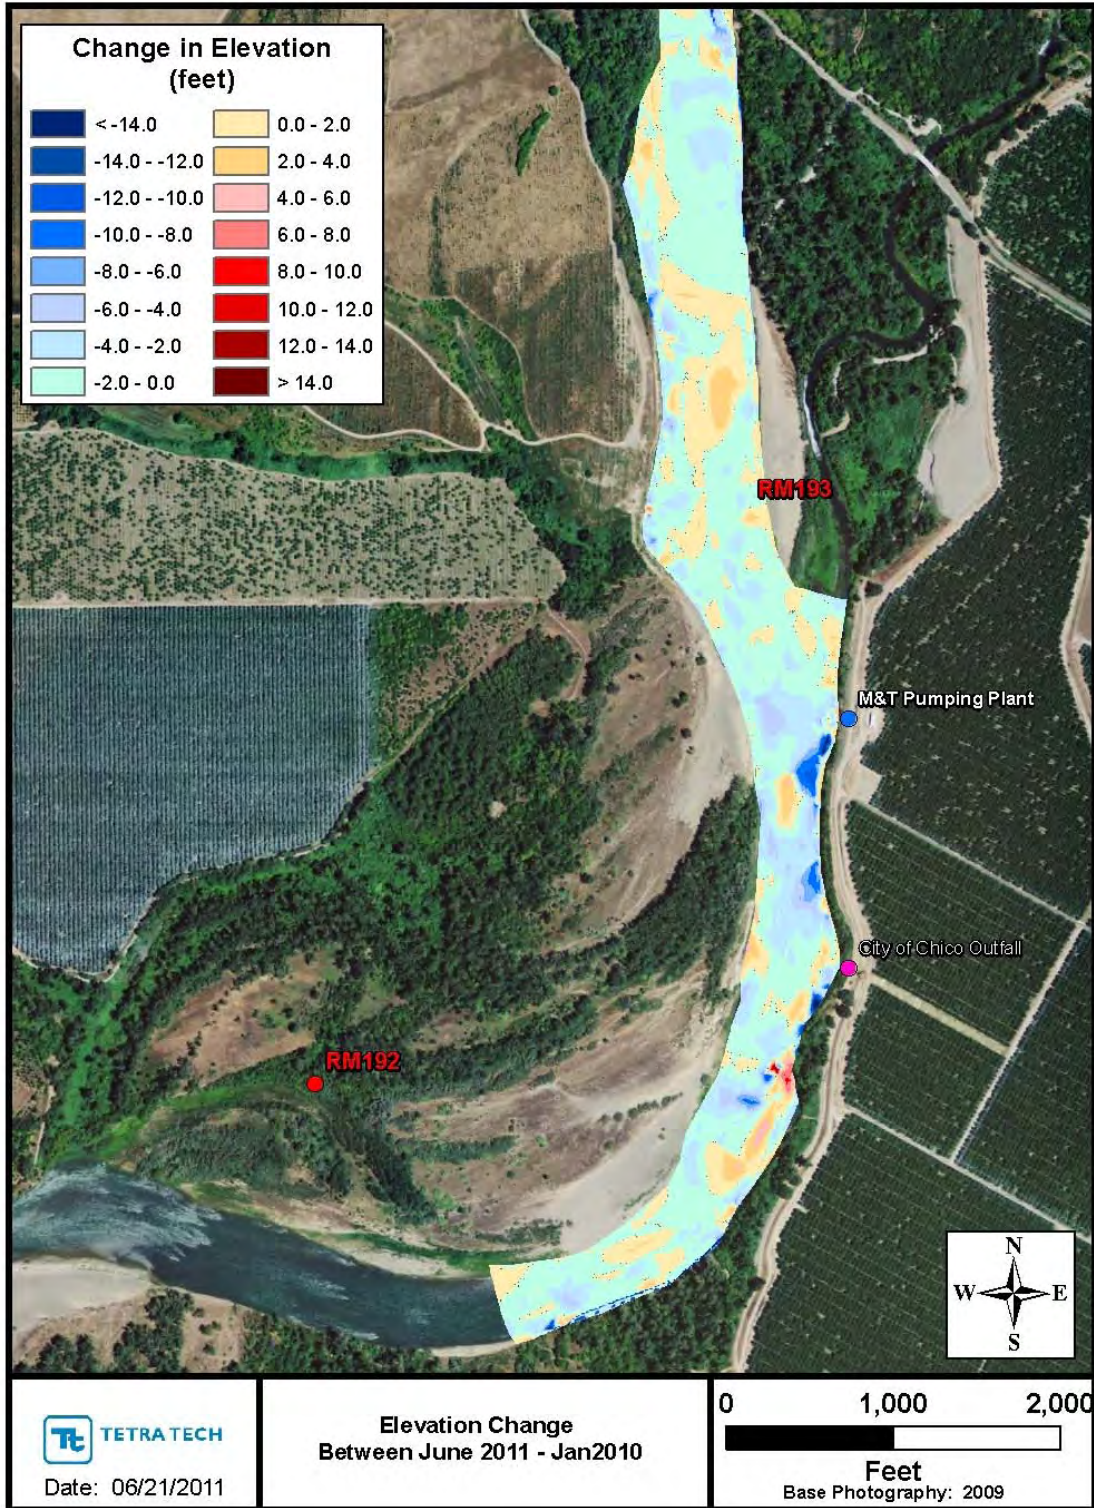
Figure 3. Elevation changes in the M&T/Llano Seco reach between the January 2010 and June 2011 surveys.

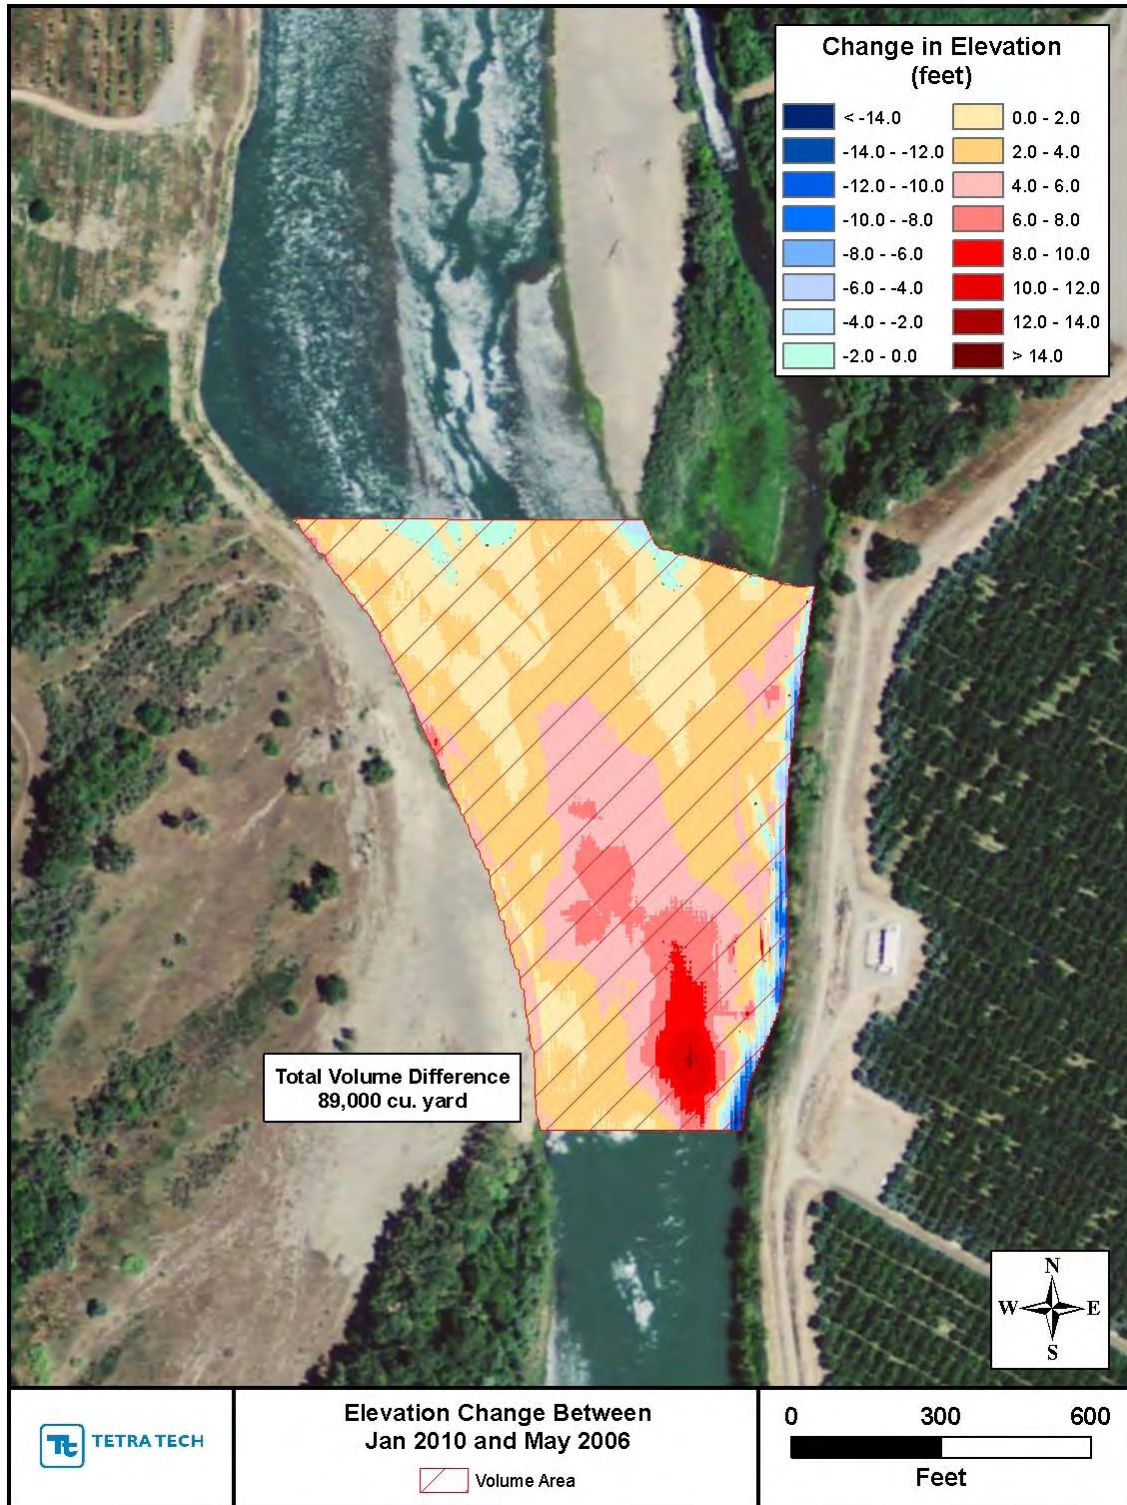
In order to determine how much material had to be dredged in the vicinity of the fish screens and pump inlets, an approximately 600- by 1,200-foot area was designated and the difference in volume between the 2006 and 2010 surveys was determined (**Figure 4**). The volume of material that had accumulated between the two surveys was about 89,000 cu.yd. (~120,000 tons). The same calculation was made to determine the difference between the 2011 and 2006 surveys (**Figure 5**). The volume of material that has accumulated between the two surveys was reduced to about 54,400 cu.yd. (~73,400 tons). The computed difference between the 2010 and 2011 surveys was about 34,800 cu.yd. (~47,000 tons) (**Figure 6**).

Figure 4. Volumetric calculation of the deposition in the 600 ft by 1200 ft segment in the vicinity of the fish screens and pump inlets between January 2010 and May 2006.

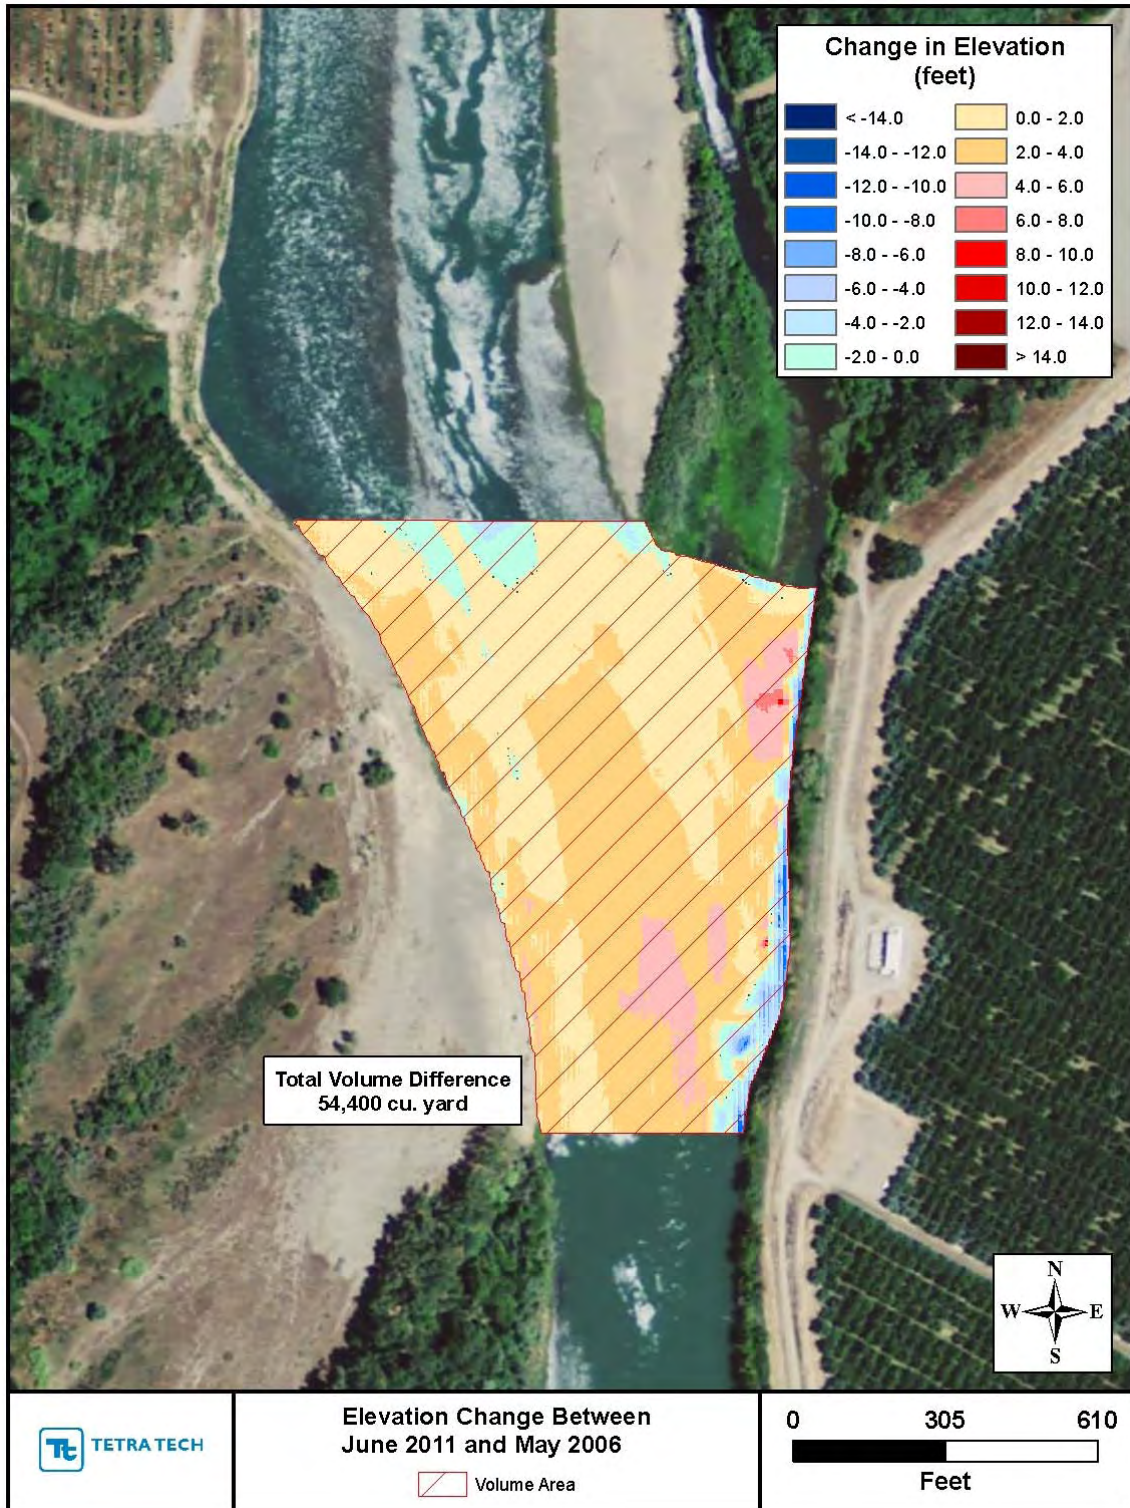
Figure 5. Volumetric calculation of the deposition in the 600- by 1,200-foot segment in the vicinity of the fish screens and pump inlets between June 2011 and May 2006.

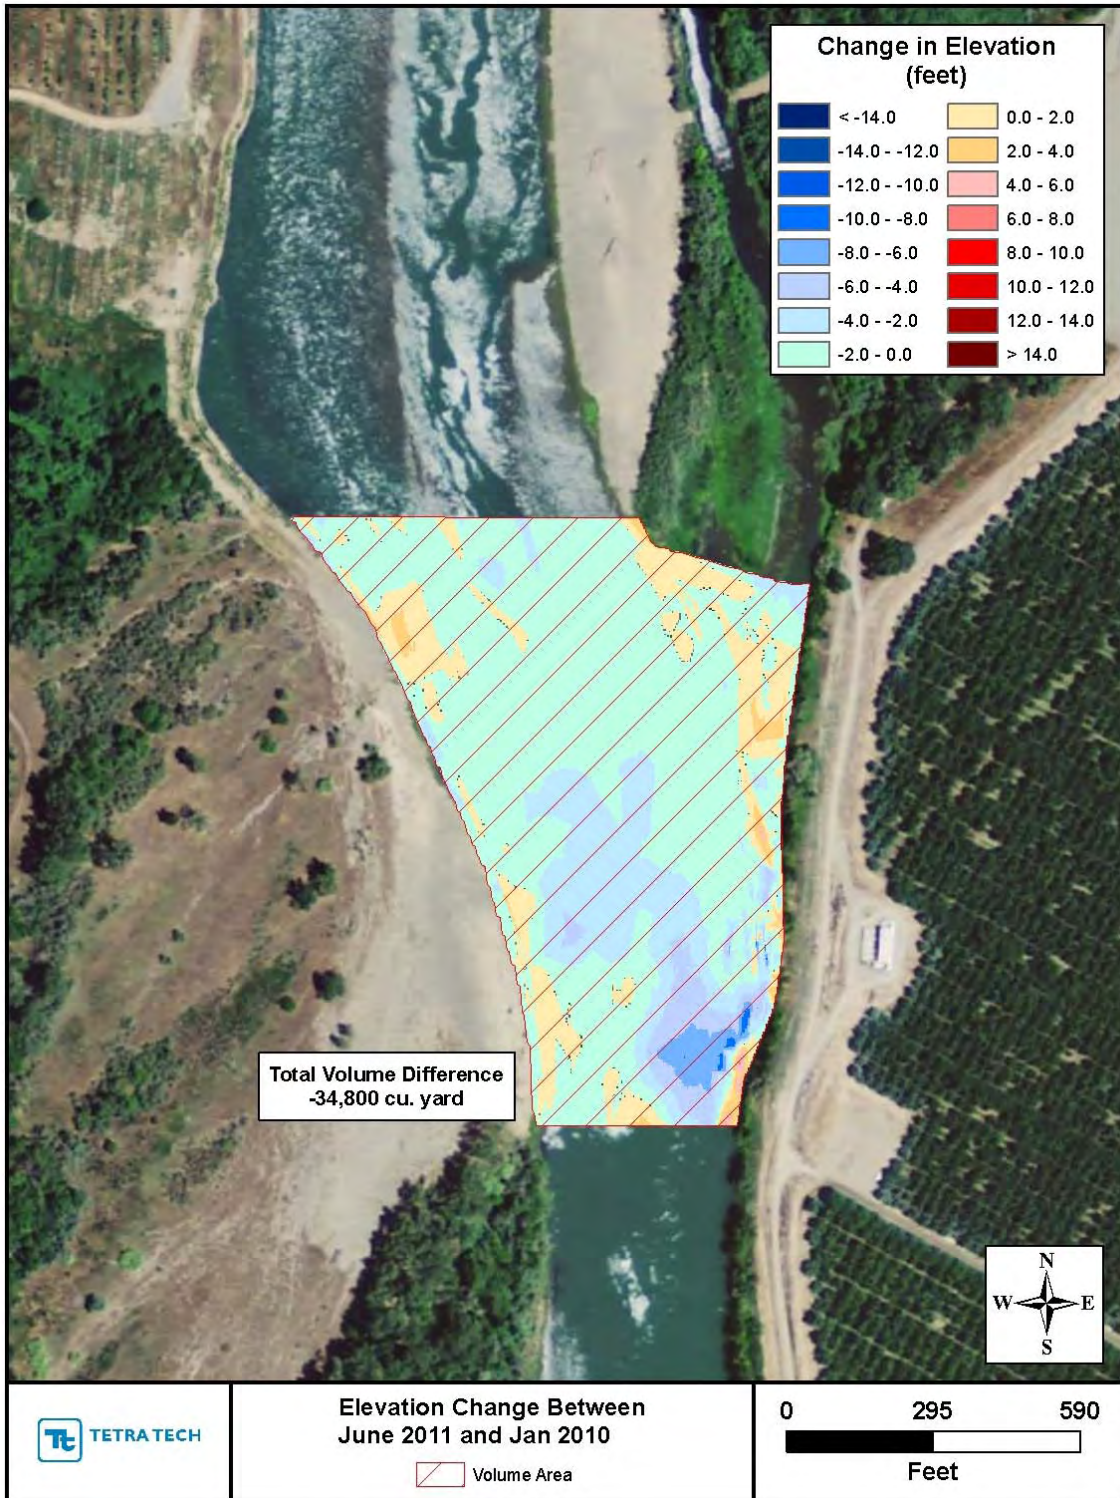
Figure 6. Volumetric calculation of the deposition in the 600- by 1,200-foot segment in the vicinity of the fish screens and pump inlets between January 2010 and June 2011.

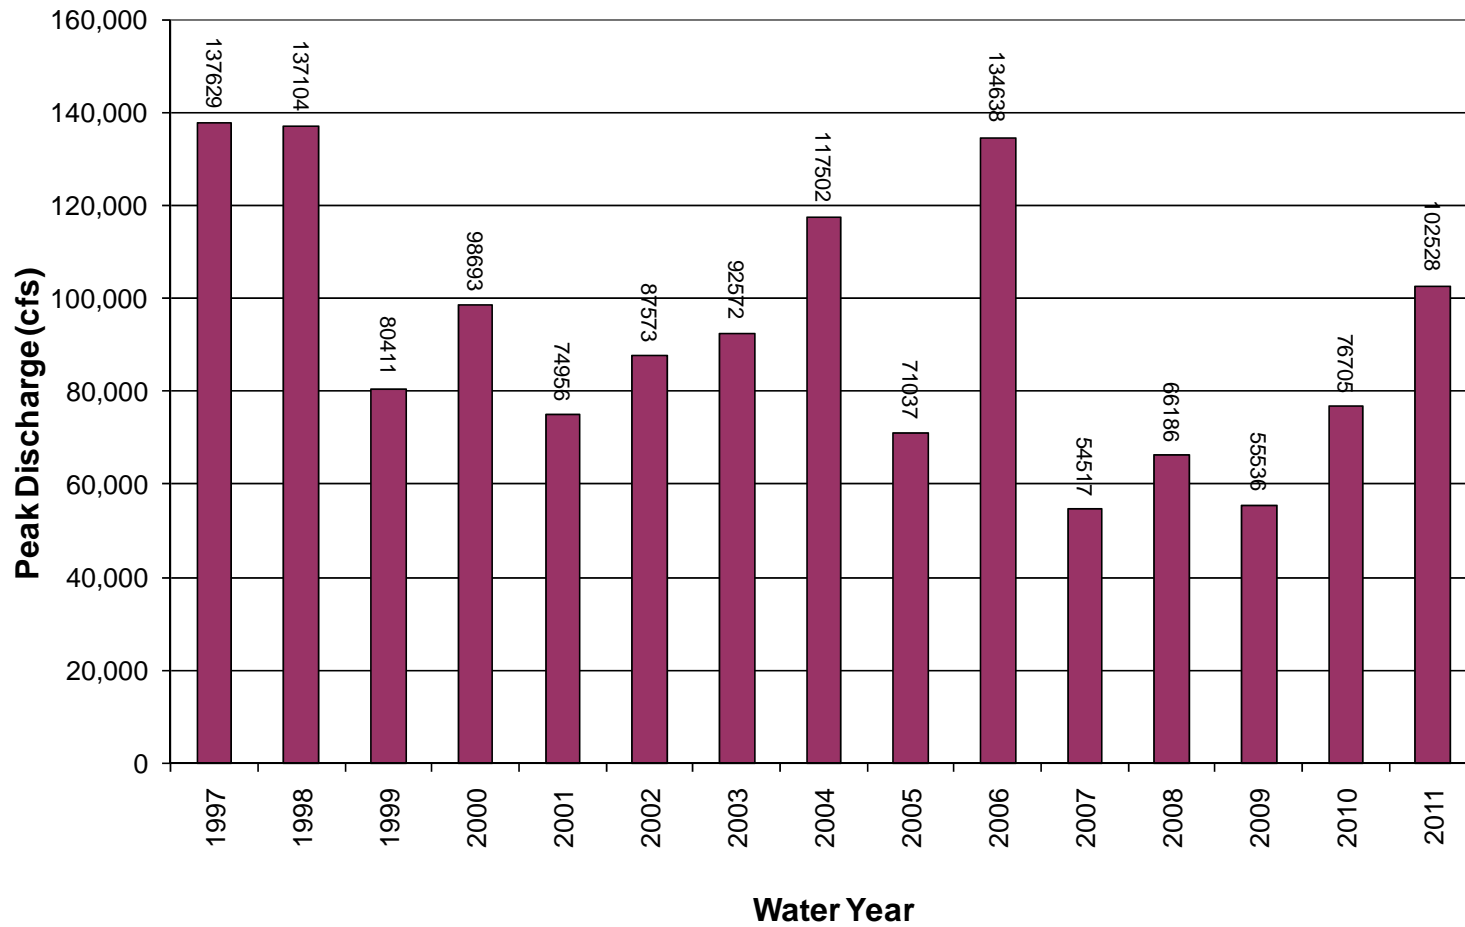
Aggradation and degradation within the M&T/Llano Seco reach appears to be tied to the peak flow hydrology (**Figure 7**). With the exception of WY2004, the peak flows in the 6 years prior to 2005 were less than the bankfull (~90,000 cfs) in the M&T/Llano Seco reach and this sequence of flows appears to be responsible for the aggradation in the channel (**Figure 8**). In WY2006, the peak flow was about 135,000 cfs and clearly there was some degradation in the reach,

Figure 7. Peak annual flows at the Hamilton City gage between WY1997 and WY2011.

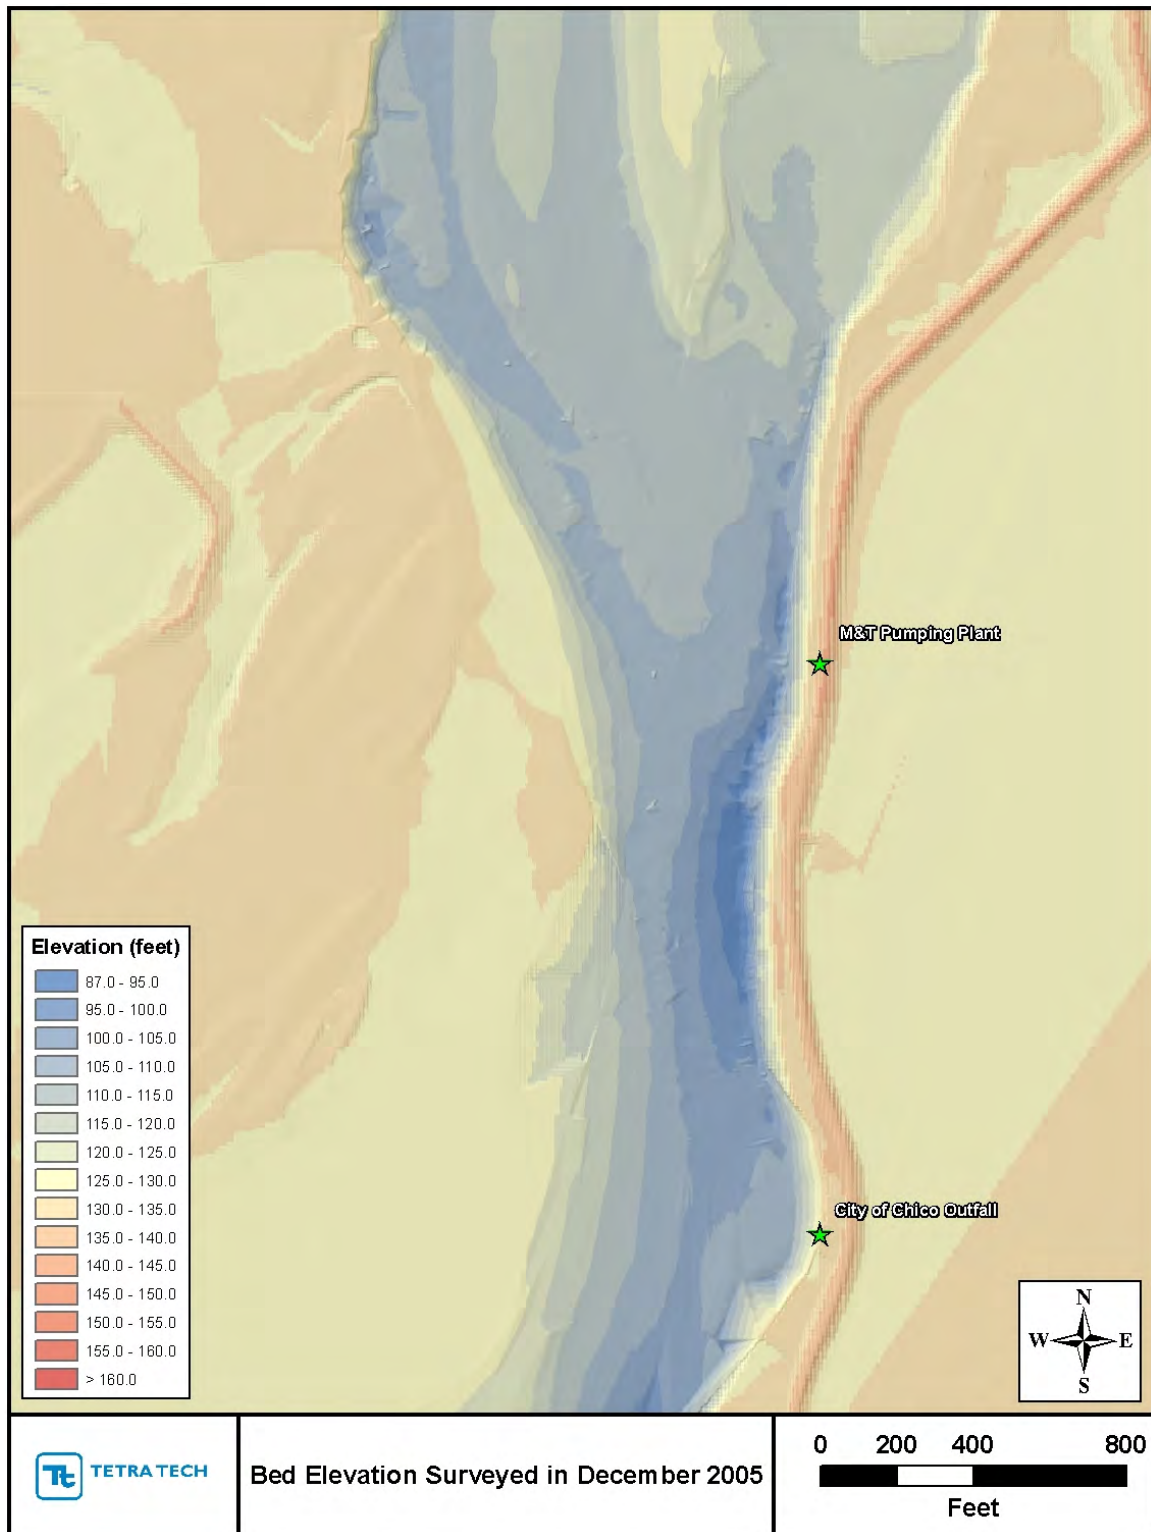
Figure 8. Color gradient plot showing the bed topography in the vicinity of the M&T/Llano Seco Pumping Plant and the relocated City of Chico Outfall in December 2005.

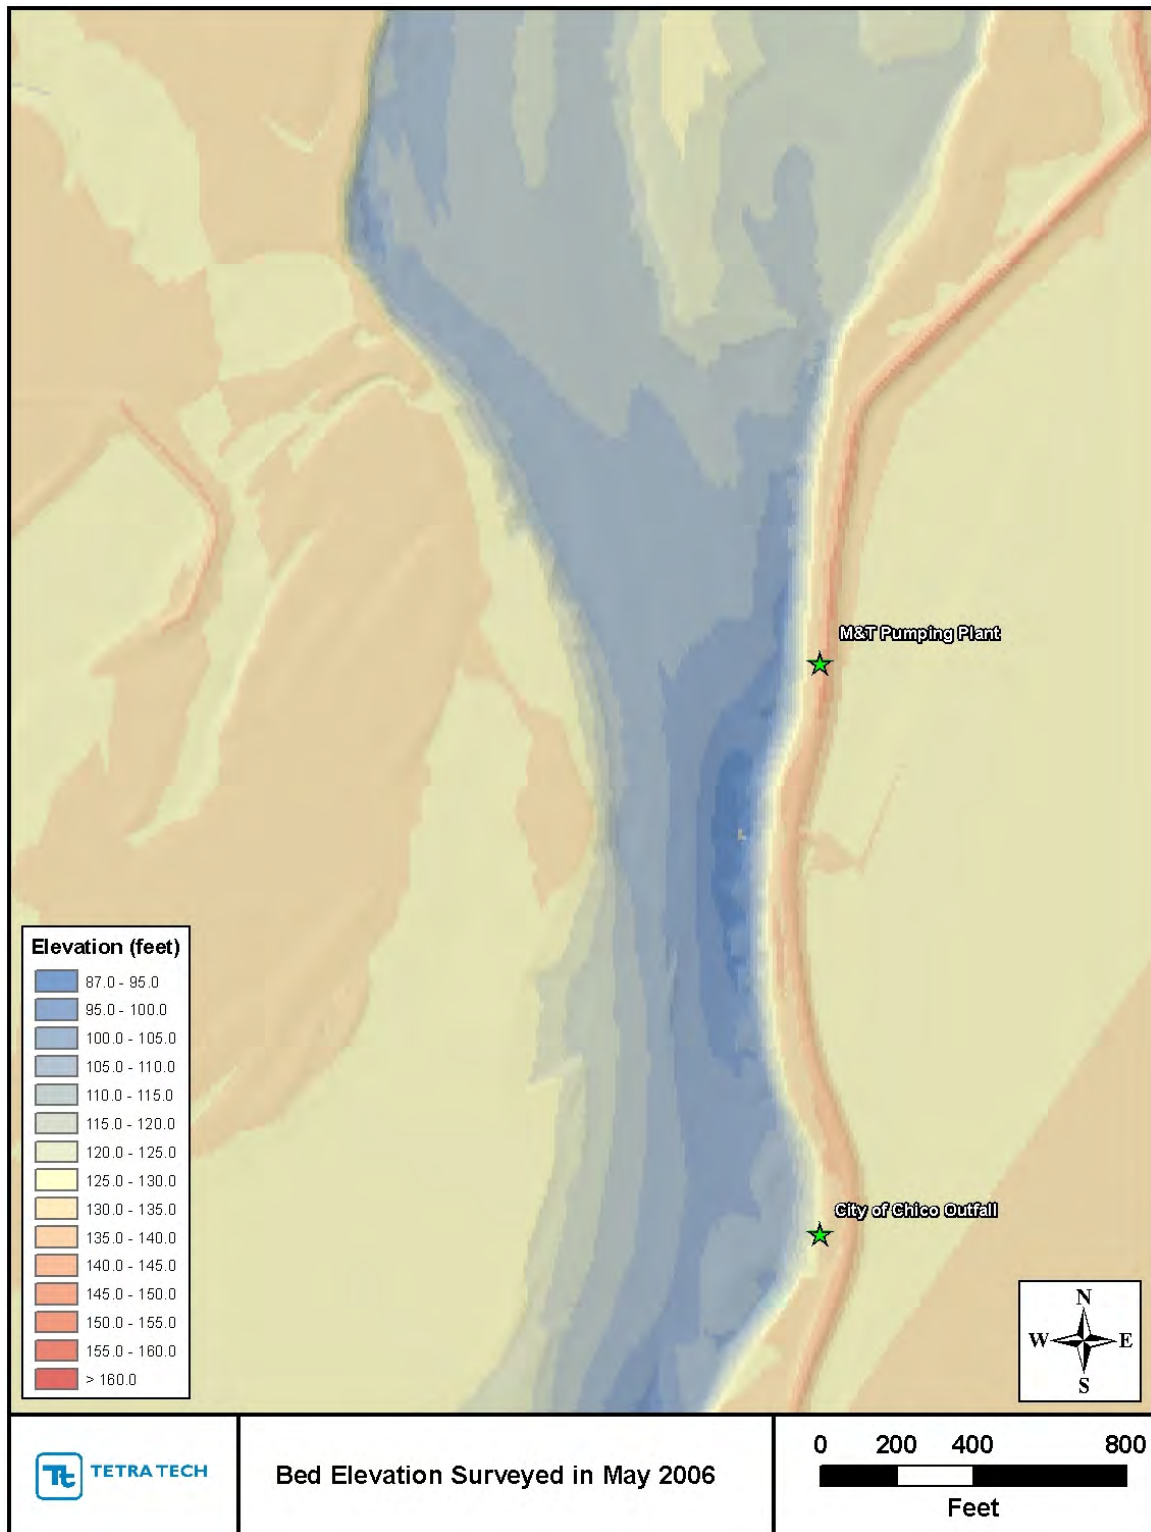
especially in the vicinity of the fish screens and pump inlets (**Figure 9**). Between WY2006 and WY2010, the peak flows were again less than the bankfull and aggradation occurred in the vicinity of the fish screens and pumps (**Figure 10**), activating the concern about the need to dredge. Peak flow in WY2011 was about 102,500 cfs and this flow appears to have caused degradation in the vicinity of the fish screens and pump inlets (**Figure 11**).

Figure 9. Color gradient plot showing the bed topography in the vicinity of the M&T/Llano Seco Pumping Plant and the relocated City of Chico Outfall in May 2006.

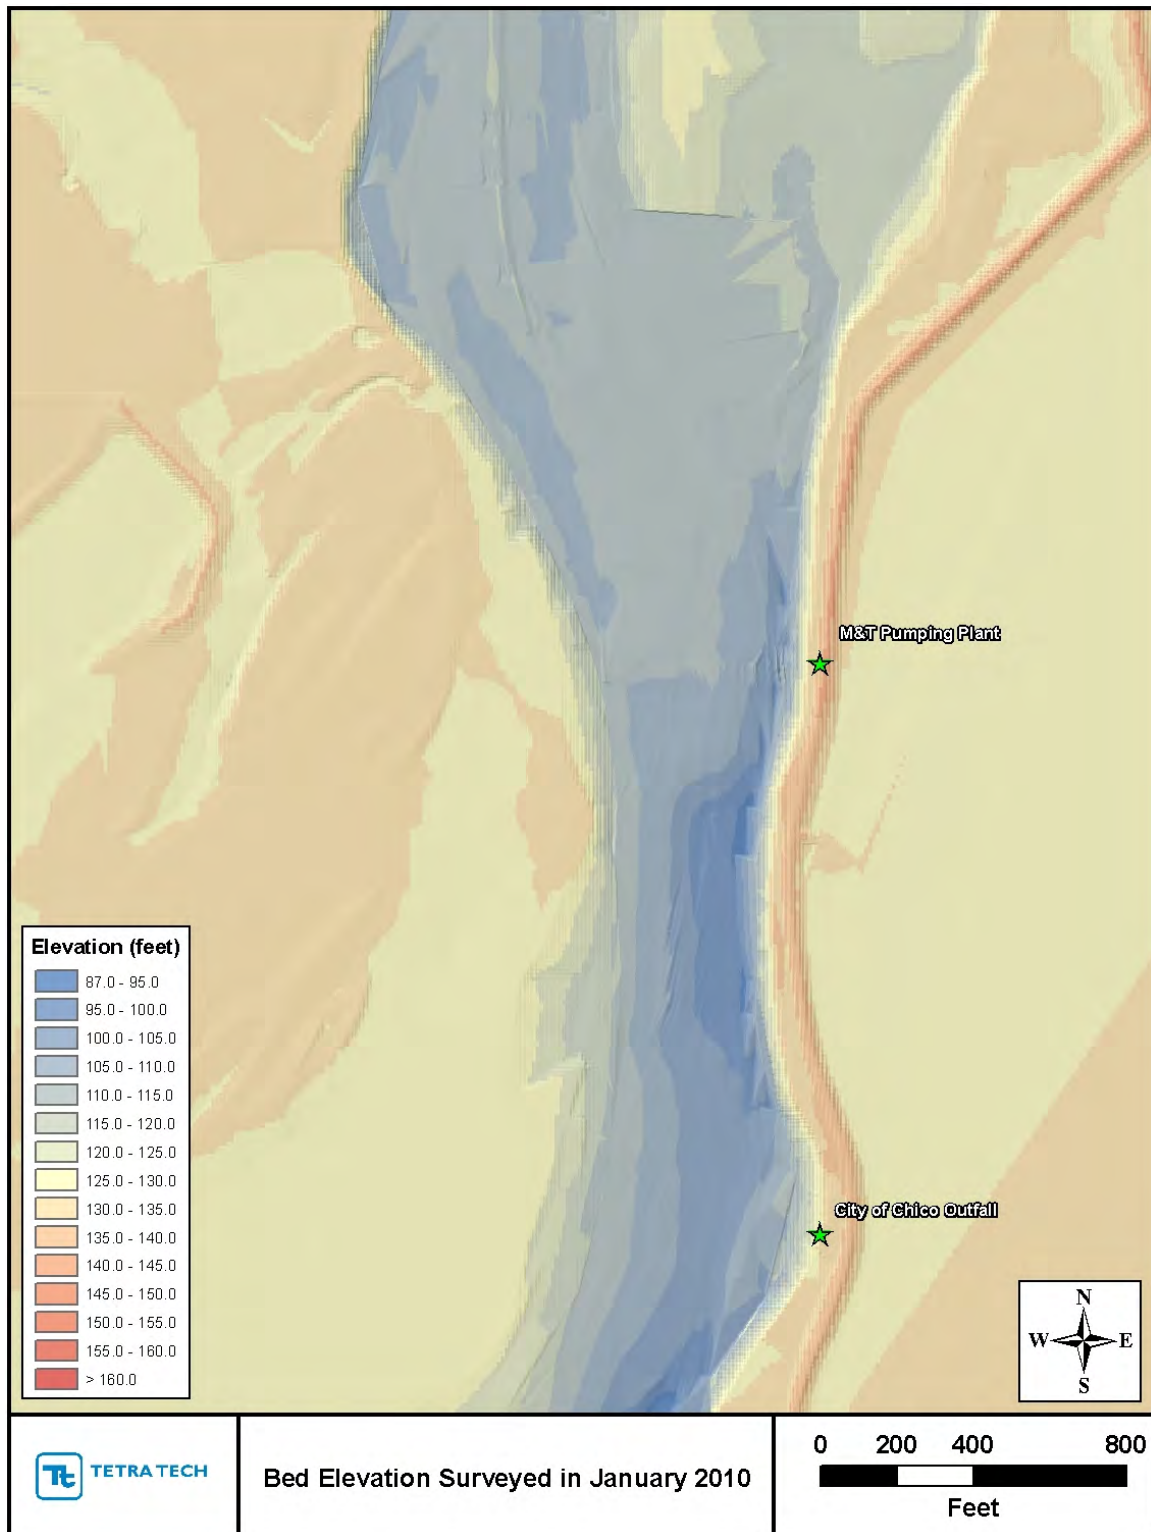
Figure 10. Color gradient plot showing the bed topography in the vicinity of the M&T/Llano Seco Pumping Plant and the relocated City of Chico Outfall in January 2010.

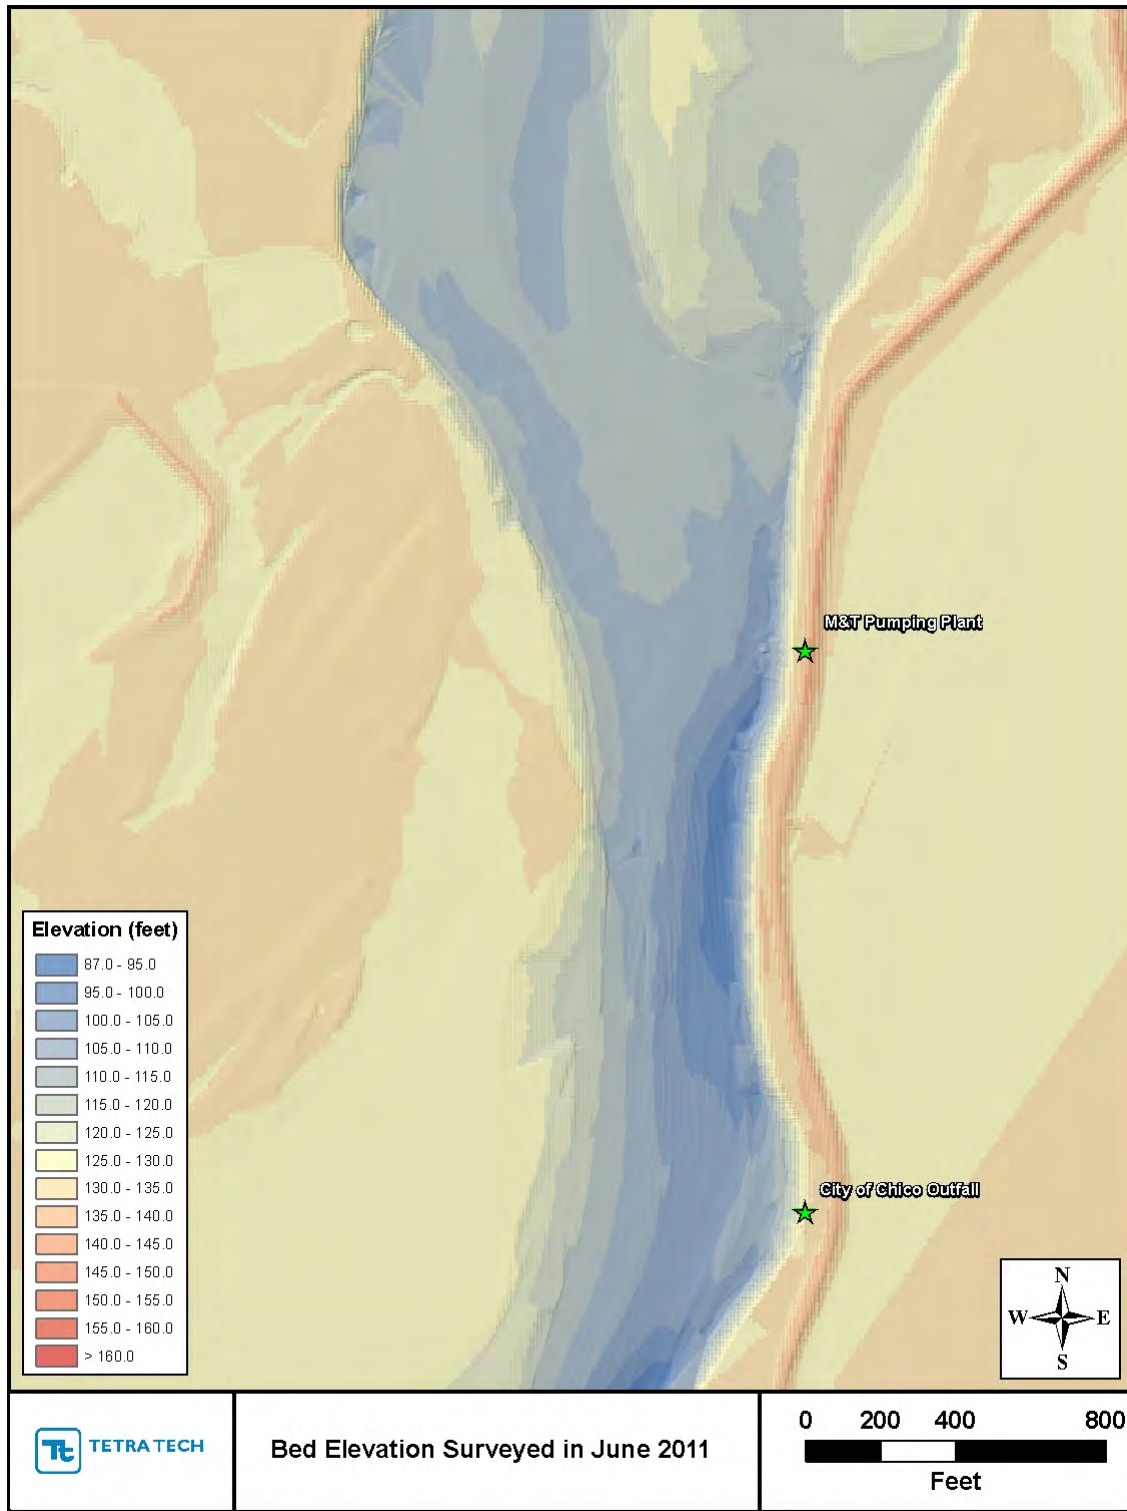
Figure 11. Color gradient plot showing the bed topography in the vicinity of the M&T/Llano Seco Pumping Plant and the relocated City of Chico Outfall in June 2011.

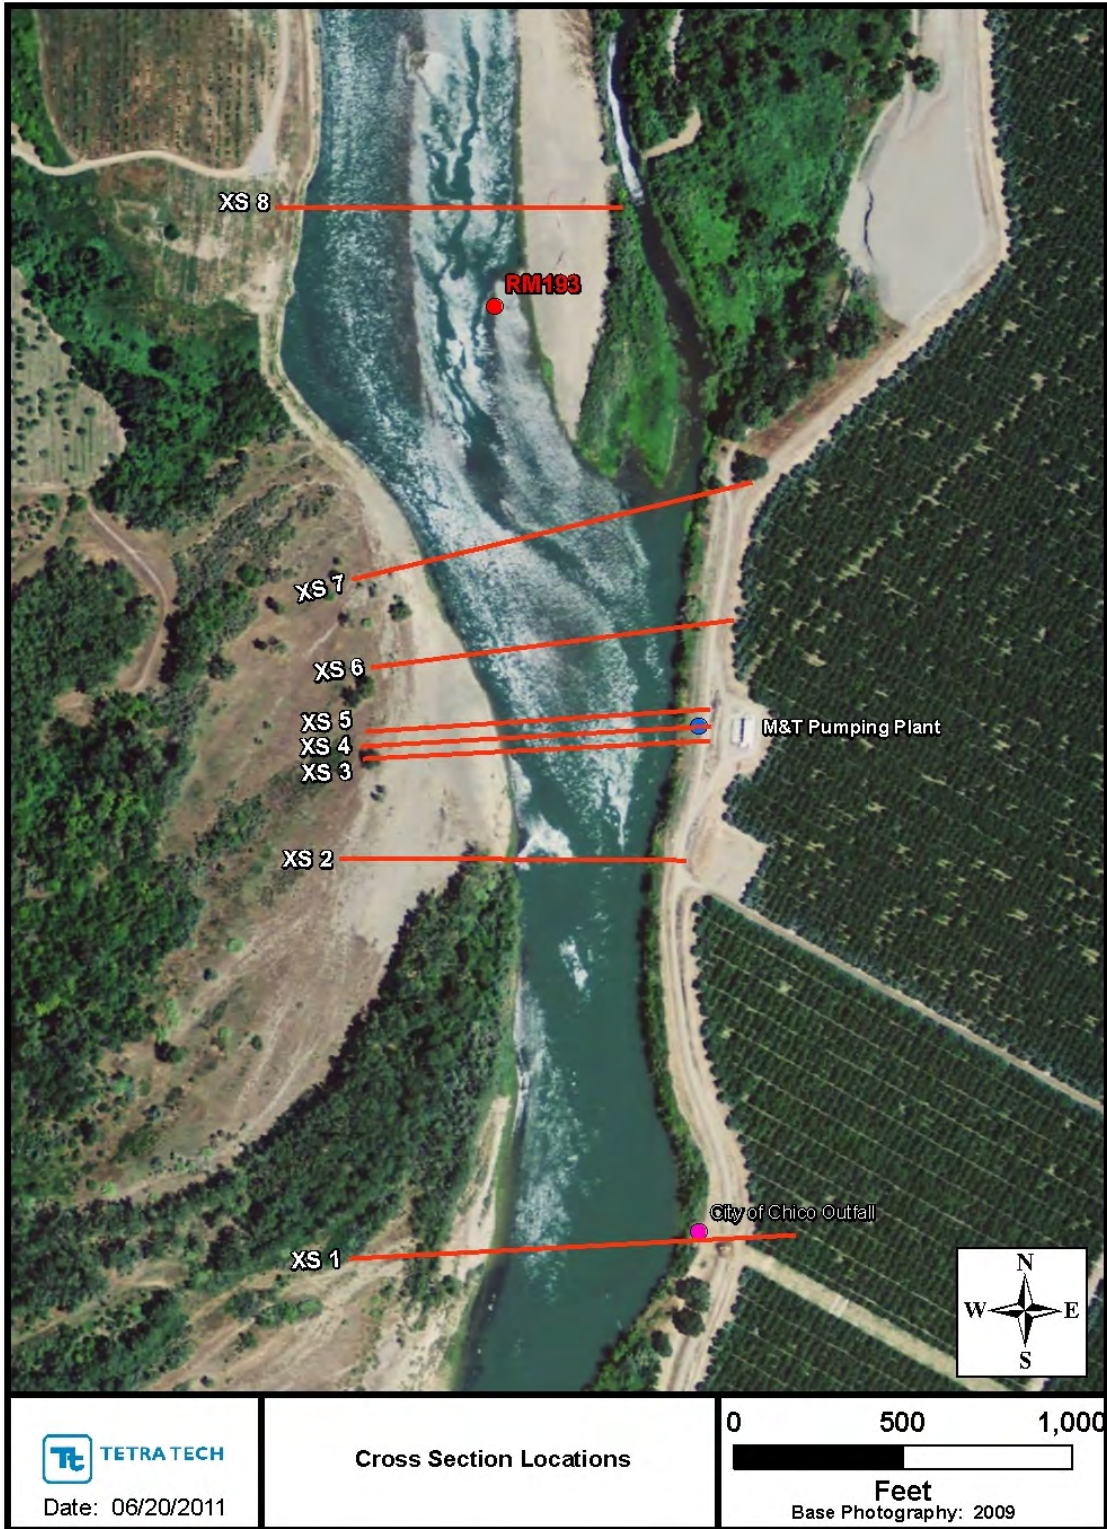
The general patterns of aggradation and degradation shown in Figures 8 through 11 are supported by comparative cross-section plots. The locations of the plotted cross sections are shown on **Figure 12**, with Cross Section 1 (XS1) being located at the newly relocated City of Chico wastewater outfall and diffuser, XS2 is located near the City's previous outfall, XS3 through XS5, span the fish screens and pump inlets and XS6 and XS7 are located upstream and incorporate the migrating gravel bar. XS8 represents the area that was dredged in 2007. At the City of Chico's outfall (**Figure 13**) the cross sections indicate that there was some aggradation on the left (east) side of the channel in 2005 but subsequent surveys show that the local aggradation has been removed. Given the similarity of the cross sections in the post-2005 period it is likely that the bench represents rock riprap, which is reinforced by the deeper channel to the right (west). At the location of the City's prior outfall (**Figure 14**), it is apparent that the aggradation in 2010 was removed by the flows in 2011 and that the depth of scour probably depends on the magnitude of the high flows since the bed elevation in 2006 is the lowest. At the location of the fish screens and pump inlets (**Figures 15,16,17**) it is clear that during the lower peak flow years the deposition approaches the inlets and fish screens, and it is eroded during the higher flow years. The same general trend is seen on the upper part of the migrating bar (**Figures 18 and 19**). Aggradation occurs during the lower peak flow years (2005, 2010) and there is scour in the higher peak flow years (2006, 2011). The comparative cross sections indicate that there has been little or no filling in the area that was dredged in 2007 (**Figure 20**).

Figure 12. Locations of comparative cross sections discussed in the text.
