TO: Jim Well, Ducks Unlimited

FROM: Mike Harvey, Ph.D., P.G.

SUBJECT: **June 7-9, 2011 Resurvey of M&T/Llano Seco Pumping Plant and City of Chico Outfall Reach of the Sacramento River**

DATE: July 11, 2011

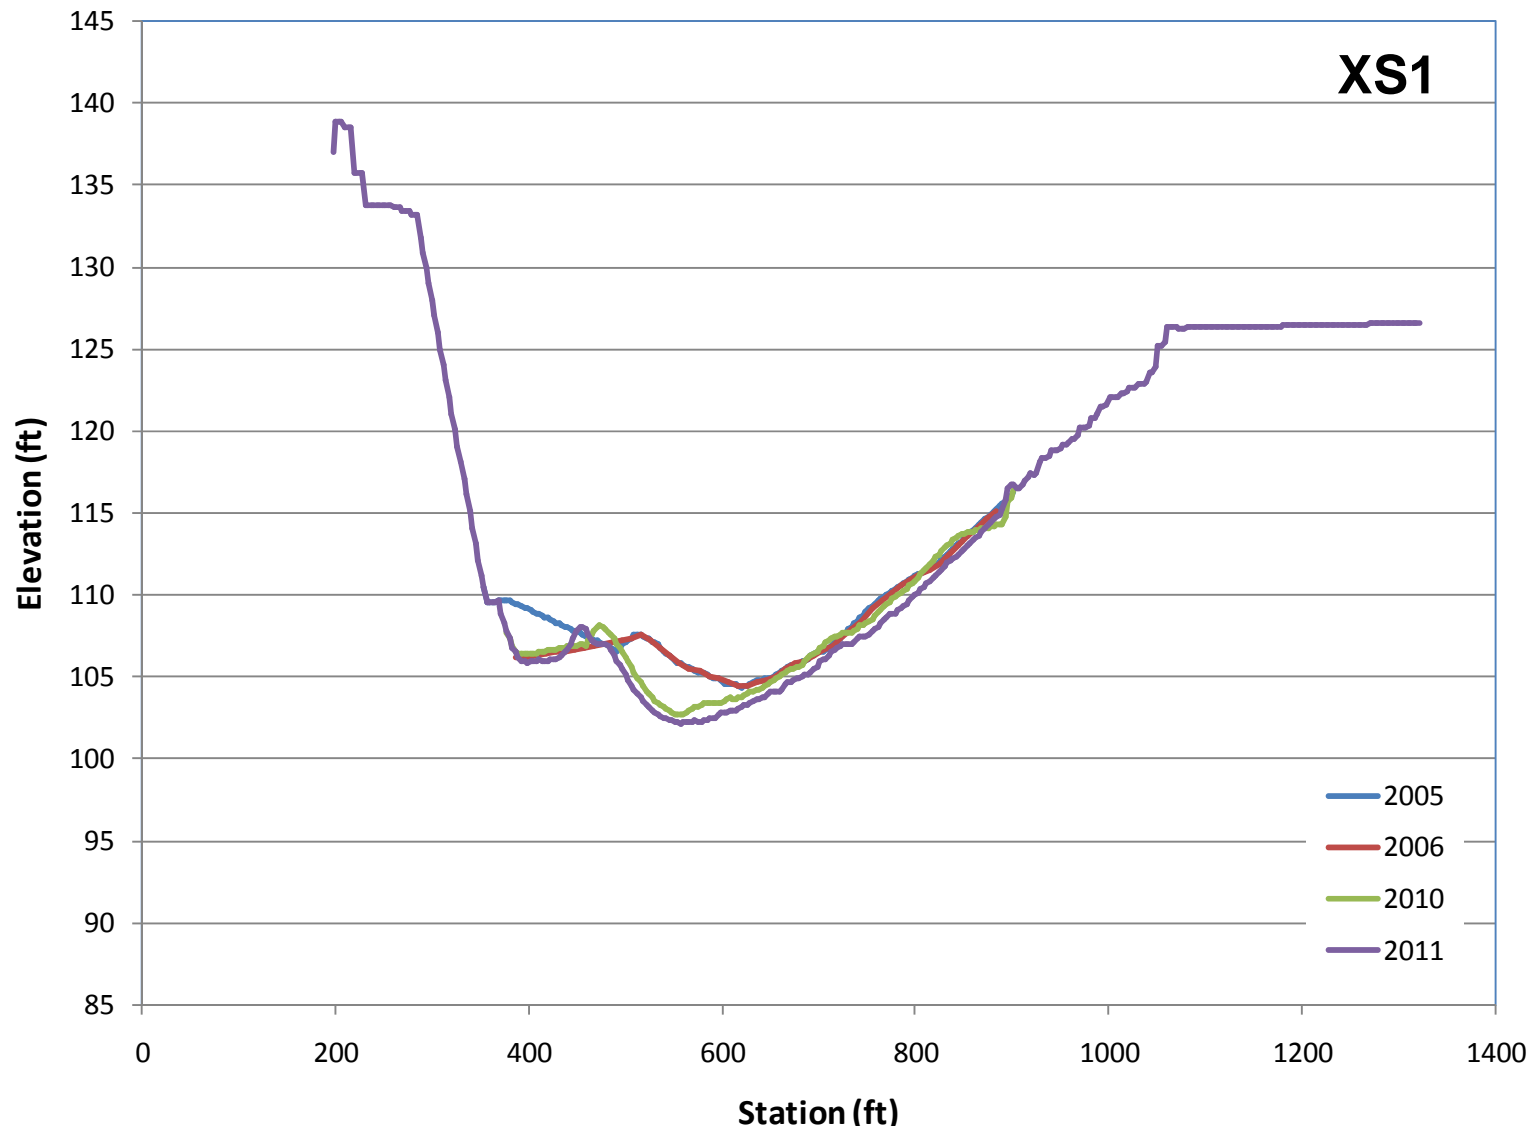
Figure 13. Comparative cross-section plots, 2005 to 2011 at the relocated City of Chico outfall.

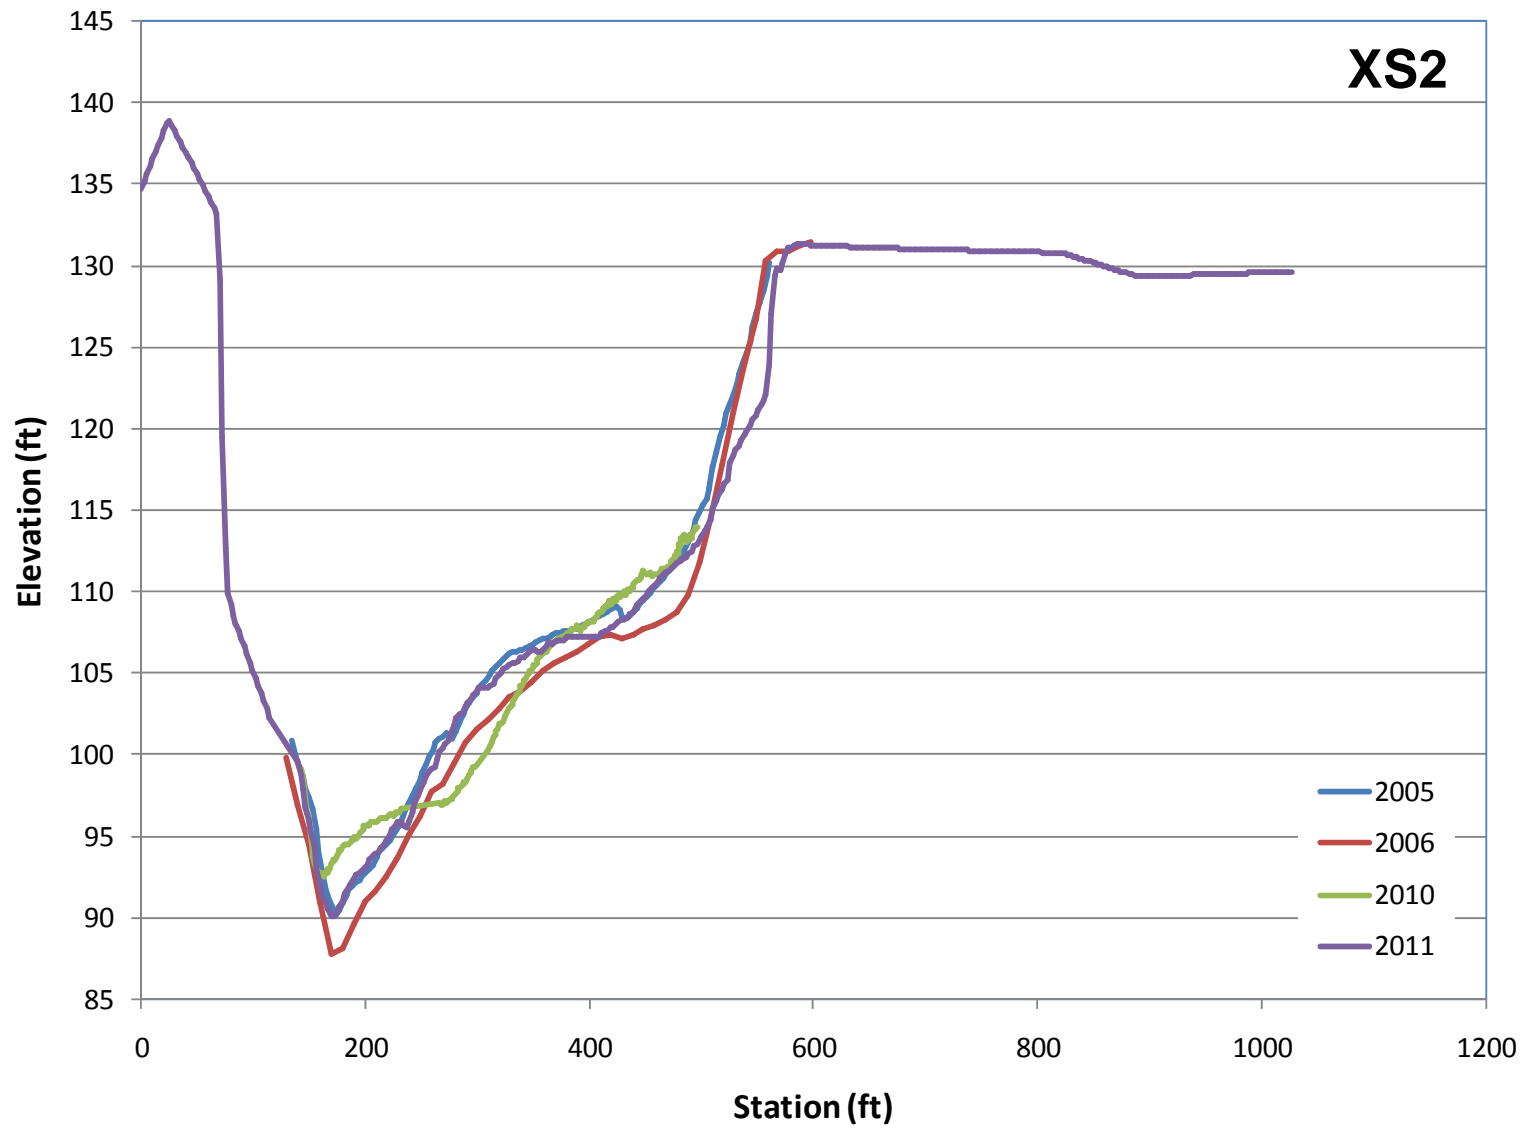
Figure 14. Comparative cross-section plots, 2005 to 2011 at the original City of Chico outfall.

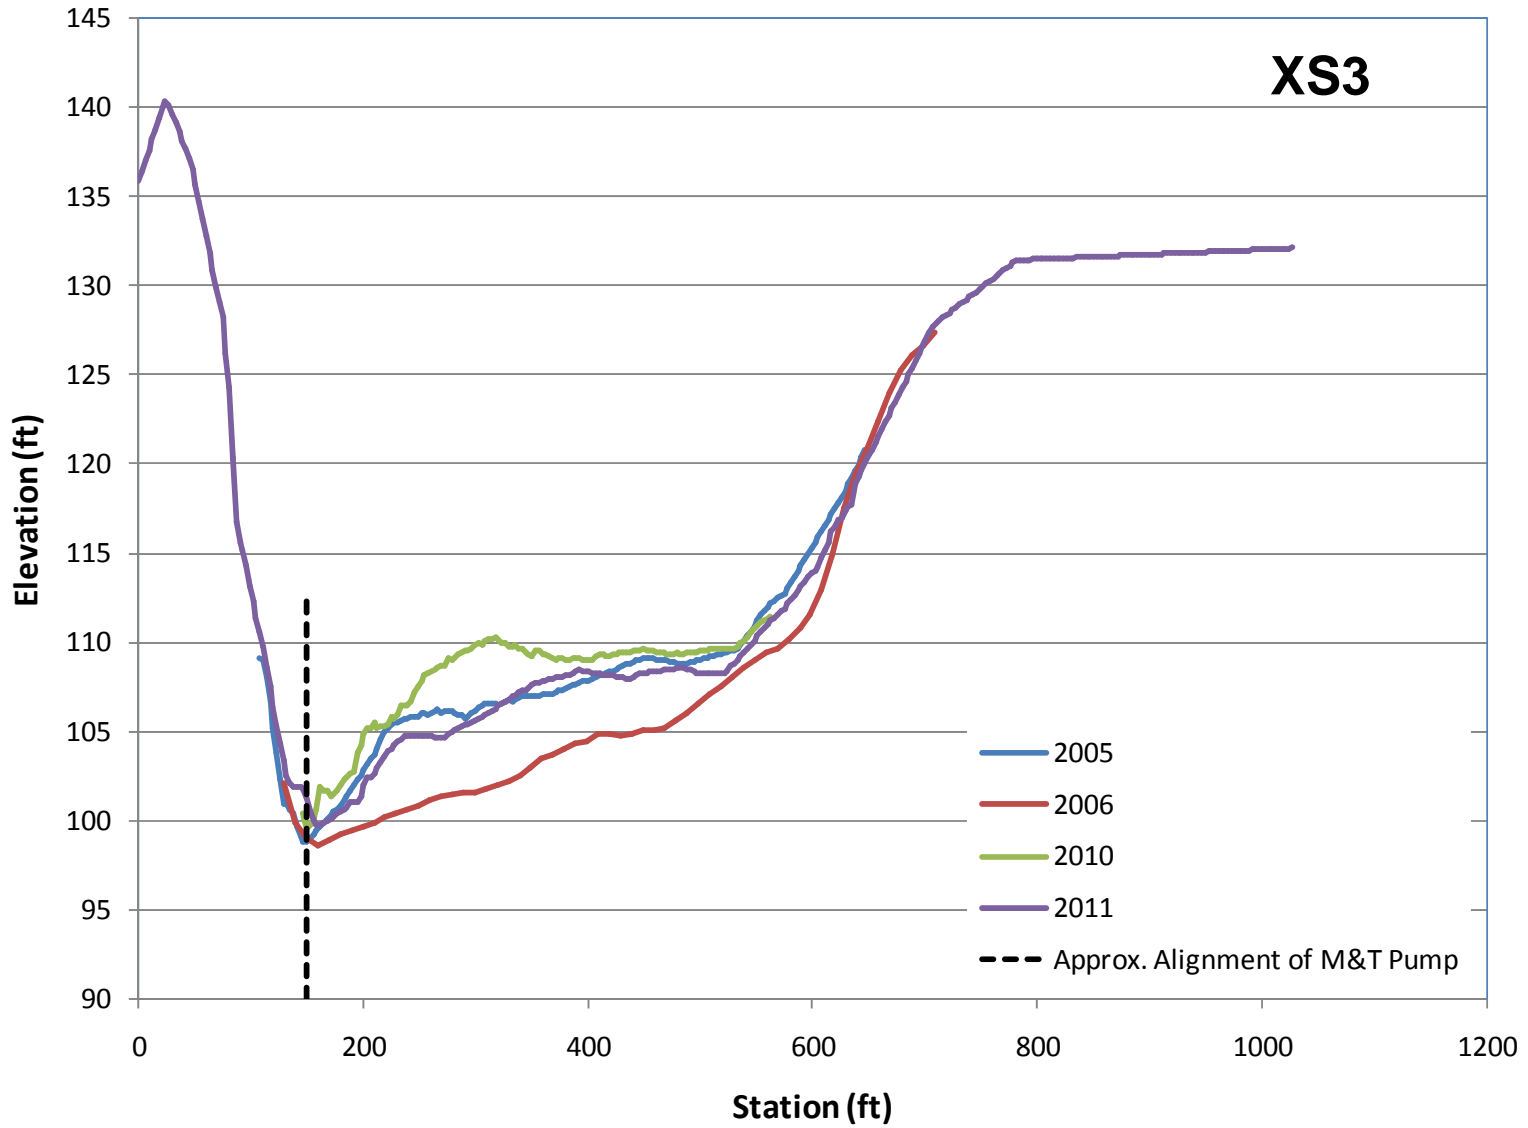
Figure 15. Comparative cross-section plots, 2005 to 2011 immediately downstream of the M&T/Llano Seco fish screens and pump inlets.

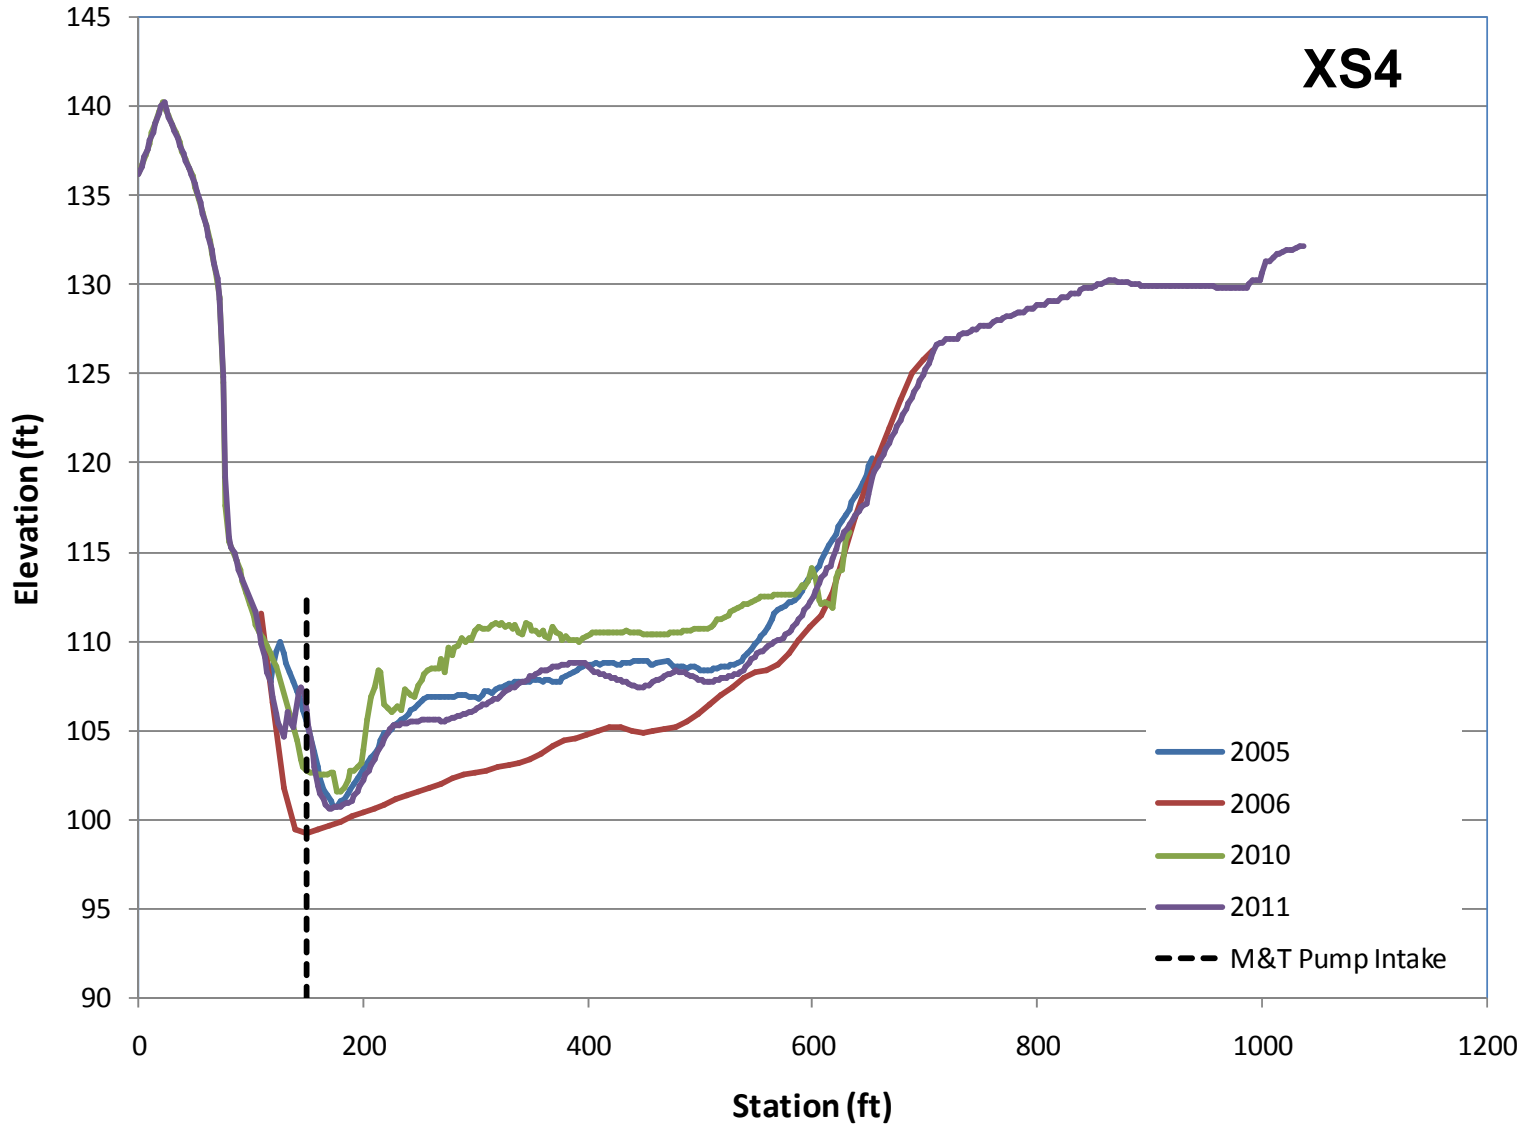
Figure 16. Comparative cross-section plots, 2005 to 2011 at the M&T/Llano Seco fish screens and pump inlets.

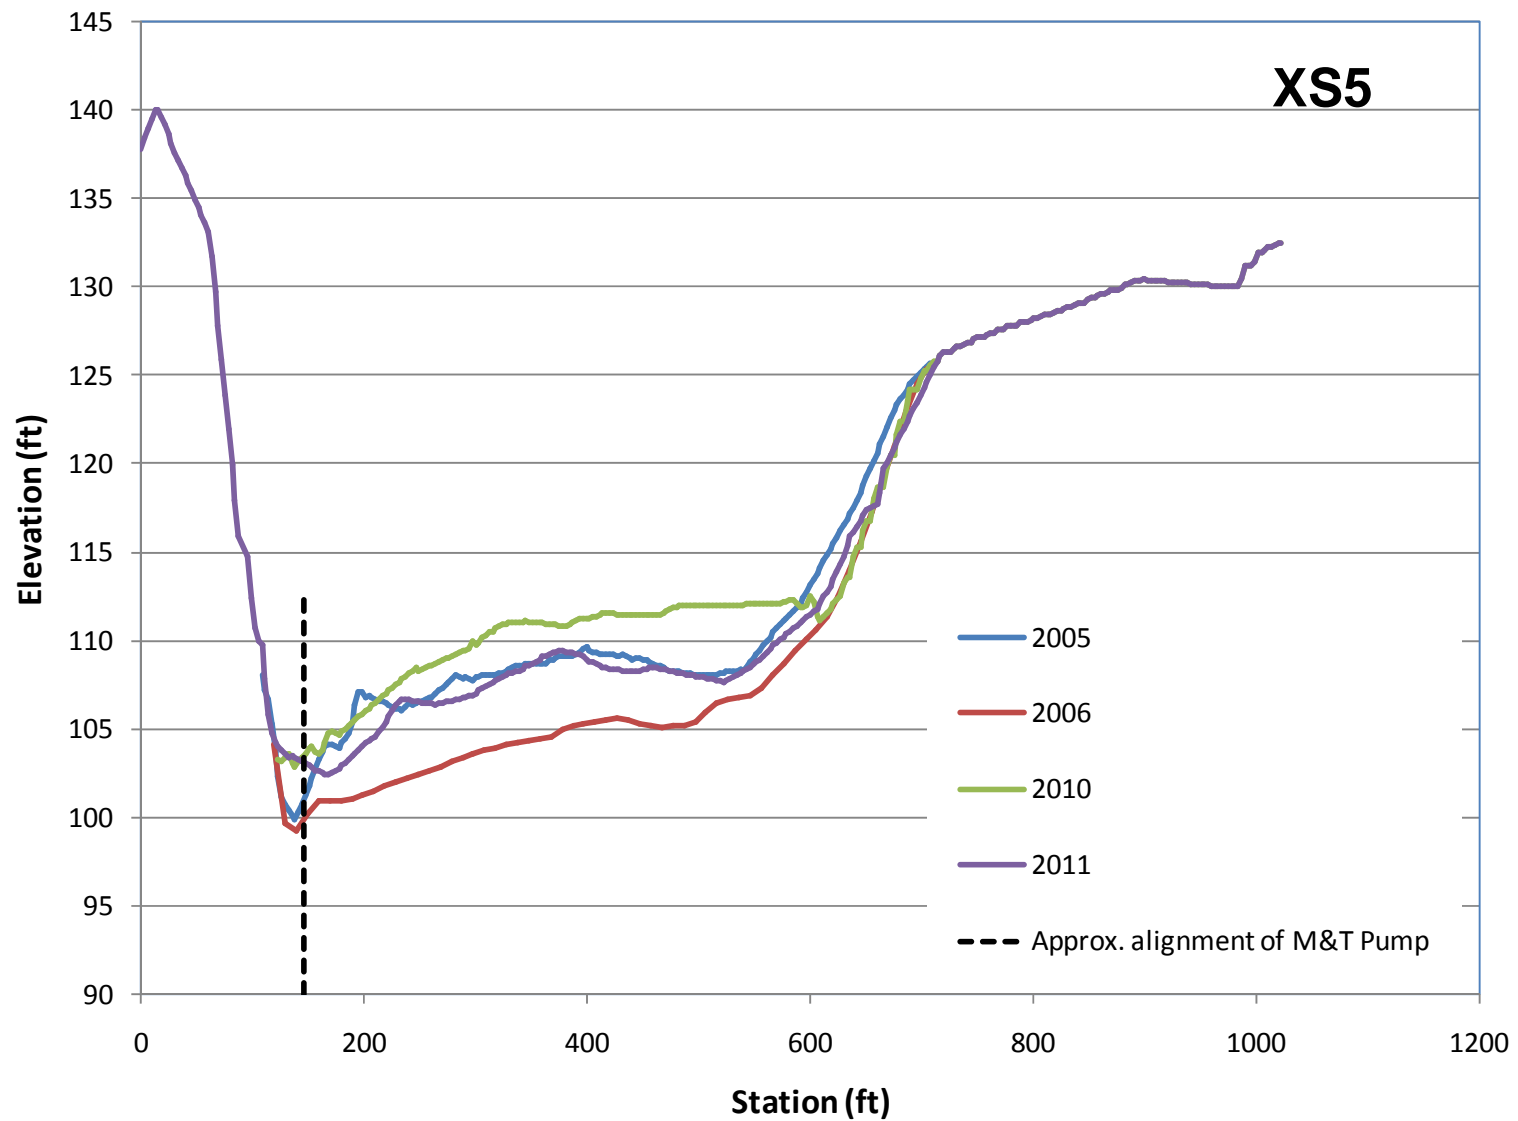
Figure 17. Comparative cross-section plots, 2005 to 2011 immediately upstream of the M&T/Llano Seco fish screens and pump inlets.

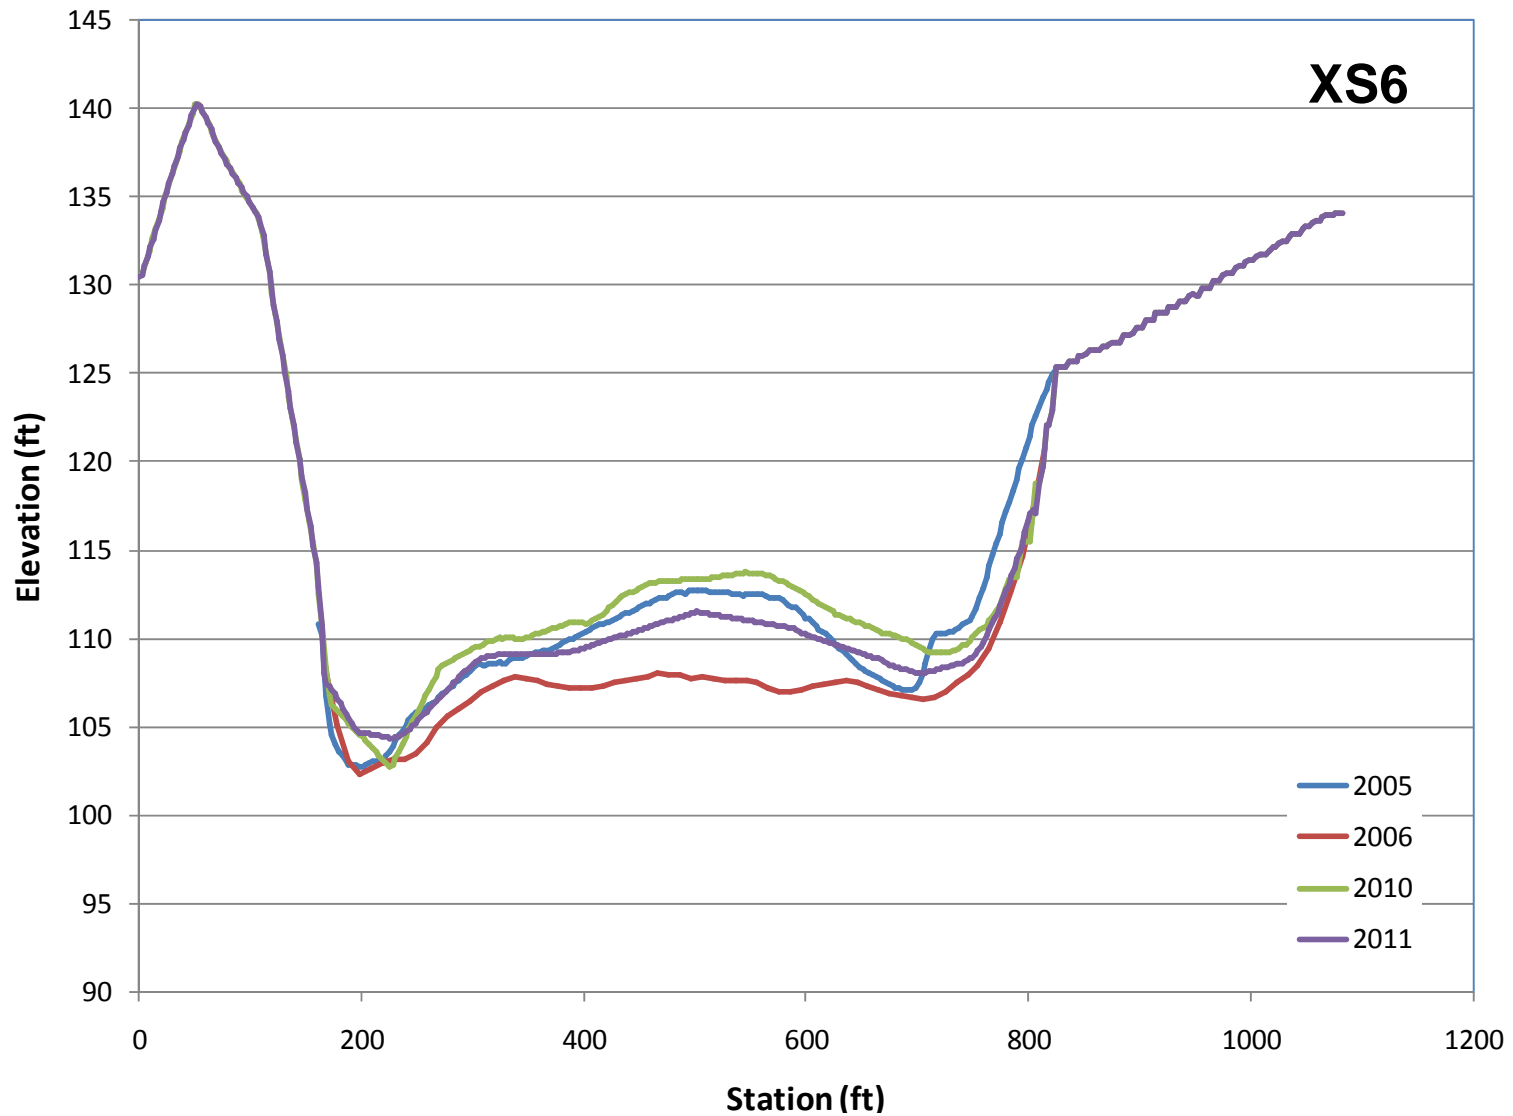
Figure 18. Comparative cross-section plots, 2005 to 2011 upstream of the M&T/Llano Seco fish screens and pump inlets on the lower part of the migrating bar.

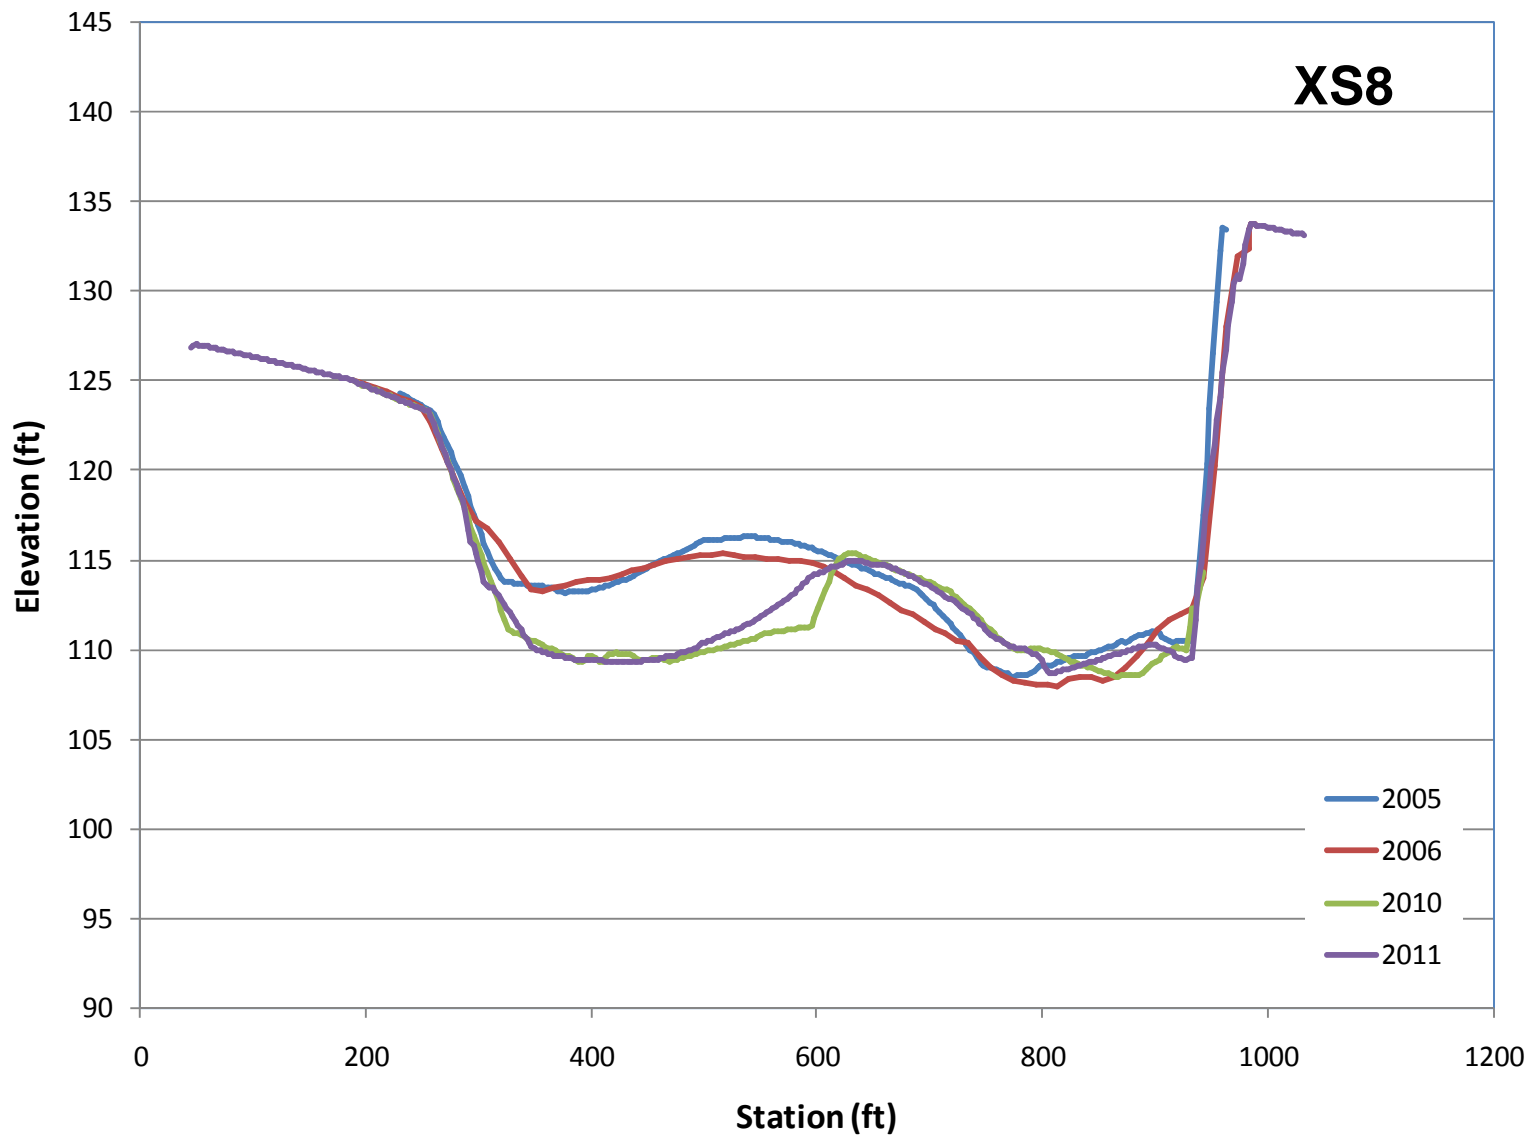
The general patterns of aggradation and degradation shown in Figures 8 through 11 are supported by comparative cross-section plots. The locations of the plotted cross sections are shown on **Figure 12**, with Cross Section 1 (XS1) being located at the newly relocated City of Chico wastewater outfall and diffuser, XS2 is located near the City's previous outfall, XS3 through XS5, span the fish screens and pump inlets and XS6 and XS7 are located upstream and incorporate the migrating gravel bar. XS8 represents the area that was dredged in 2007. At the City of Chico's outfall (**Figure 13**) the cross sections indicate that there was some aggradation on the left (east) side of the channel in 2005 but subsequent surveys show that the local aggradation has been removed. Given the similarity of the cross sections in the post-2005 period it is likely that the bench represents rock riprap, which is reinforced by the deeper channel to the right (west). At the location of the City's prior outfall (**Figure 14**), it is apparent that the aggradation in 2010 was removed by the flows in 2011 and that the depth of scour probably depends on the magnitude of the high flows since the bed elevation in 2006 is the lowest. At the location of the fish screens and pump inlets (**Figures 15,16,17**) it is clear that during the lower peak flow years the deposition approaches the inlets and fish screens, and it is eroded during the higher flow years. The same general trend is seen on the upper part of the migrating bar (**Figures 18 and 19**). Aggradation occurs during the lower peak flow years (2005, 2010) and there is scour in the higher peak flow years (2006, 2011). The comparative cross sections indicate that there has been little or no filling in the area that was dredged in 2007 (**Figure 20**).

Figure 20. Comparative cross-section plots, 2005 to 2011 across the area that was dredged in 2007.

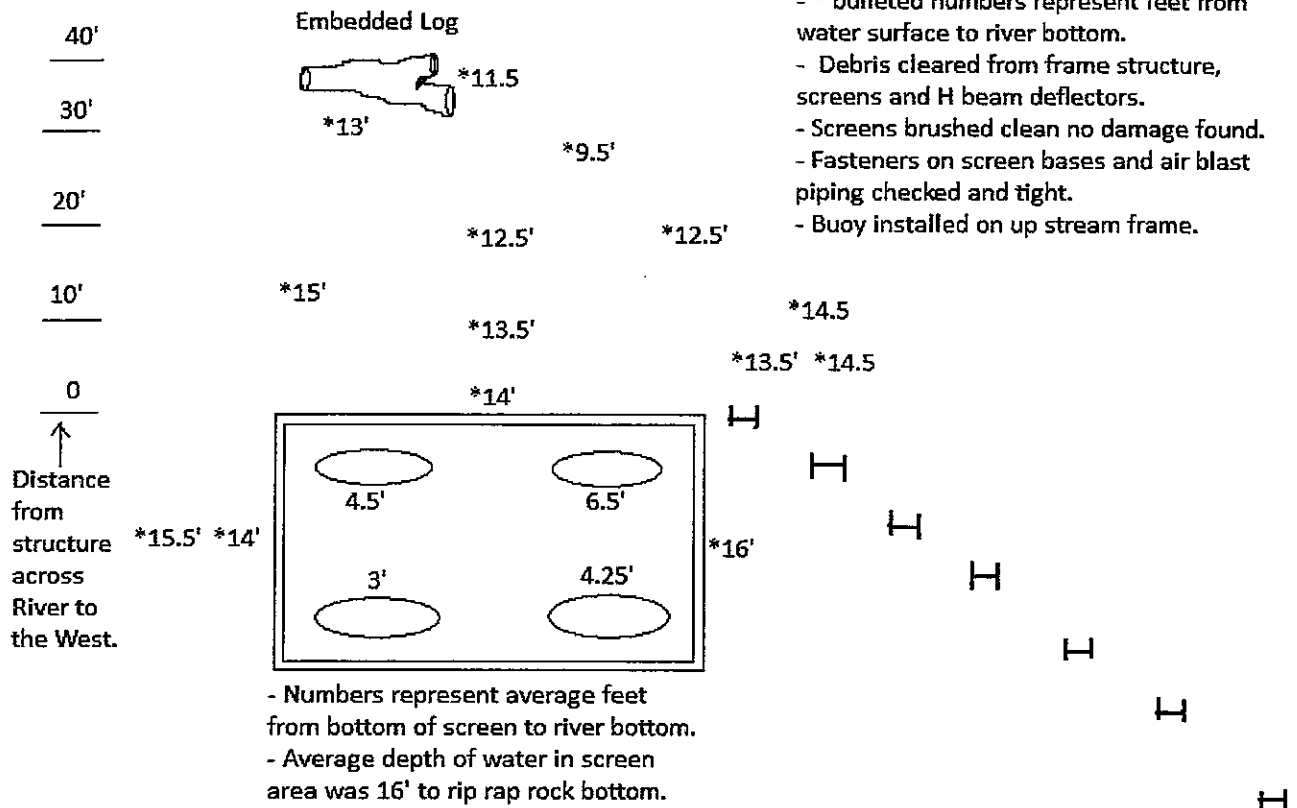
- * bulleted numbers represent feet from water surface to river bottom.
- Debris cleared from frame structure, screens and H beam deflectors.
- Screens brushed clean no damage found.
- Fasteners on screen bases and air blast piping checked and tight.
- Buoy installed on up stream frame.

- Numbers represent average feet from bottom of screen to river bottom.
- Average depth of water in screen area was 16' to rip rap rock bottom.

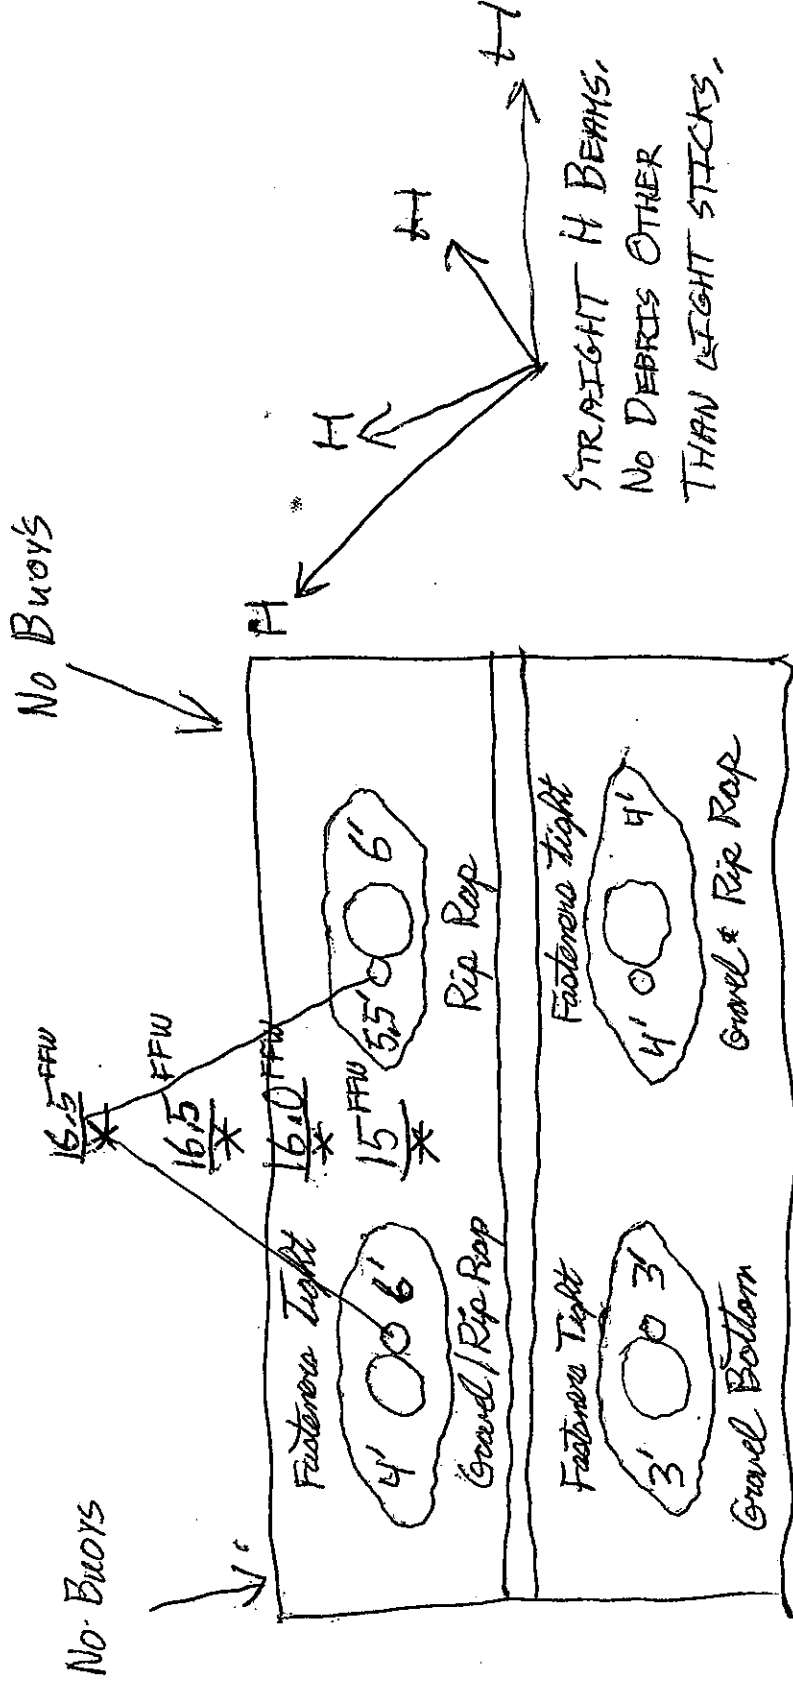
201- * 15'
 151- * 15'
 101- * 14'
 51- * 15'
 * 13.5'

DOWN STREAM
 BOUY BAD
 SUNKEN

UPSTREAM BOUY
 BAD SUNKEN

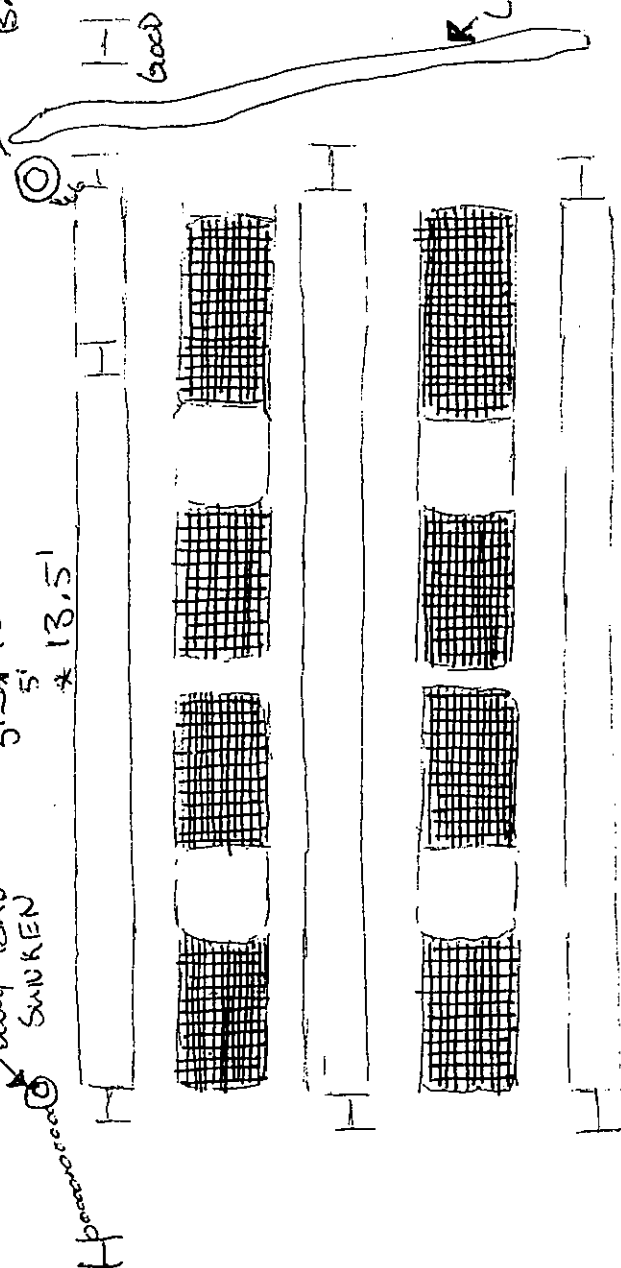
Good
 Good
 Good
 Good
 Good
 LOG REMOVED
 6" to 8" Dia.
 Good CLEAR
 Good

- 5' = 15'
 - 10' = 14'
 - 15' = 15'
 - 20' = 15'
 - 25' = 15'
 - 30' = 14'
- * PAST 30' SLOPES UP GRADUALLY
 * BOTH BOUY'S SUNKEN
 * REMOVED LOG FROM STRUCTURE
 * ALL H-BEAMS GOOD

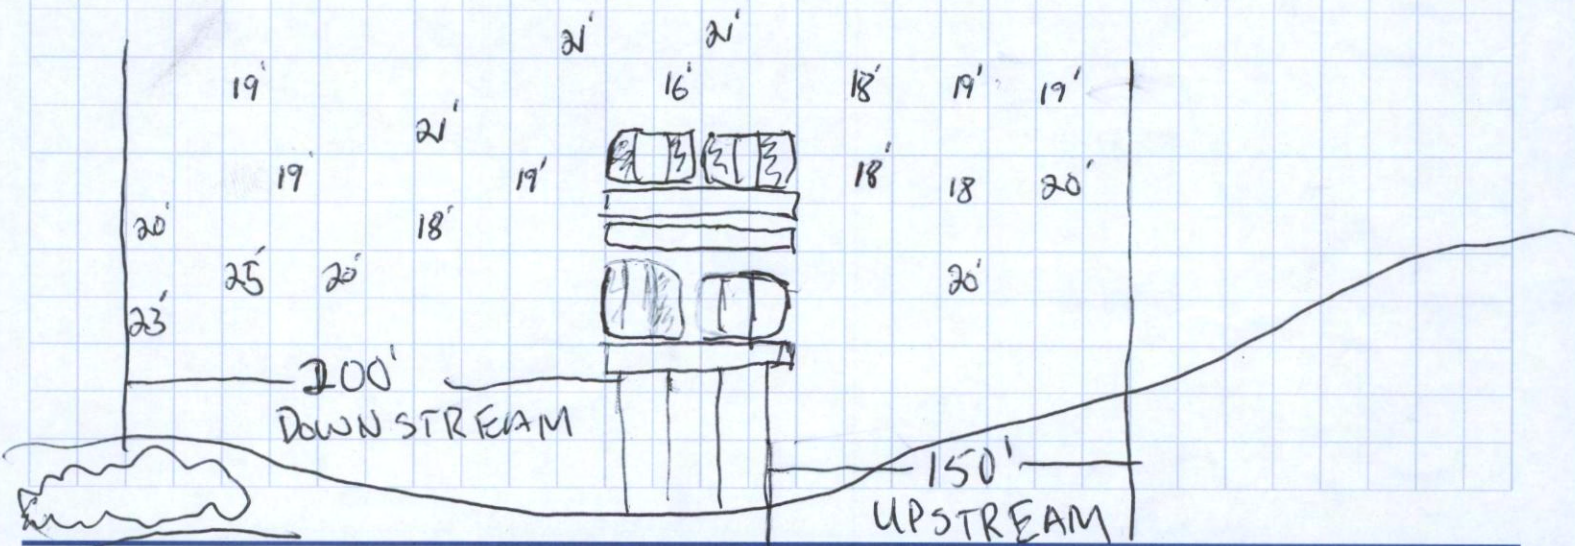
Area under screens clear to concrete/rip rap.
