TO: Jim Well, Ducks Unlimited

SUBJECT: **June 26, 2012 Resurvey of M&T/Llano Seco Pumping Plant and City of Chico Outfall Reach of the Sacramento River**

DATE: July 16, 2012

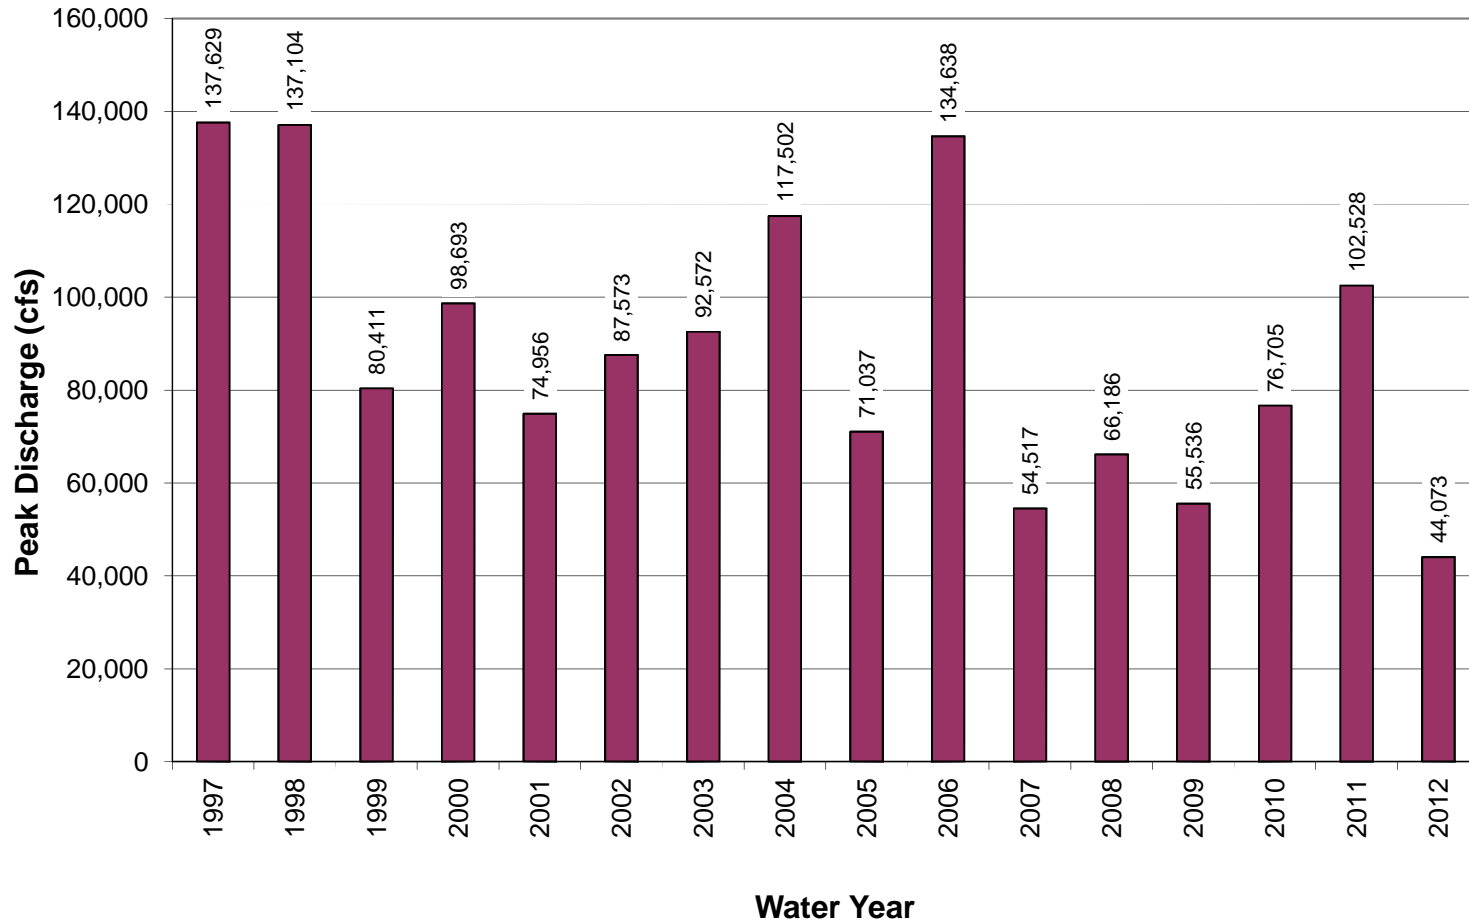
Figure 1. Peak annual flows at the Hamilton City gage between WY1997 and WY2011.

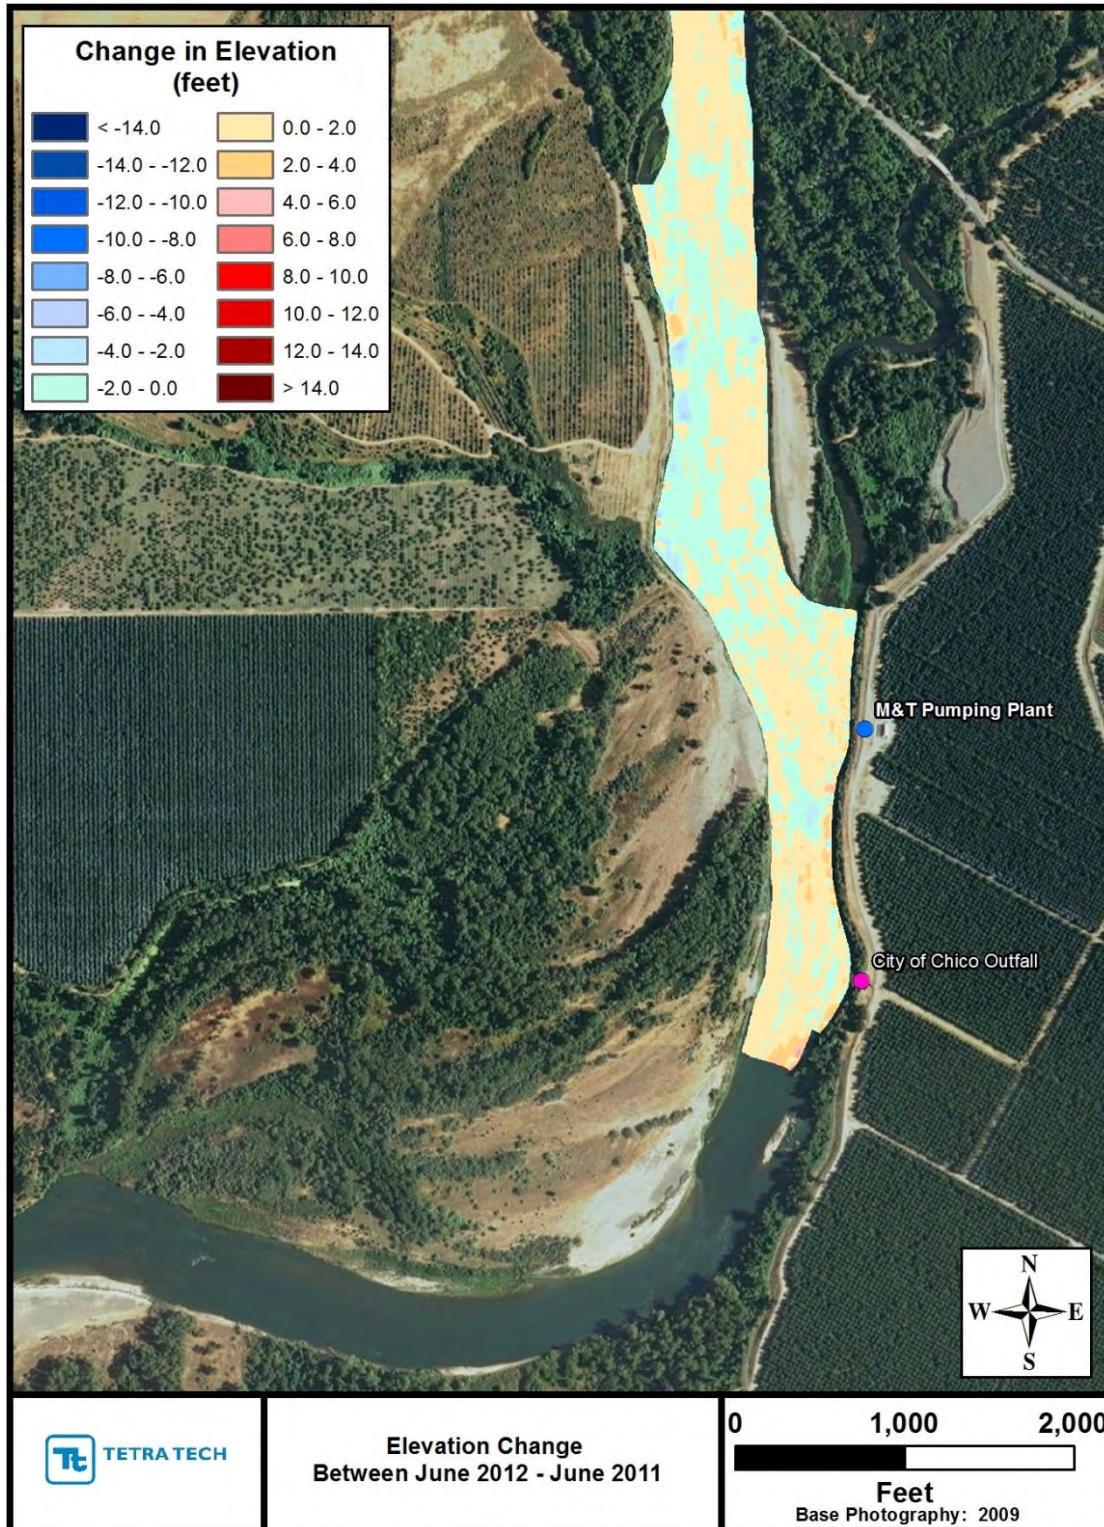
Figure 5 presents the changes in bed elevation between the 2011 survey and the 2012 surveys. The data indicate that there has been some additional aggradation in the vicinity of the pump intake as compared to the 2011 survey, which is likely due to the lack of significant peak flows during the 2012 spring runoff period (peak flow at Hamilton City was about 44,000 cfs). **Figure 6** presents the differences in elevation of the bed of the river between the 2012 and 2006 surveys, and demonstrates that the site is still net aggradational.

Figure 5. Elevation changes in the M&T/Llano Seco reach between the June 2012 and June 2011 surveys.

The 2011 peak flow event exceeded bankfull conditions and eroded the previously deposited material in the vicinity of the fish screens and pump inlets, leaving the area relatively clear of deposition. The 2012 survey indicated relatively little deposition in this area, and therefore, dredging is not recommended at this time.

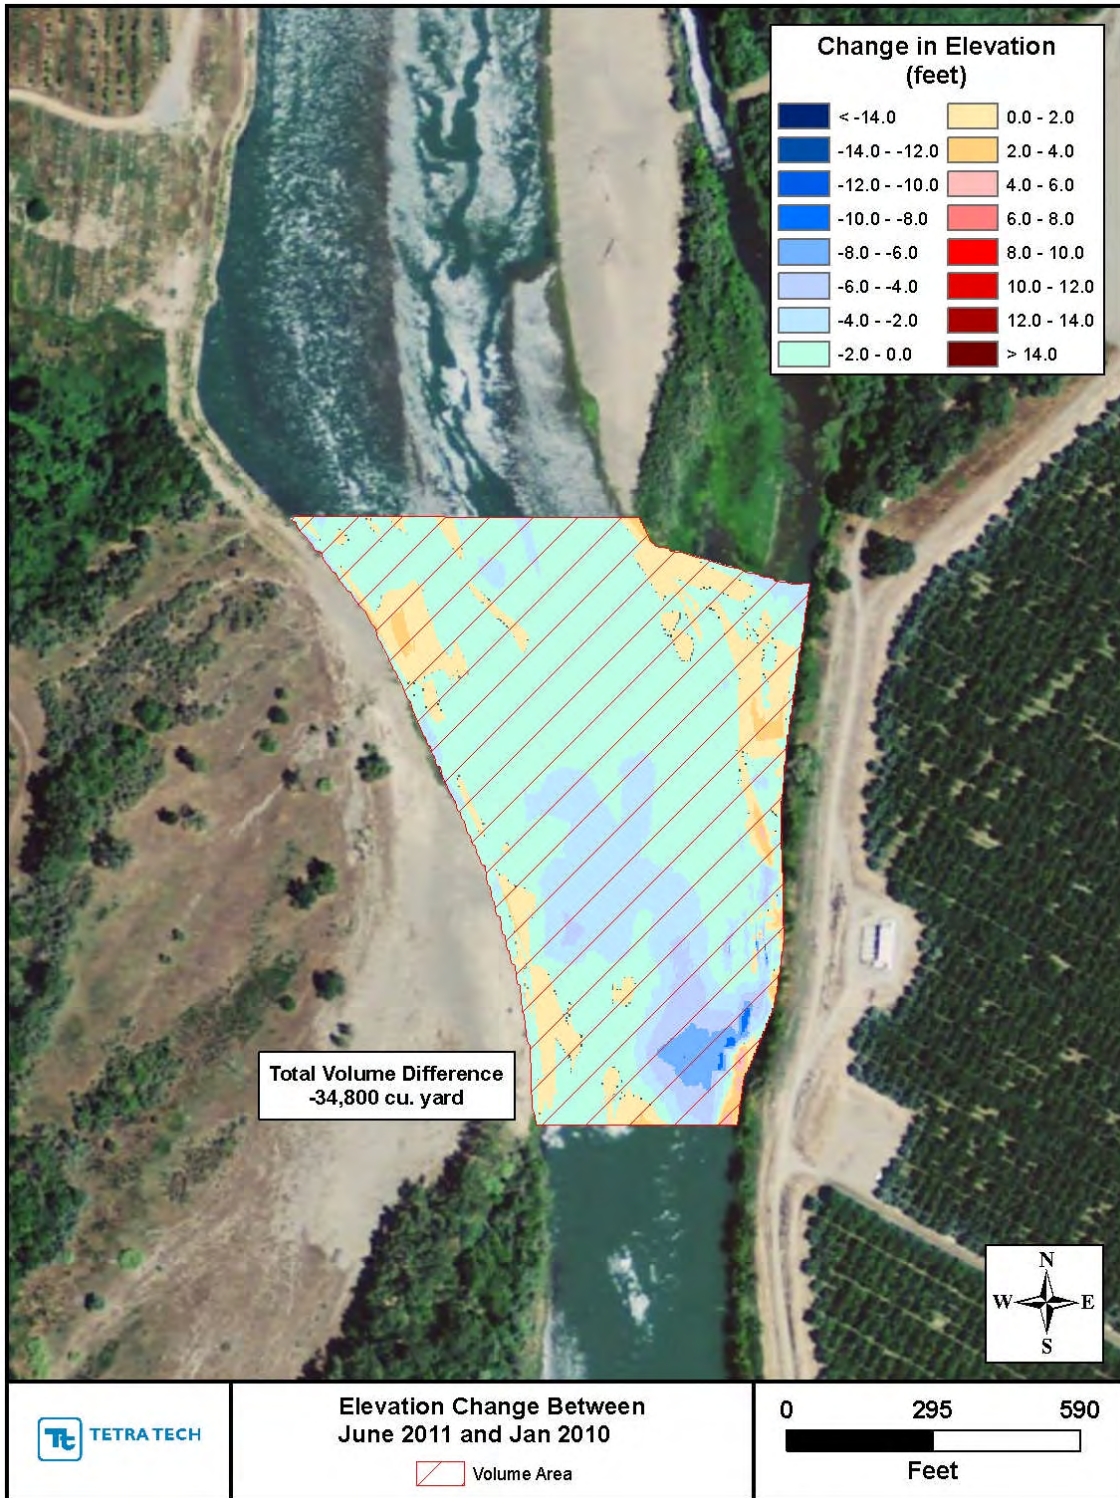
In order to further evaluate bed elevation changes between 2006 and 2012, and to determine the volume of dredge material in the vicinity of the fish screens and pump inlets, an approximately 600- by 1,200-foot area was designated and the difference in volume between surveys was determined. Between the 2006 and 2010 surveys, about 89,000 cu.yd. (~120,000 tons) of material accumulated (**Figure 7**). Between the 2011 and 2006 surveys, the volume of material that accumulated was reduced to about 54,400 cu.yd. (~72,900 tons) (**Figure 8**). Between 2010 and 2011, there was net loss of about 34,800 cu.yd. (~47,000 tons) of material (**Figure 9**).

Figure 9. Volumetric calculation of the deposition in the 600- by 1,200-foot segment in the vicinity of the fish screens and pump inlets between the June 2011 and January 2010 surveys.

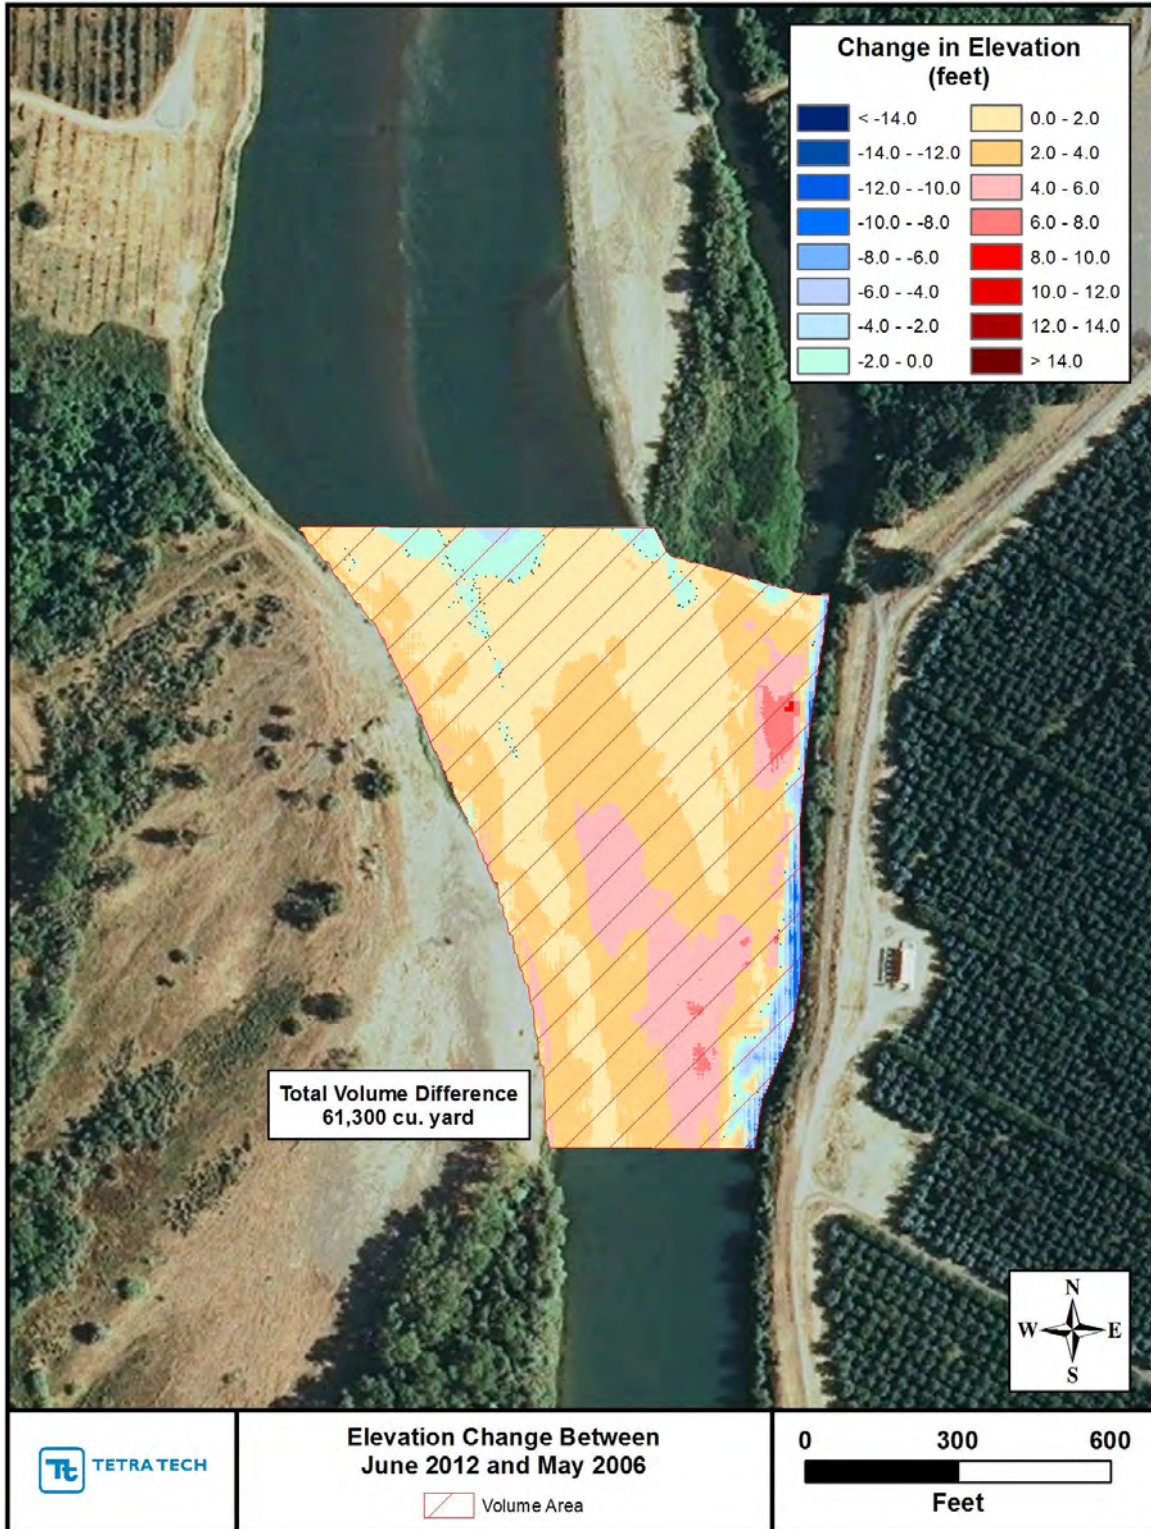
Between the 2012 and 2006 surveys, there was a net accumulation of about 61,300 cu.yd. (~82,800 tons) (**Figure 10**). From 2011 to 2012, there was slight aggradation in the delineated area and a net gain of about 6,700 cu.yd. (~9,000 tons) of material (**Figure 11**).

Figure 10. Volumetric calculation of the deposition in the 600- by 1,200-foot segment in the vicinity of the fish screens and pump inlets between the June 2012 and May 2006 surveys.

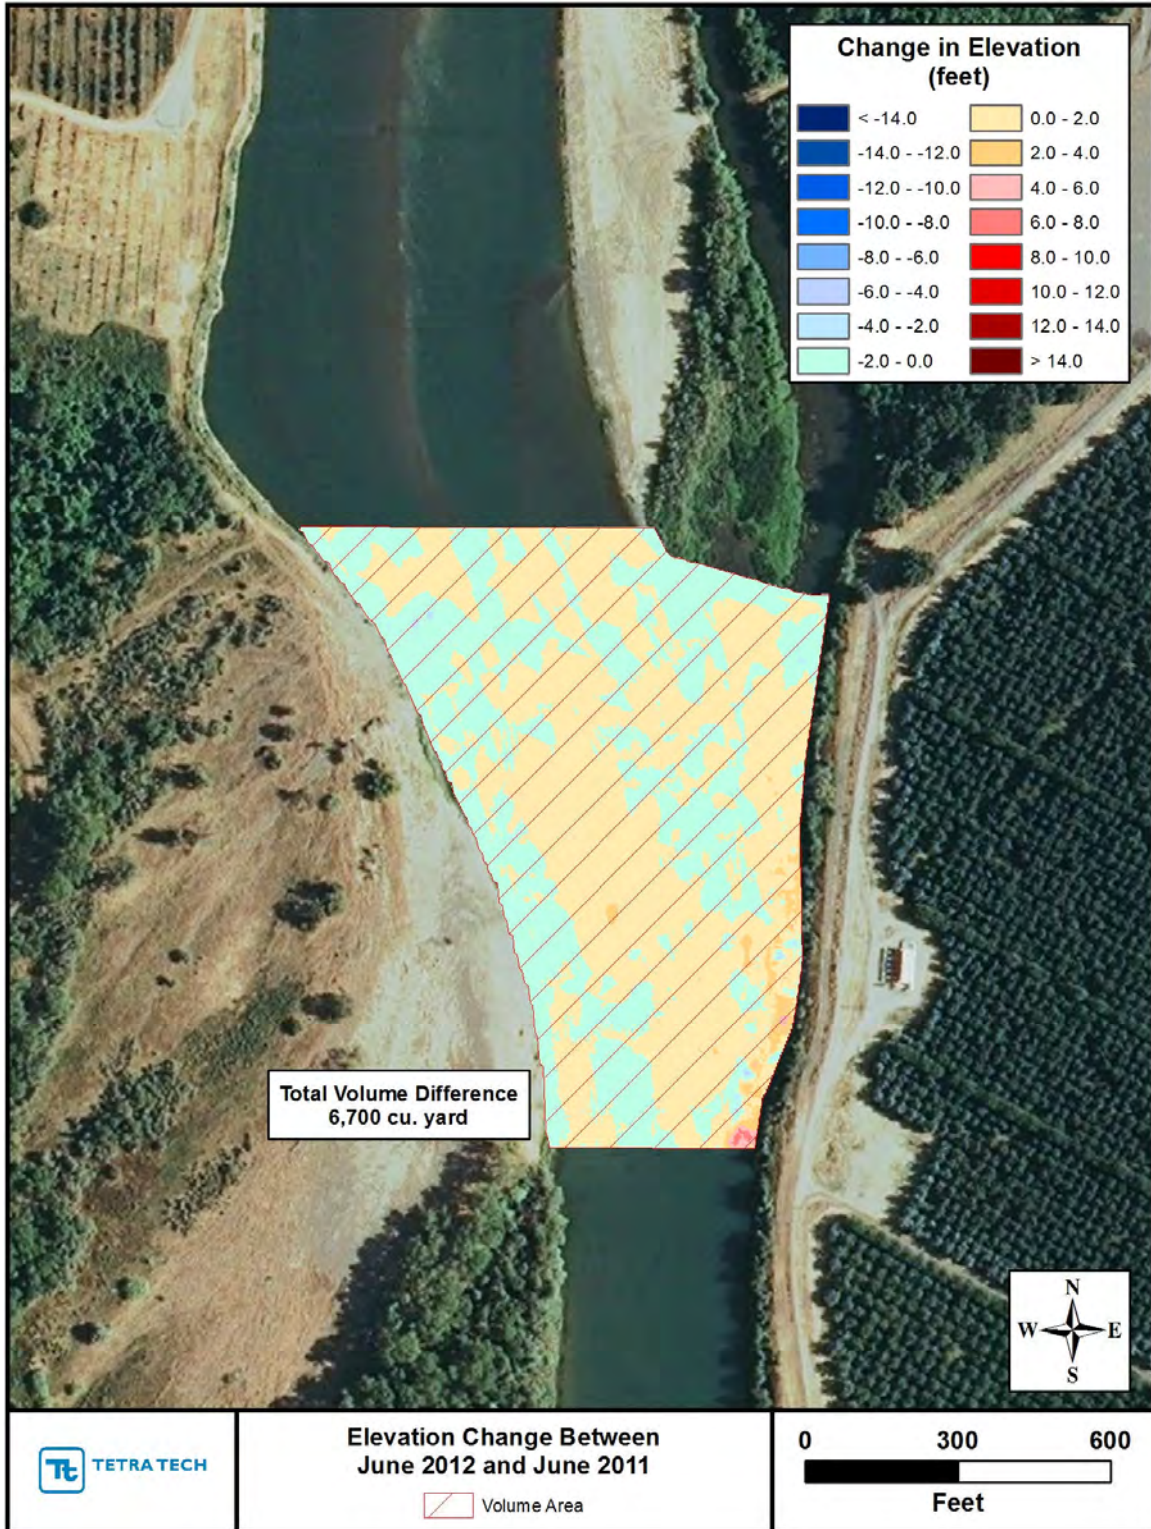
Figure 11. Volumetric calculation of the deposition in the 600- by 1,200-foot segment in the vicinity of the fish screens and pump inlets between the June 2011 and June 2012 surveys.

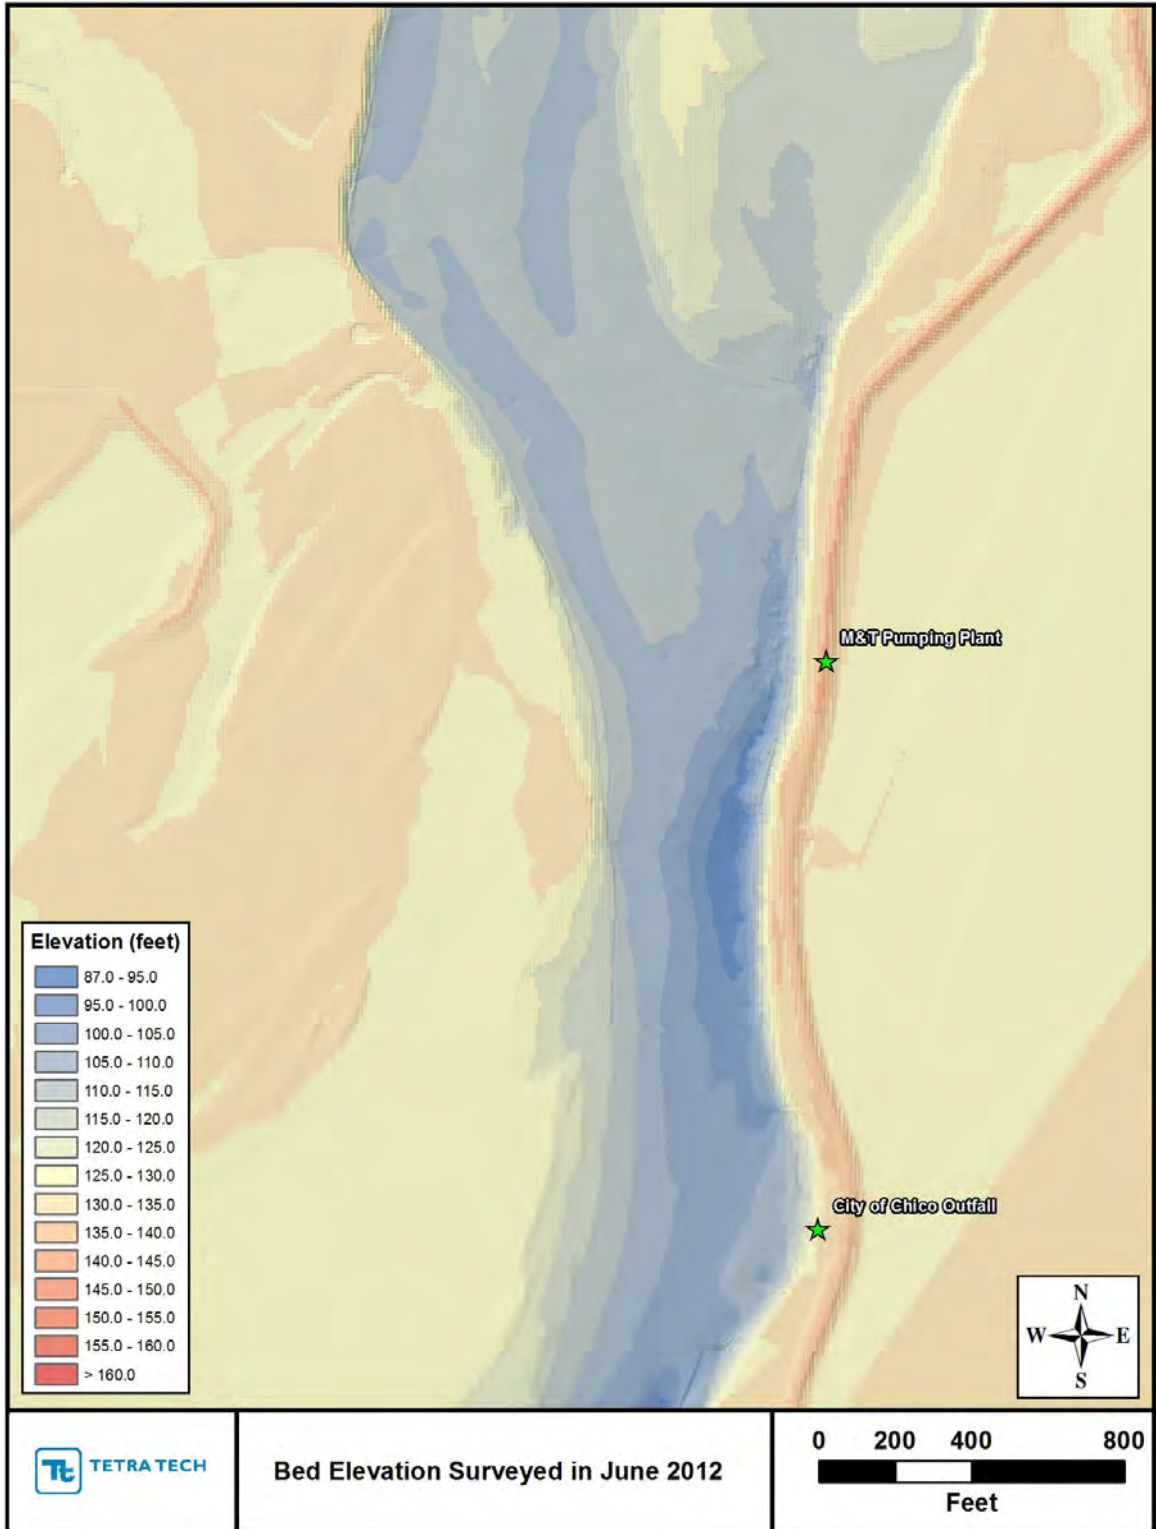
Aggradation and degradation within the M&T/Llano Seco reach appears to be tied to the peak flow hydrology. With the exception of WY2004, the peak flows in the six years prior to 2005 were less than the bankfull (~90,000 cfs) in the M&T/Llano Seco reach and this sequence of flows appears to be responsible for the aggradation in the channel (Figure 1). In WY2006, the peak flow was about 135,000 cfs and clearly there was some degradation in the reach, especially in the vicinity of the fish screens and pump inlets (**Figure 12**). Between WY2006 and WY2010, the peak flows were again less than the bankfull and aggradation occurred in the vicinity of the fish screens and pumps (**Figure 13**). Peak flow in WY2011 was about 102,500 cfs and this flow appears to have caused degradation in the vicinity of the fish screens and pump inlets (**Figure 14**). The peak flows during the spring 2012 runoff period was about 44,000 cfs (approximately half of the bankfull flow), which re-activated a concern about the need to dredge. Between 2011 and 2012, there was a relatively small amount of deposition in the vicinity of the fish screens and pump inlets but the general problem of deposition during low flow years was observed (**Figure 15**).

Figure 15. Color gradient plot showing the bed topography in the vicinity of the M&T/Llano Seco Pumping Plant and the relocated City of Chico Outfall in June 2012.

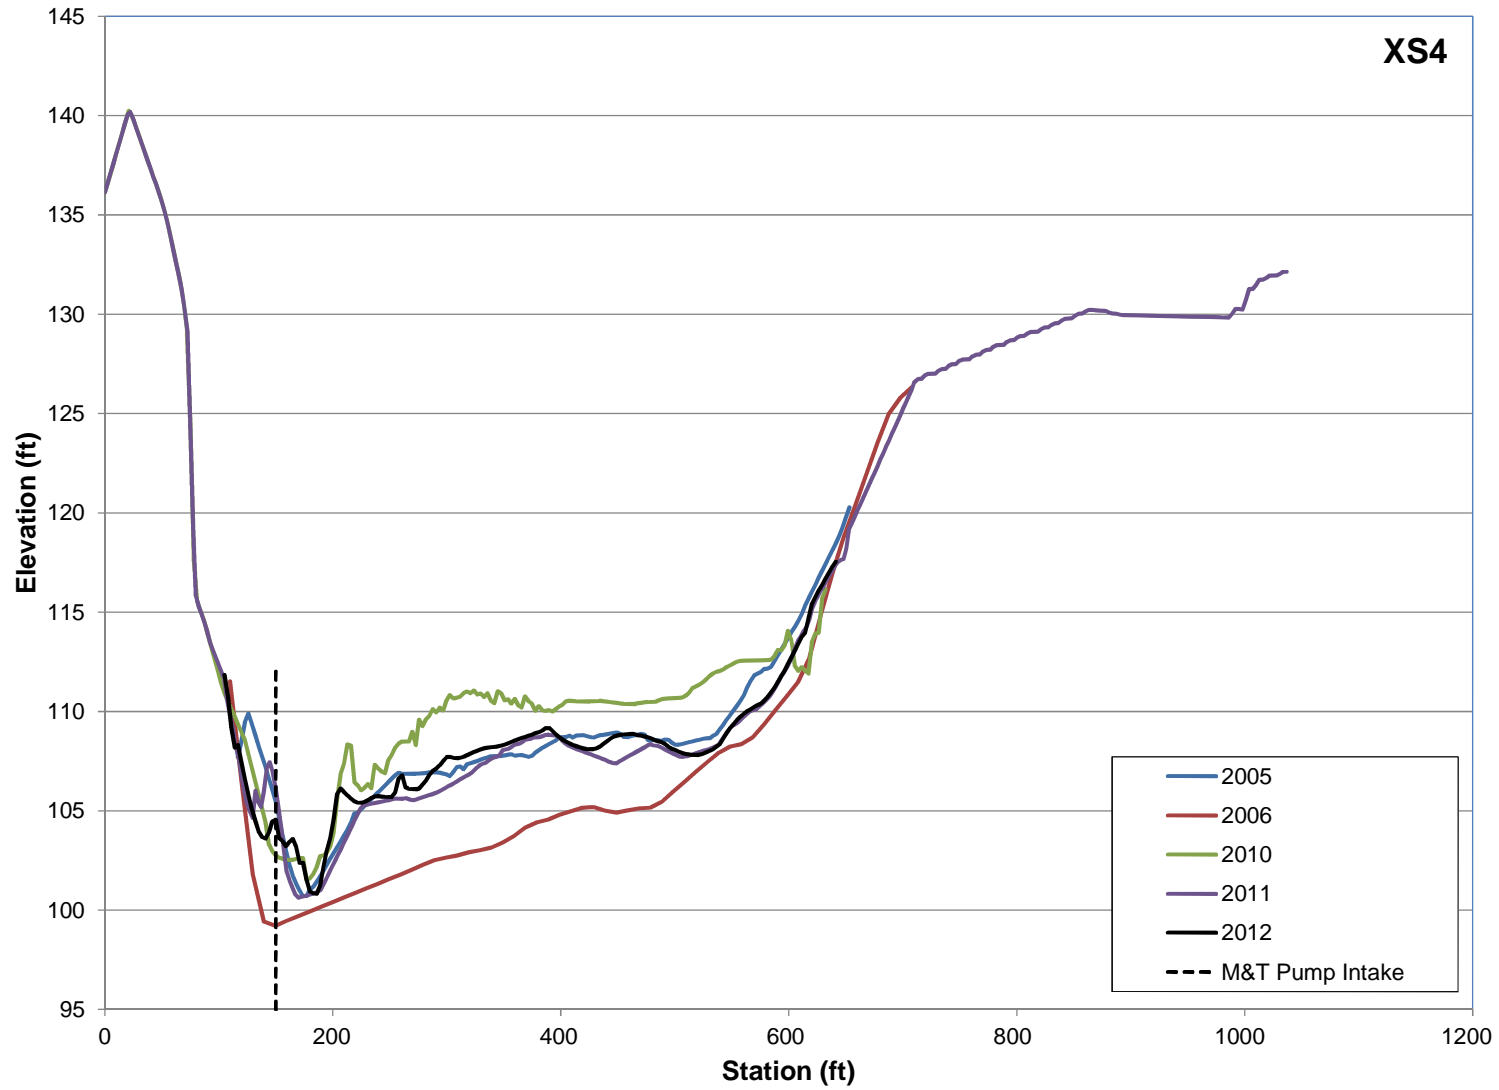
The general patterns of aggradation and degradation shown in Figures 12 through 15 are supported by comparative cross-sectional plots. The locations of the plotted cross sections are shown on **Figure 16**, with Cross Section 1 (XS1) being located at the newly relocated City of Chico wastewater outfall and diffuser, XS2 is located near the City's previous outfall, XS3 through XS5, span the fish screens and pump inlets and XS6 and XS7 are located upstream and incorporate the migrating gravel bar. XS8 represents the area that was dredged in 2007. At the City of Chico's outfall (**Figure 17**) the cross sections indicate that there was some aggradation on the left (east) side of the channel in 2005 but the 2006, 2010 and 2011 surveys show that the local aggradation was removed. Given the similarity of the cross sections in the post-2005 period it is likely that the bench represents the coarse gravel material placed along the alignment of the diffuser outfall during construction. The 2012 survey shows aggradation along the left side of the channel from near the left bank (east) to approximately Station 430. The 2012 survey also shows slight aggradation in the main channel compared to the 2011 survey. At the location of the City's prior outfall (**Figure 18**), it is apparent that the aggradation in 2010 was removed by the flows in 2011 and that the depth of scour probably depends on the magnitude of the high flows since the bed elevation in 2006 is the lowest. The 2012 survey shows there was very little change along the cross section compared to 2011 conditions. At the location of the fish screens and pump inlets (**Figures 19, 20, 21**) it is clear that during the lower

peak flow years the deposition approaches the inlets and fish screens, and it is eroded during the higher-flow years. The 2012 survey shows there was up to 3 feet of aggradation near the left bank (east) as well as some aggradation in localized areas in the main channel compared to the 2011 conditions.

Figure 20. Comparative cross-section plots, 2005 to 2012 at the M&T/Llano Seco fish screens and pump inlets.

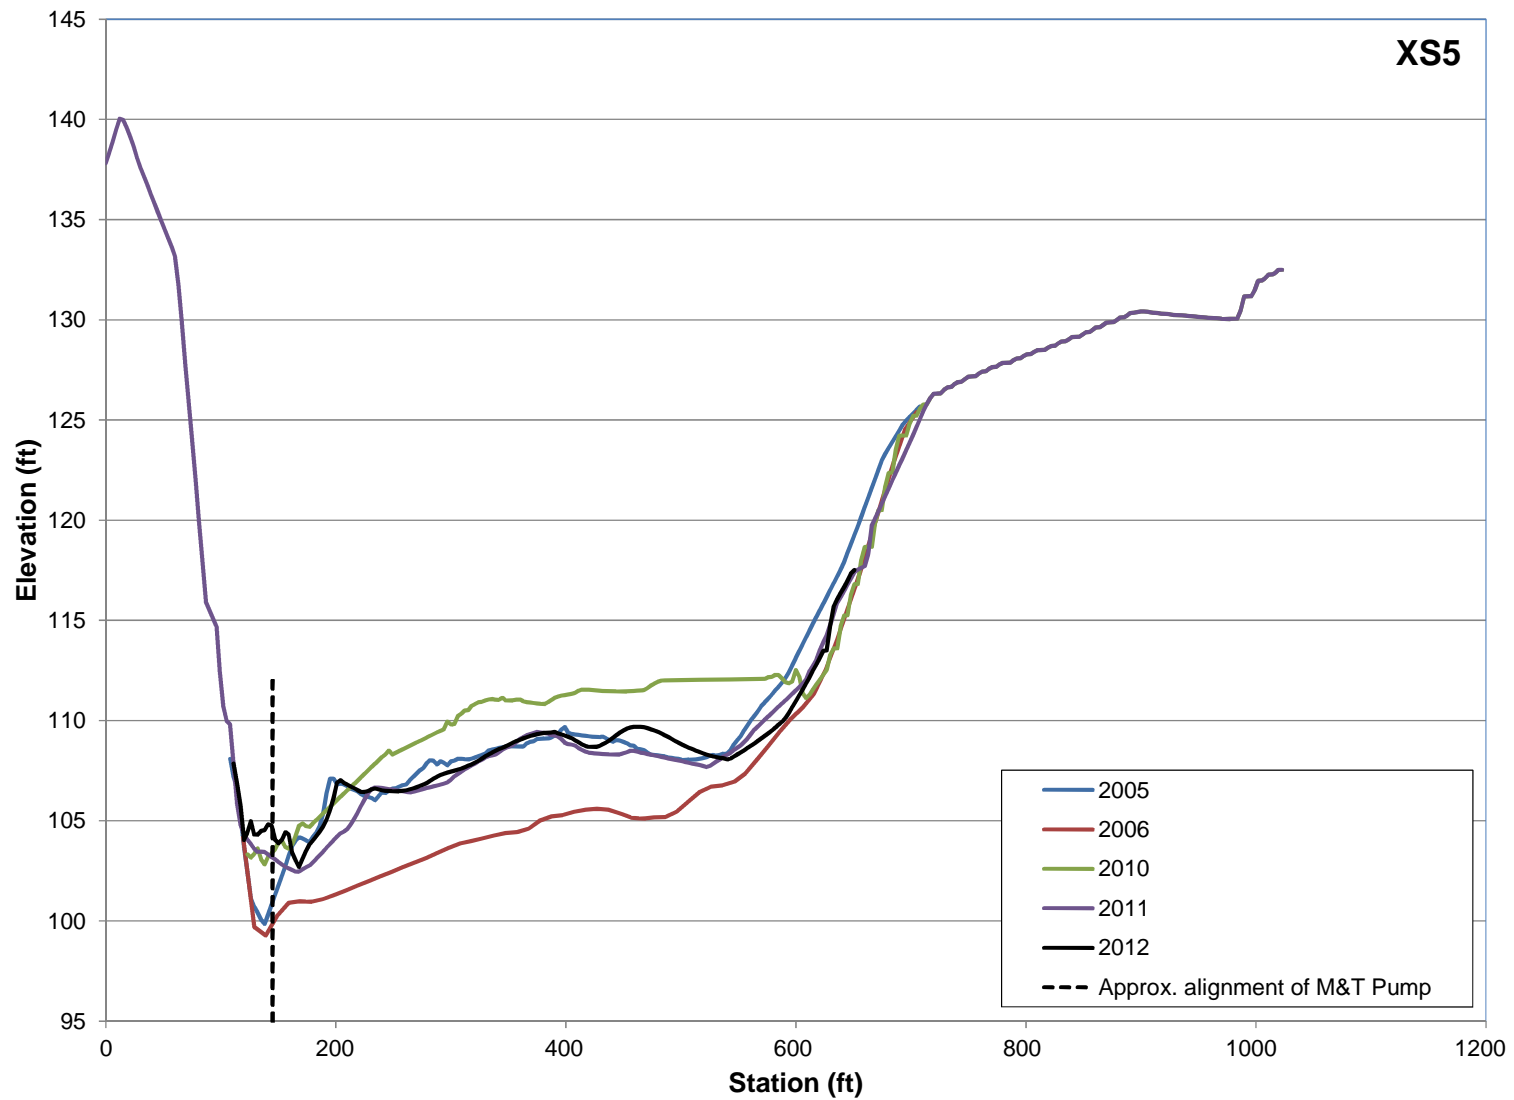
Figure 21. Comparative cross-section plots, 2005 to 2012 immediately upstream of the M&T/Llano Seco fish screens and pump inlets.

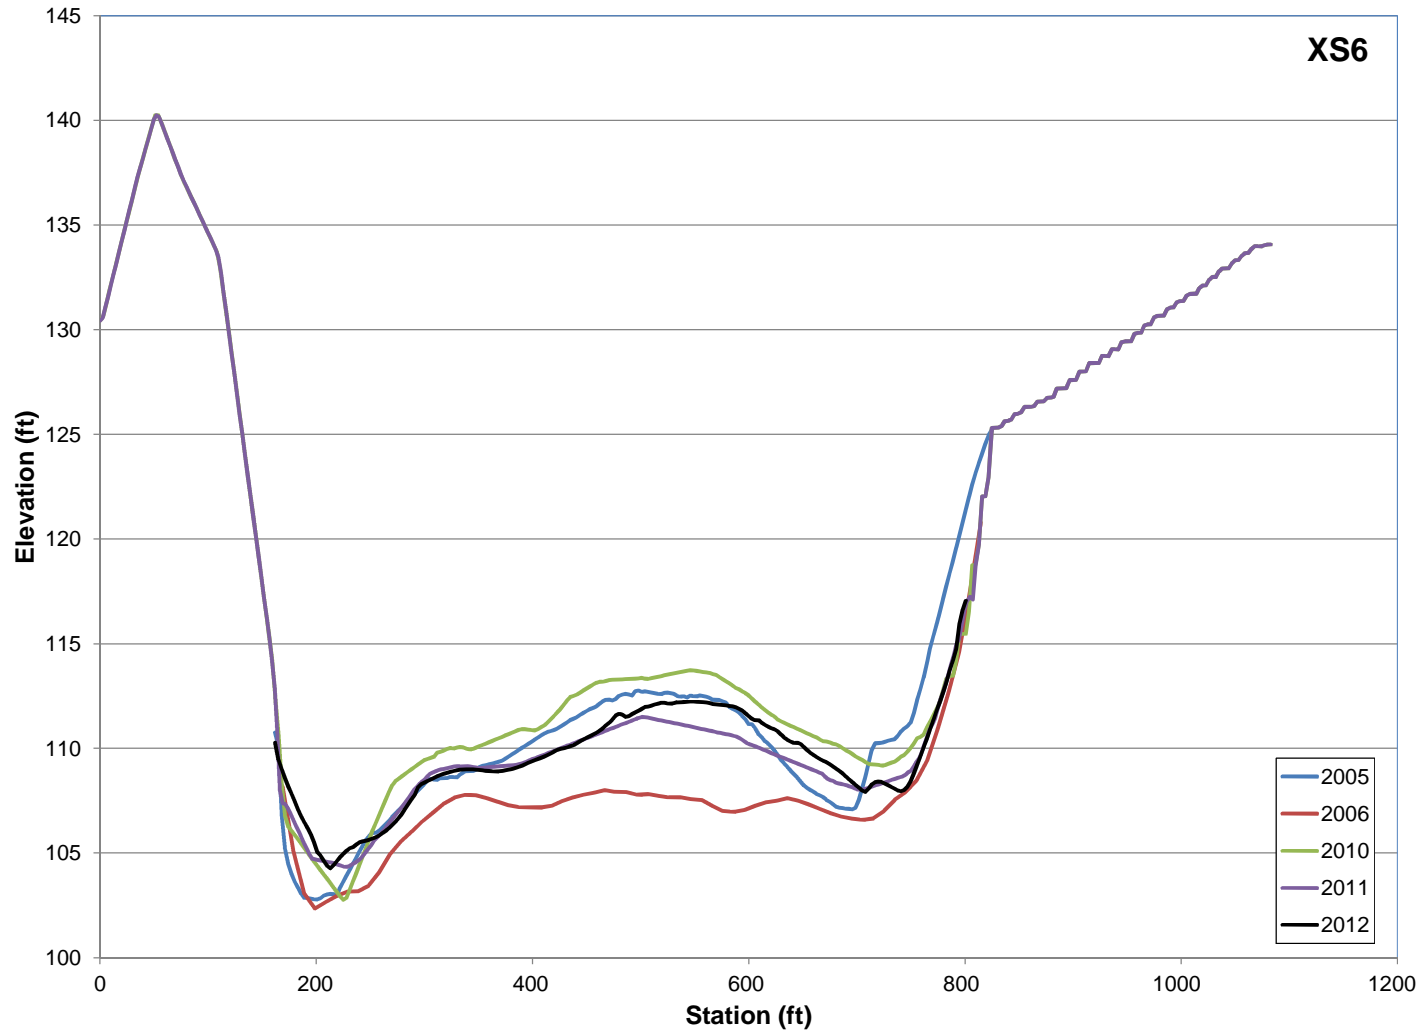
The same general trend is seen on the upper part of the migrating bar (**Figures 22 and 23**). Aggradation occurs during the lower peak flow years (2005, 2010) and there is scour in the higher peak flow years (2006, 2011). The 2012 survey shows there was aggradation near the left bank of XS6 and localized aggradation of up to 1.2 feet in the main channel, but in general, the 2012 survey is very similar to the 2011 survey. At XS7, there was approximately 1 foot of aggradation downstream from the bank attached bar.

Figure 22. Comparative cross-section plots, 2005 to 2012 upstream of the M&T/Llano Seco fish screens and pump inlets on the lower part of the migrating bar.

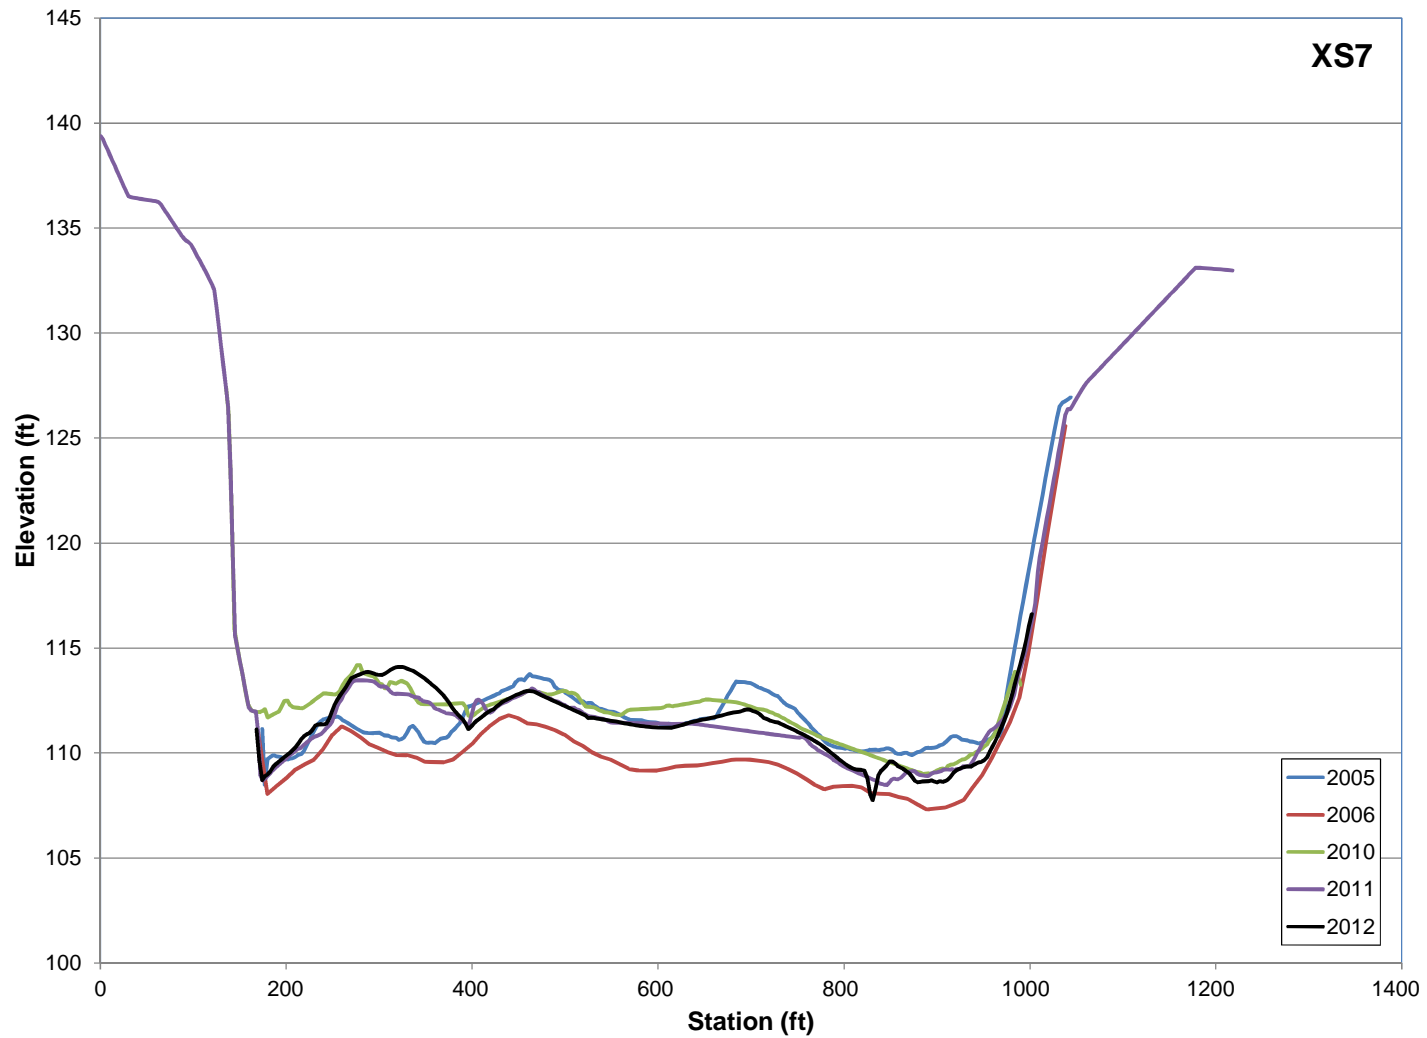
Figure 23. Comparative cross-section plots, 2005 to 2012 upstream of the M&T/Llano Seco fish screens and pump inlets on the upper part of the migrating bar.

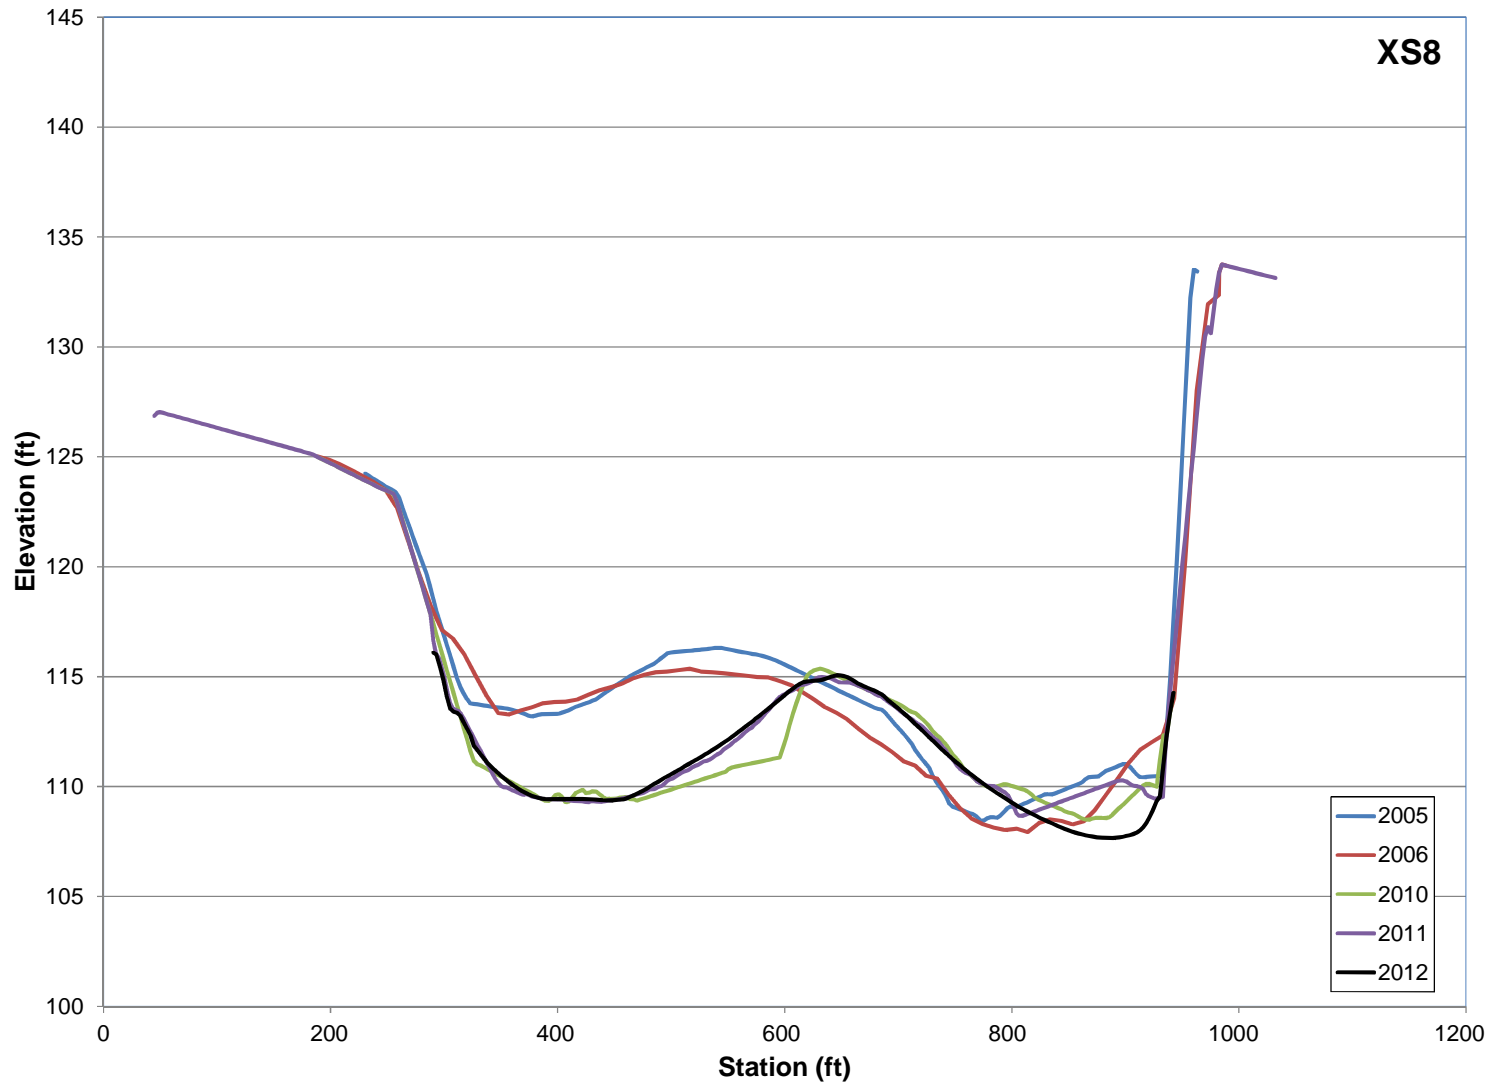
The comparative cross sections indicate that there has been little or no filling in the area that was dredged in 2007 (**Figure 24**) (left side of the cross section). The 2012 survey shows up to 2.5 feet of degradation along the right bank compared to the 2011 survey; this is likely due to scour along the base of the rock-toe revetment.

Figure 24. Comparative cross-section plots, 2005 to 2012 across the area that was dredged in 2007.

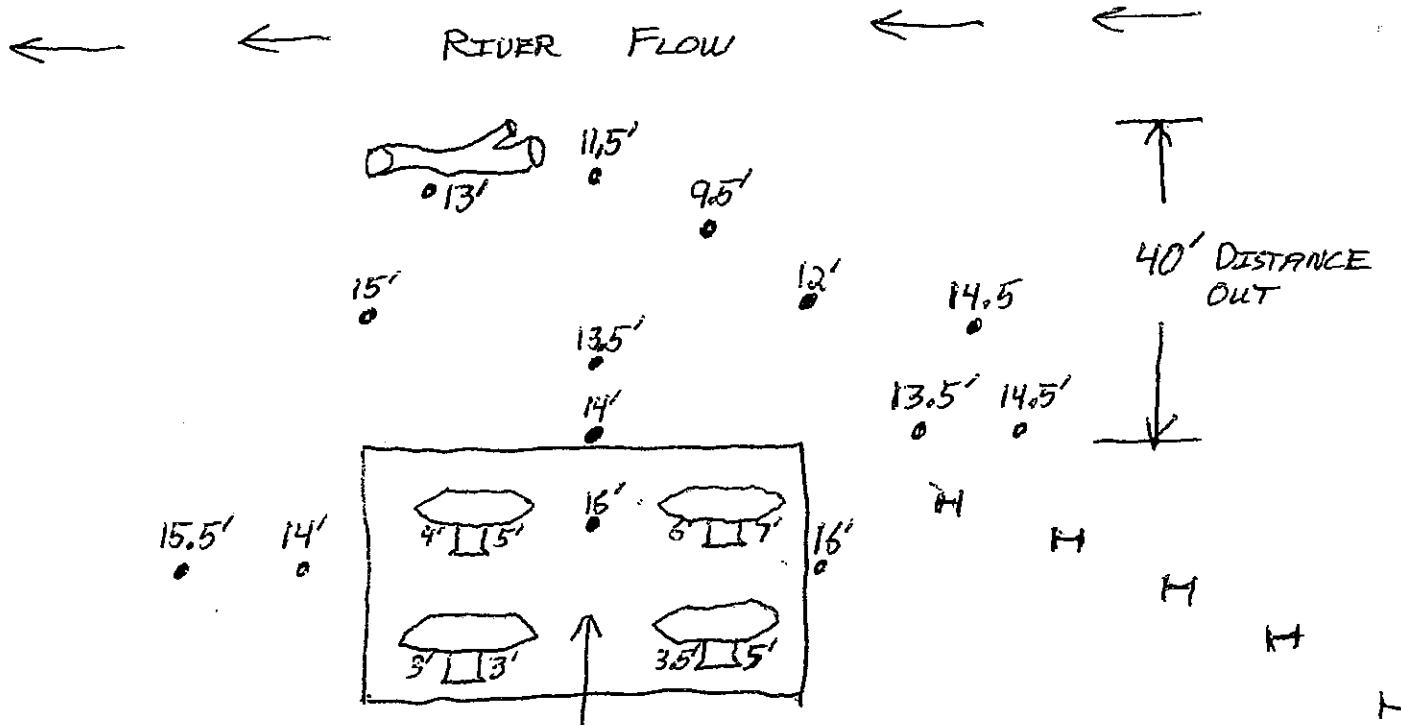
- RED RAP BOTTOM MIXED WITH SAND UNDER ALL THE SCREENS.

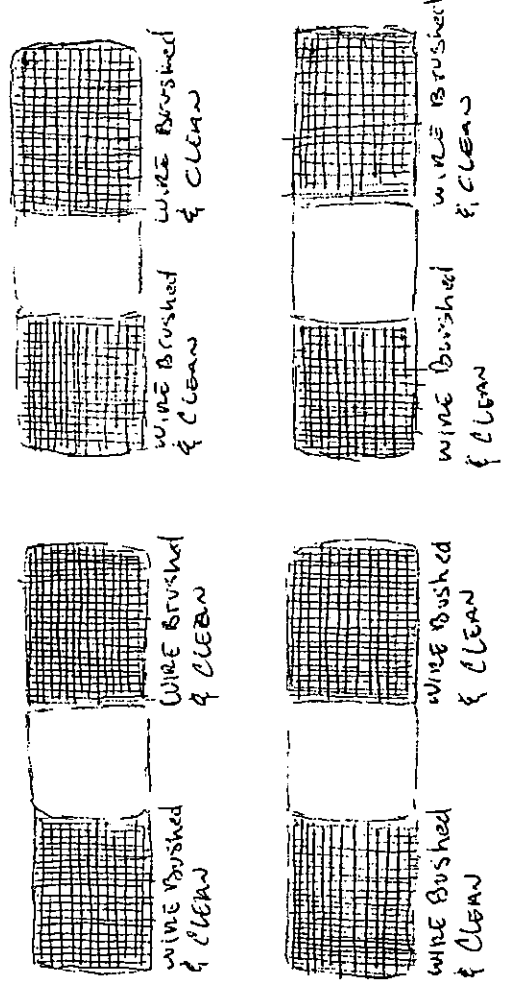
201- * 15'
 151- * 15'
 101- * 14'
 51- * 15'
 * 13.5'

DOWN STREAM
 BOUY BAD
 SUNKEN

UPSTREAM BOUY
 BAD SUNKEN

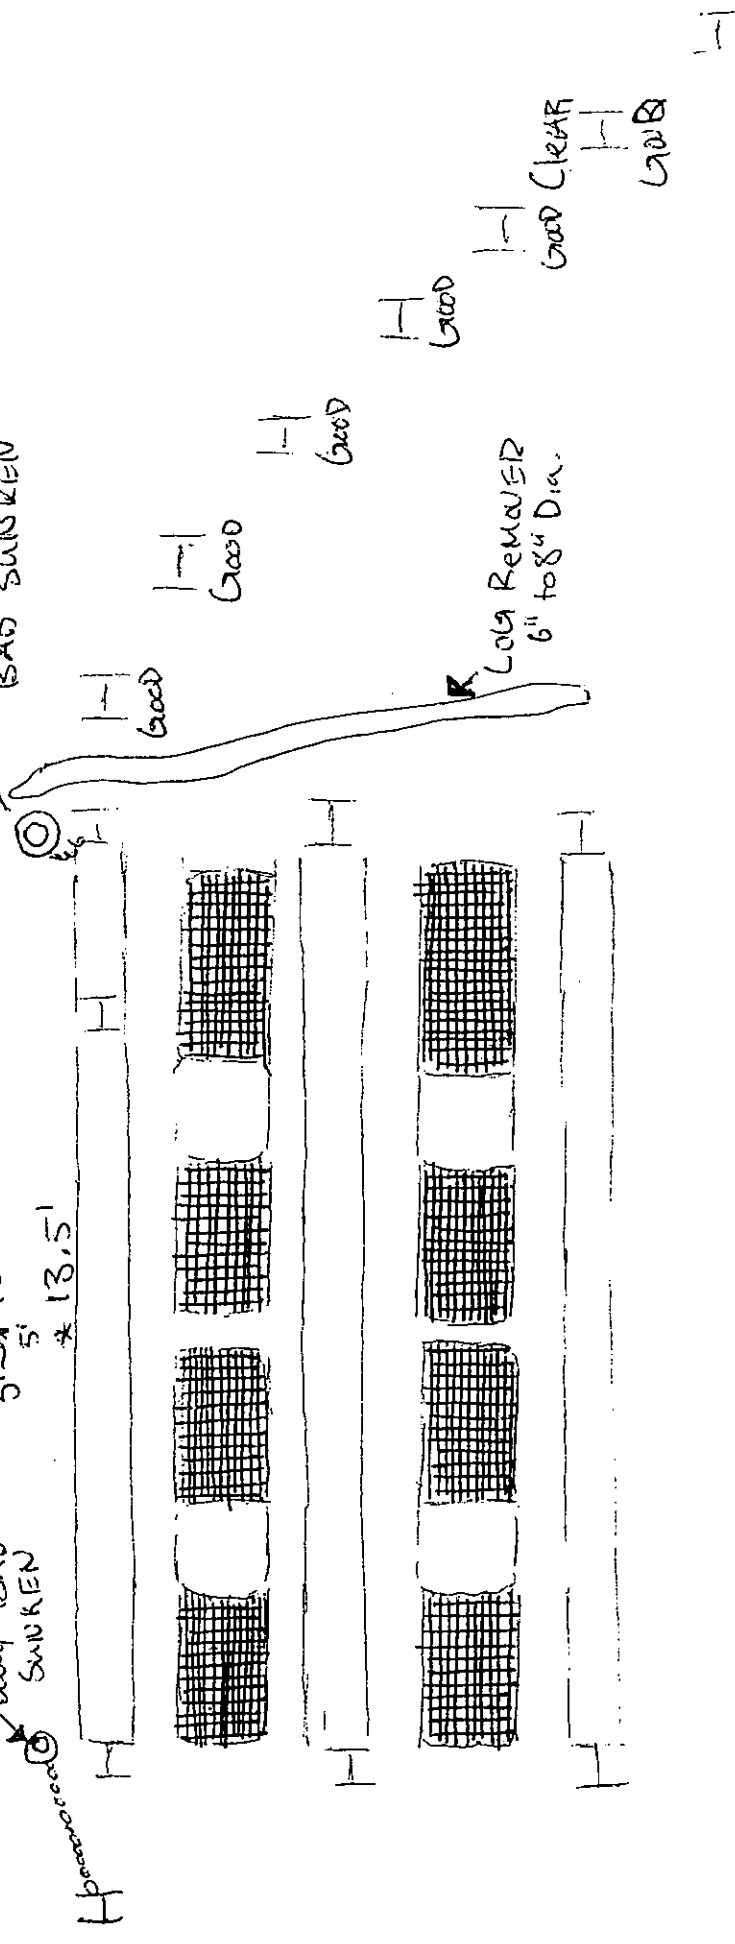
NOTES: * Depth Reading STRAIGHT OUT FROM MIDDLE OF STRUCTURE

- 5' = 15'
 - 10' = 14'
 - 15' = 15'
 - 20' = 15'
 - 25' = 15'
 - 30' = 14'
- * PAST 30' SLOPES UP GRADUALLY
 * BOTH BOUY'S SUNKEN
 * REMOVED LOW FROM STRUCTURE
 * ALL H-BEAMS GOOD
