TO: Jim Well, Ducks Unlimited

SUBJECT: **June 26, 2012 Resurvey of M&T/Llano Seco Pumping Plant and City of Chico Outfall Reach of the Sacramento River**

DATE: July 16, 2012

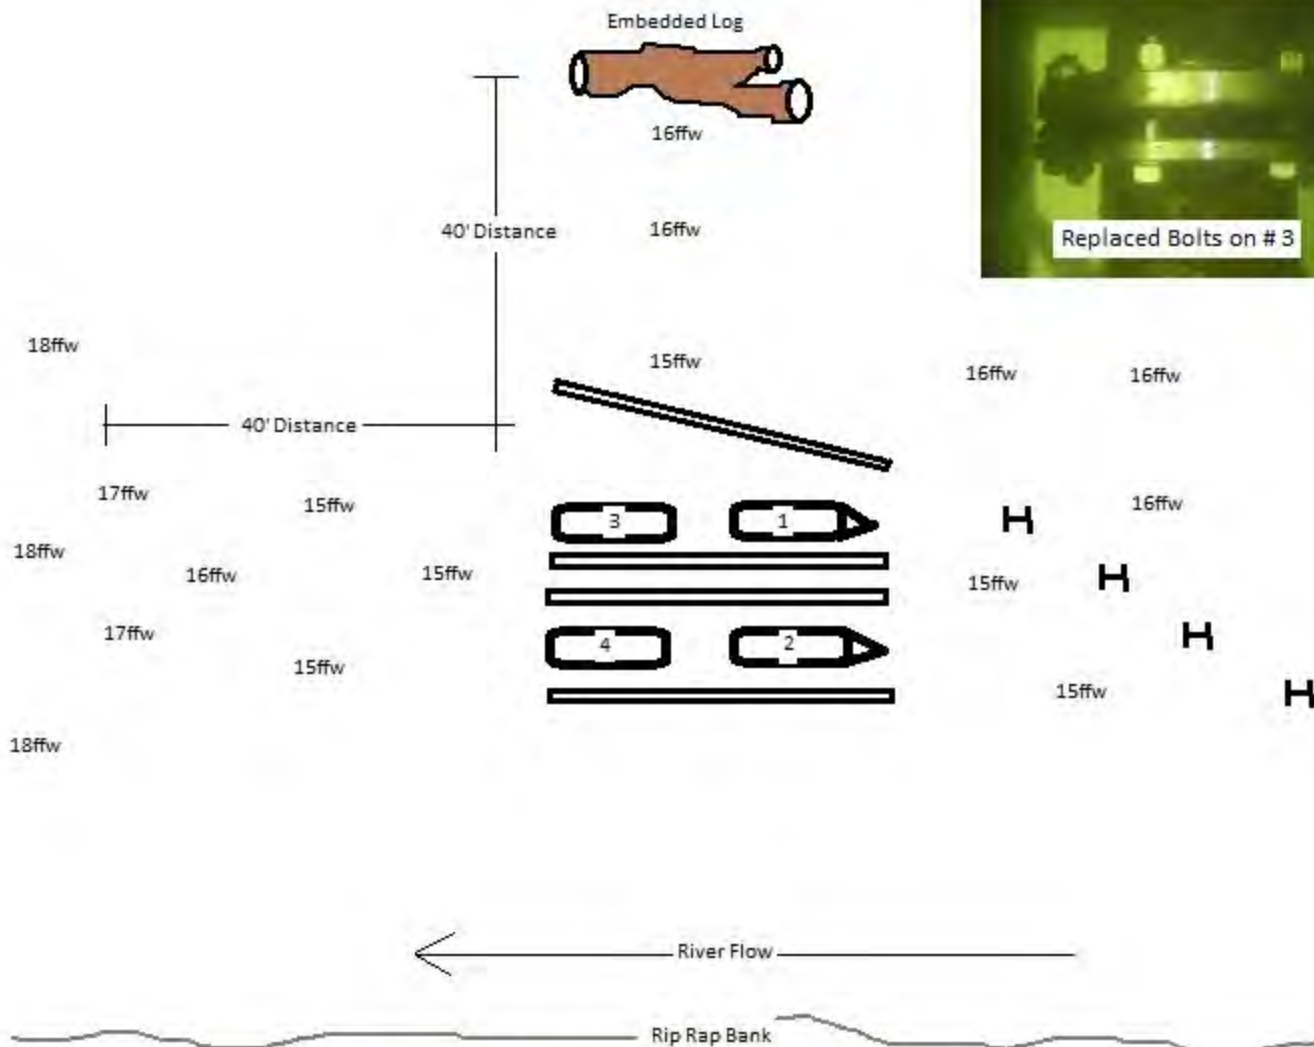
- Screen #1 - Flanges and bolts tight. Air test = No leaks. Screen cleaned. No dents.
 6' from bottom of screen to sandy bottom.
- Screen #2 - Flanges and bolts tight. Air test = No leaks. Screen cleaned. No dents.
 5' From bottom of screen to sandy bottom.
- Screen #3 - Flanges and bolts checked. 2 Galled Stainless Steel bolts found. Bolts removed and replaced. Bolts tightened. Air test = Small leak at beginning of air burst. Determined leak is workable and not to be repaired but will monitor. Screen cleaned. Two dents found. Diver able to rebend wedge wire back to operational status and closed up small gap. 4' From bottom of screen to sandy bottom.
- Screen #4 - Flanges and bolts tight. Air test = No leaks. Screen cleaned. No dents.
 3' From bottom of screens to sandy bottom.
