Rock Toe and Brush Revetment Update.

M&T/Llano Seco Fish Screen

Interim Protection

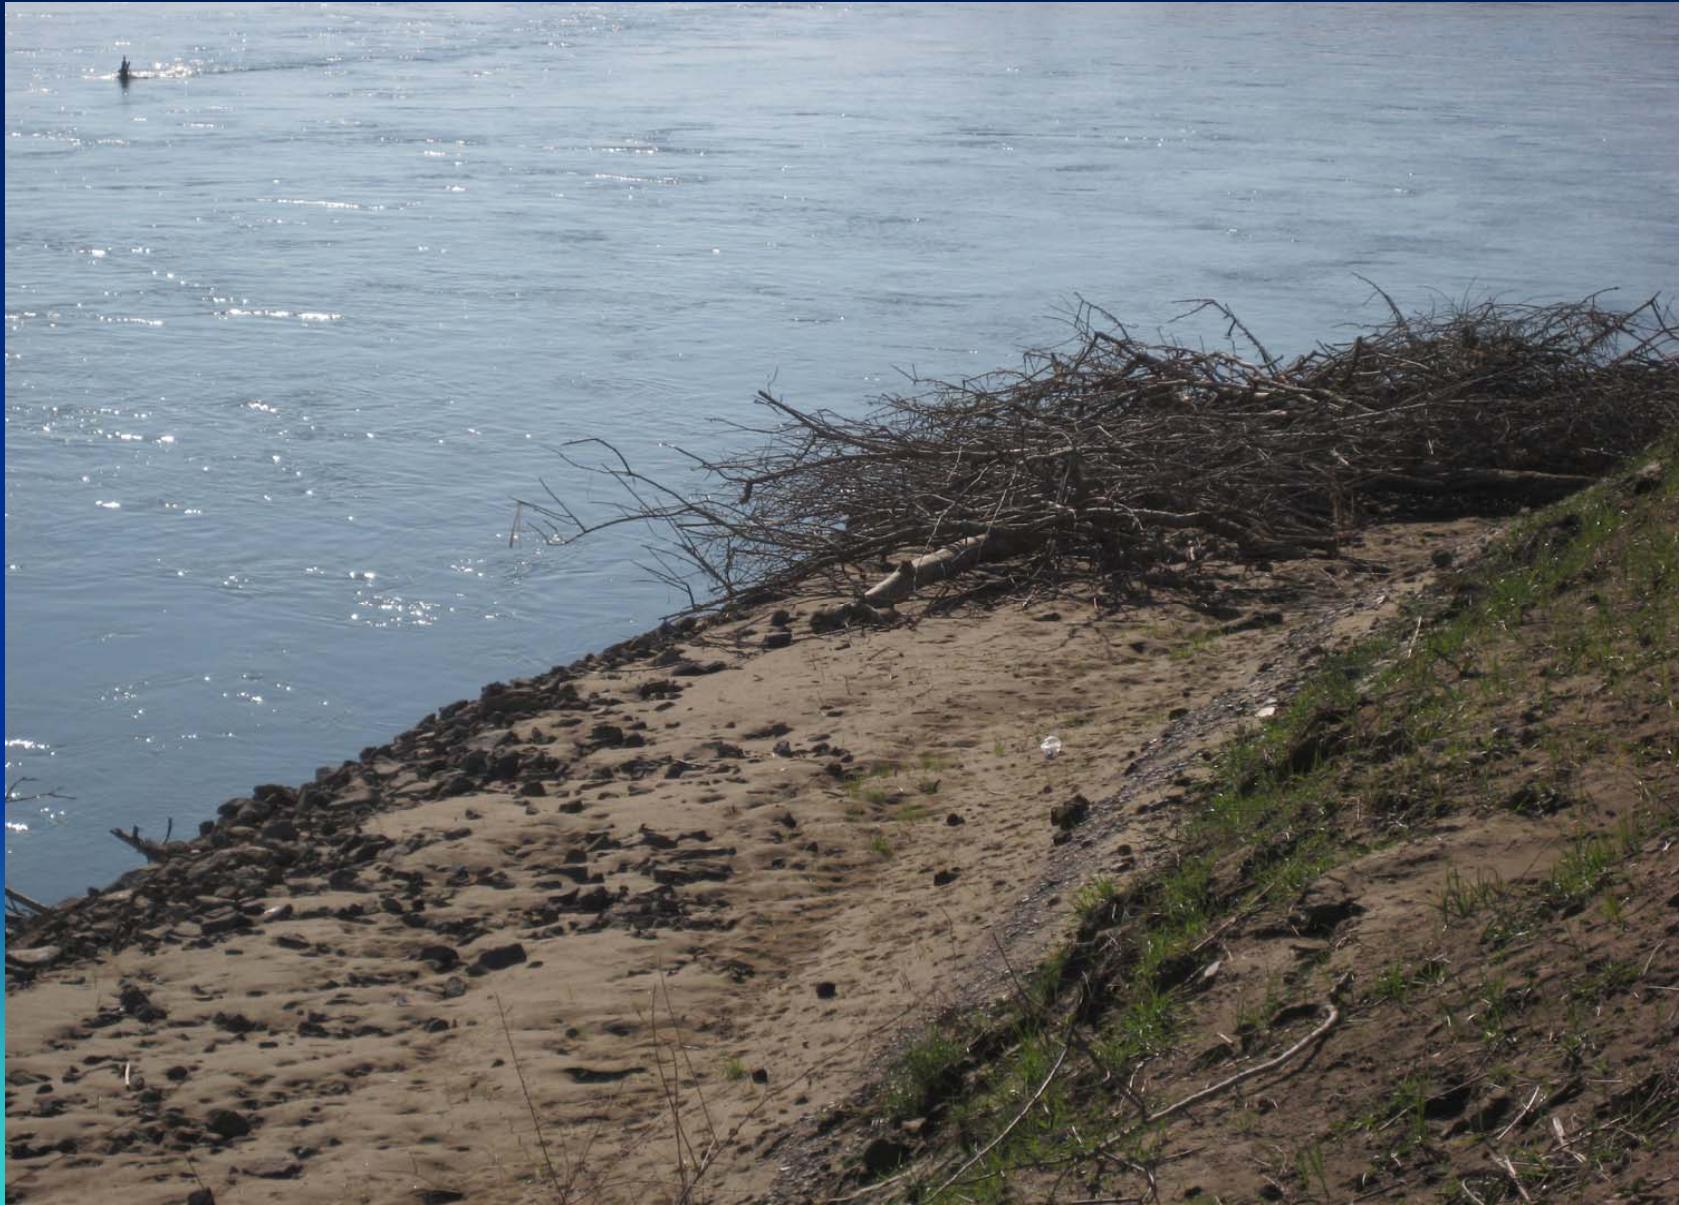
Woody debris on top of structure, 2008

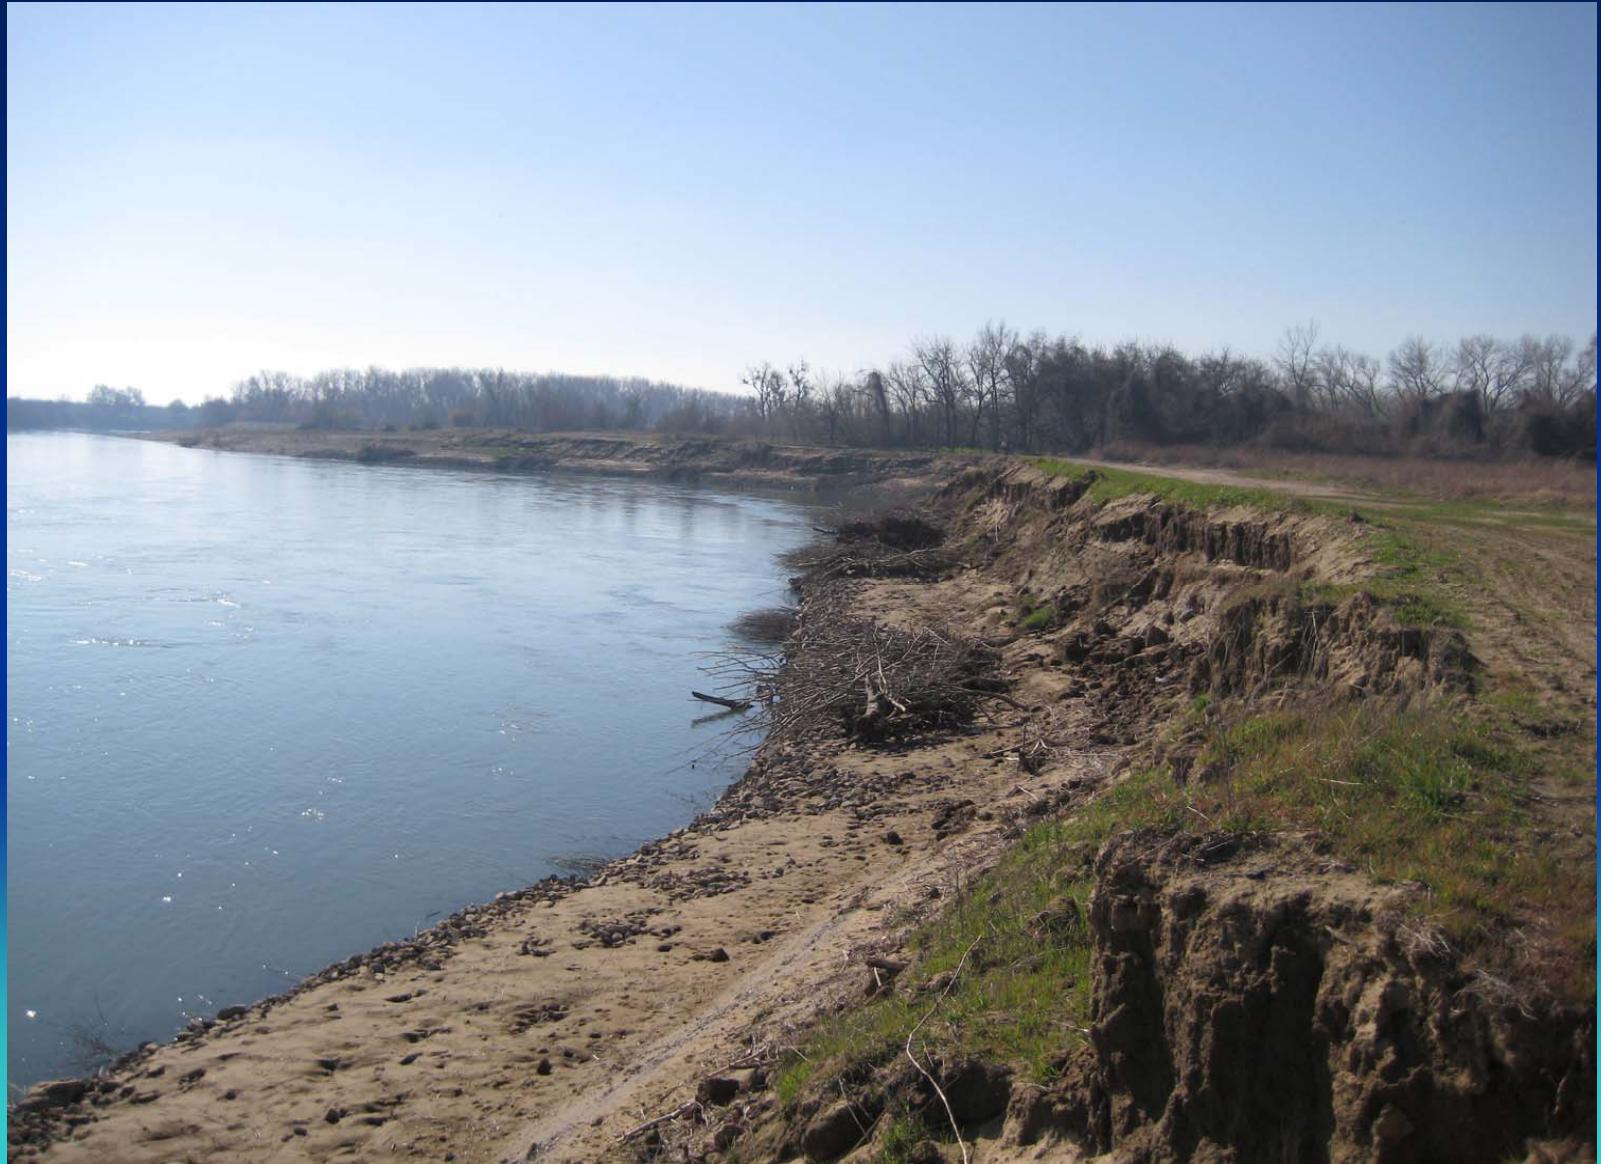
View downstream of bank erosion caused by Winter 2008 high flows

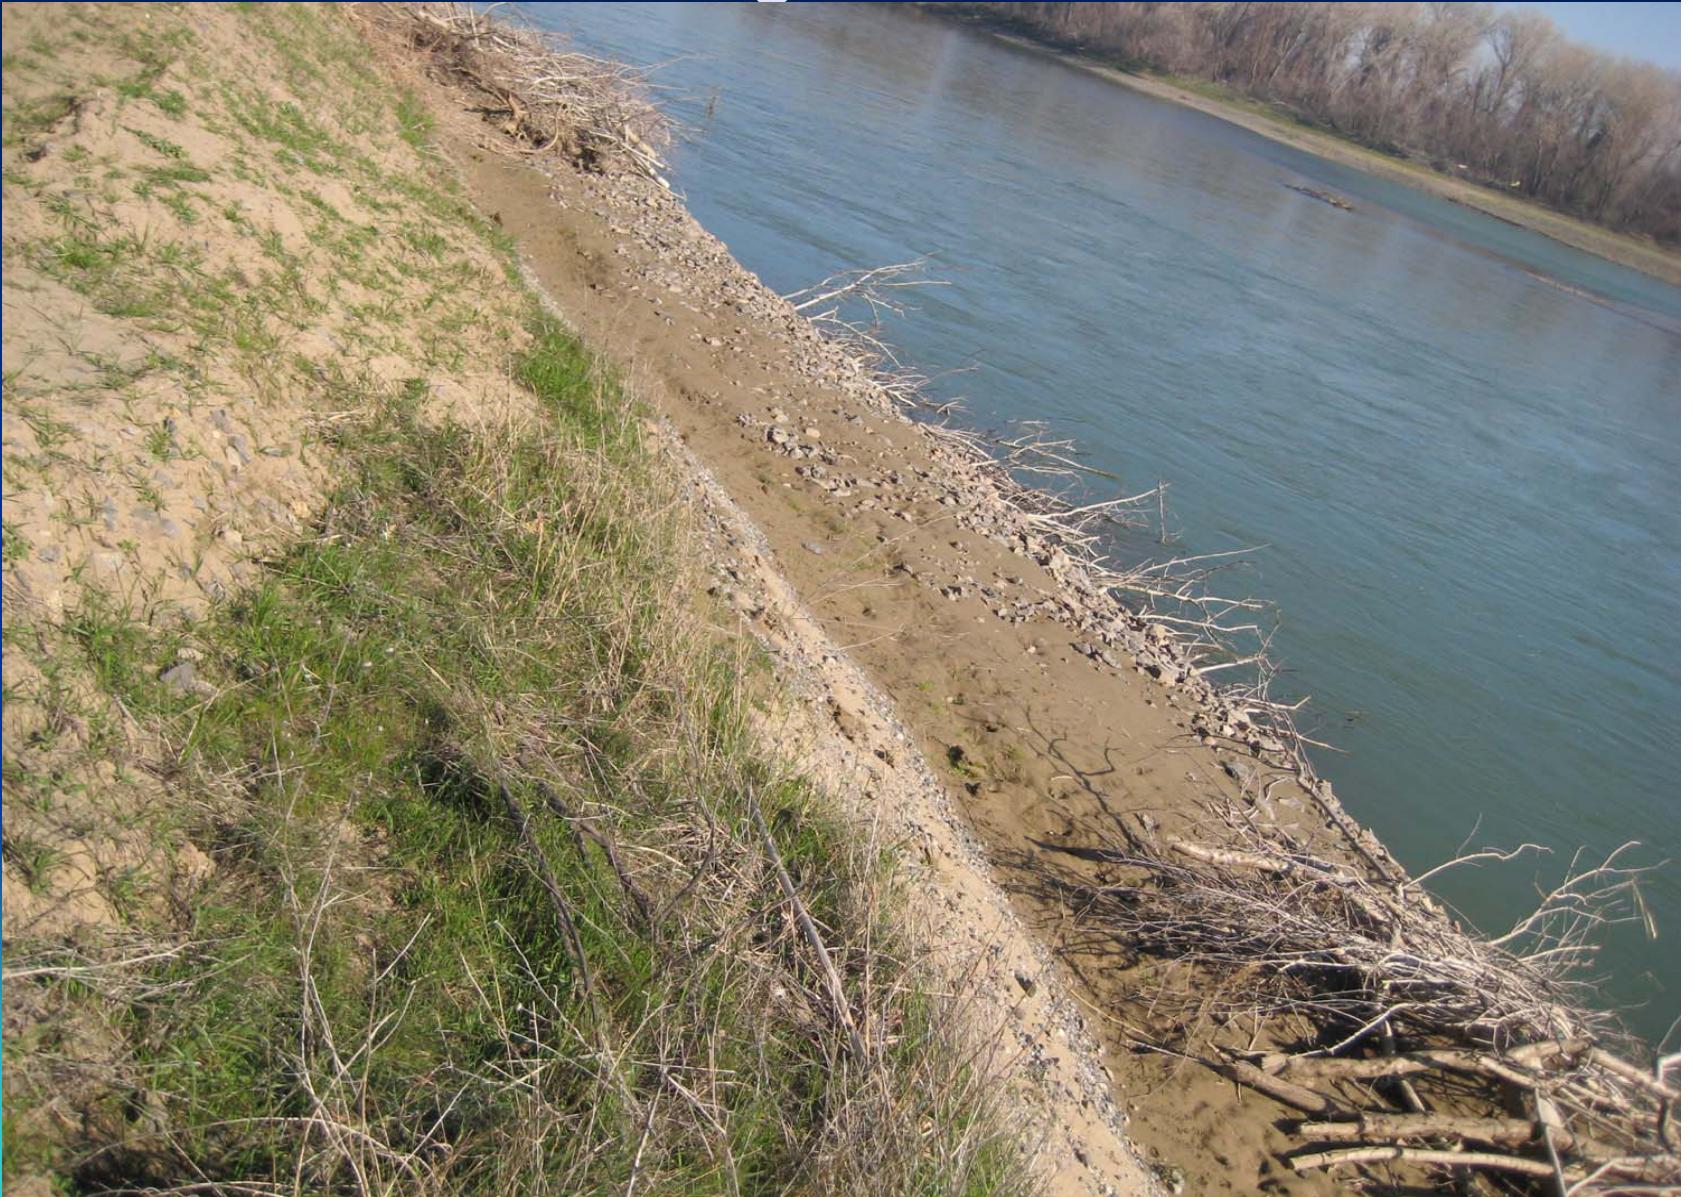
Woody debris in and on structure in 2008 after high flows

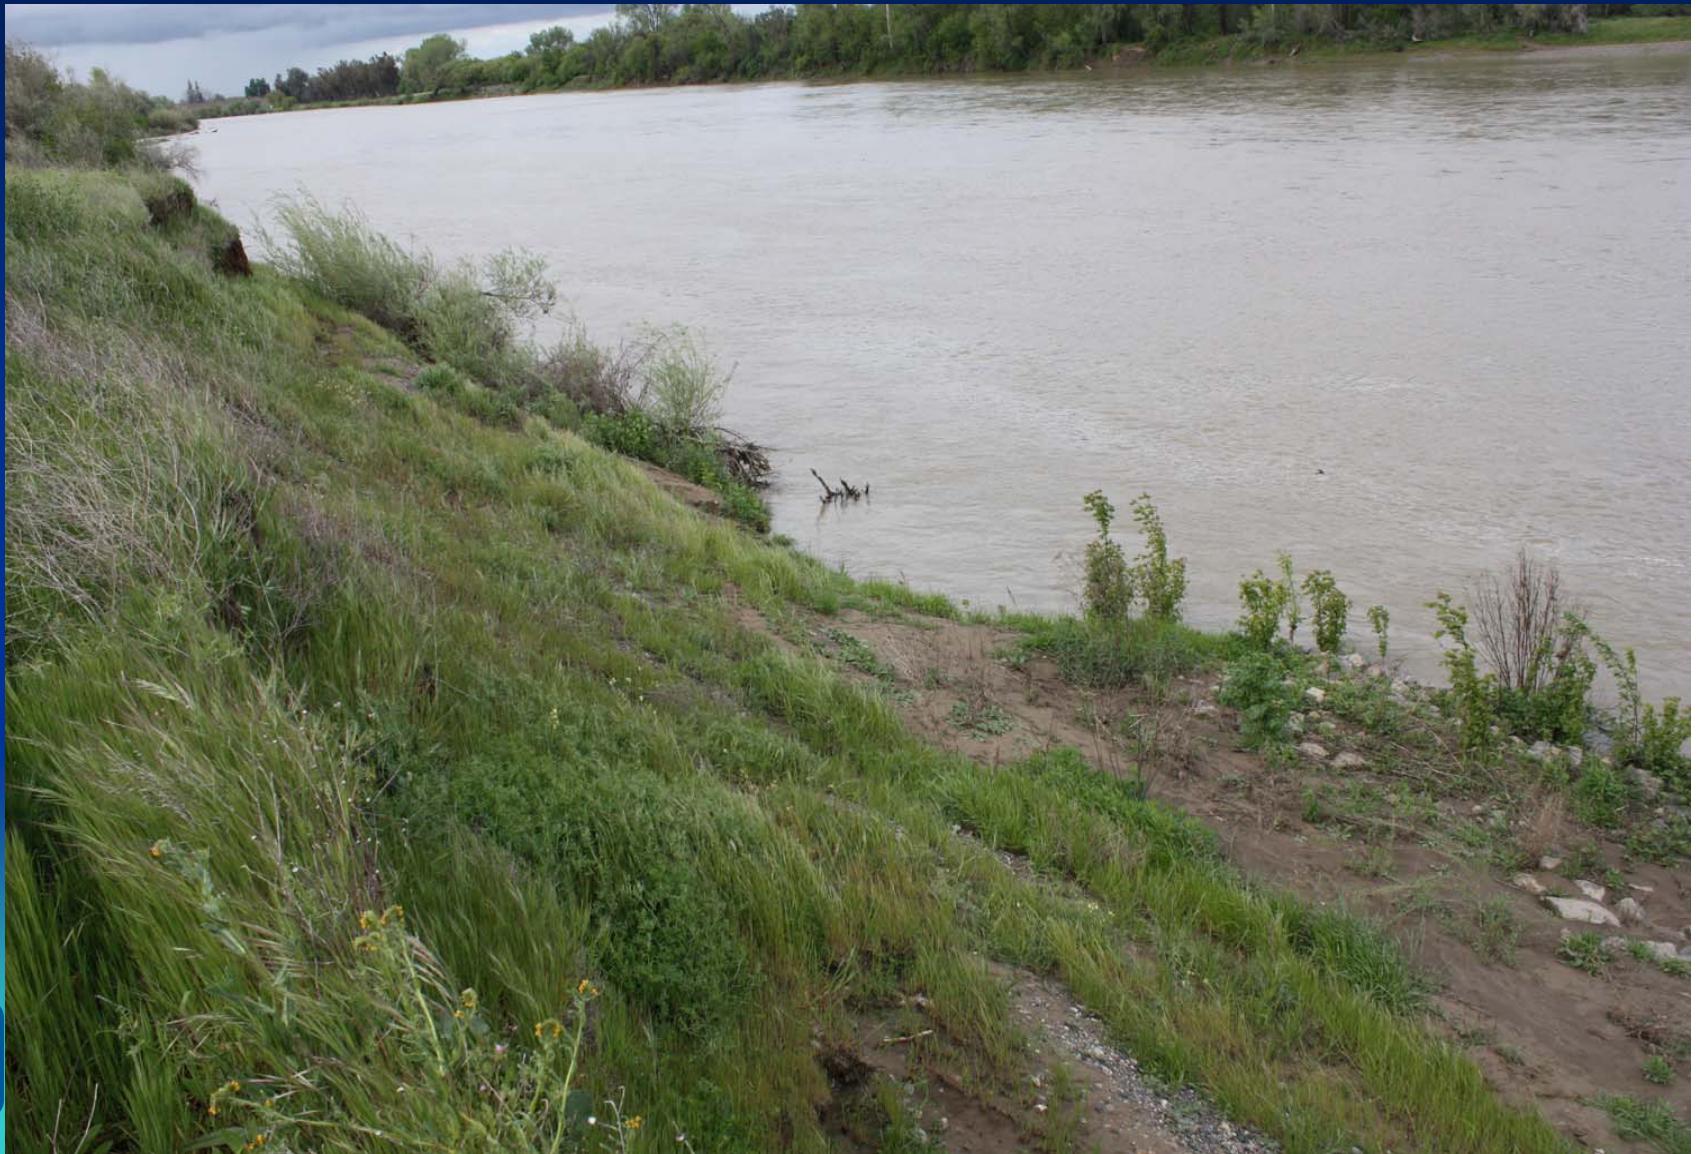
Upstream end of the revetment in 2010

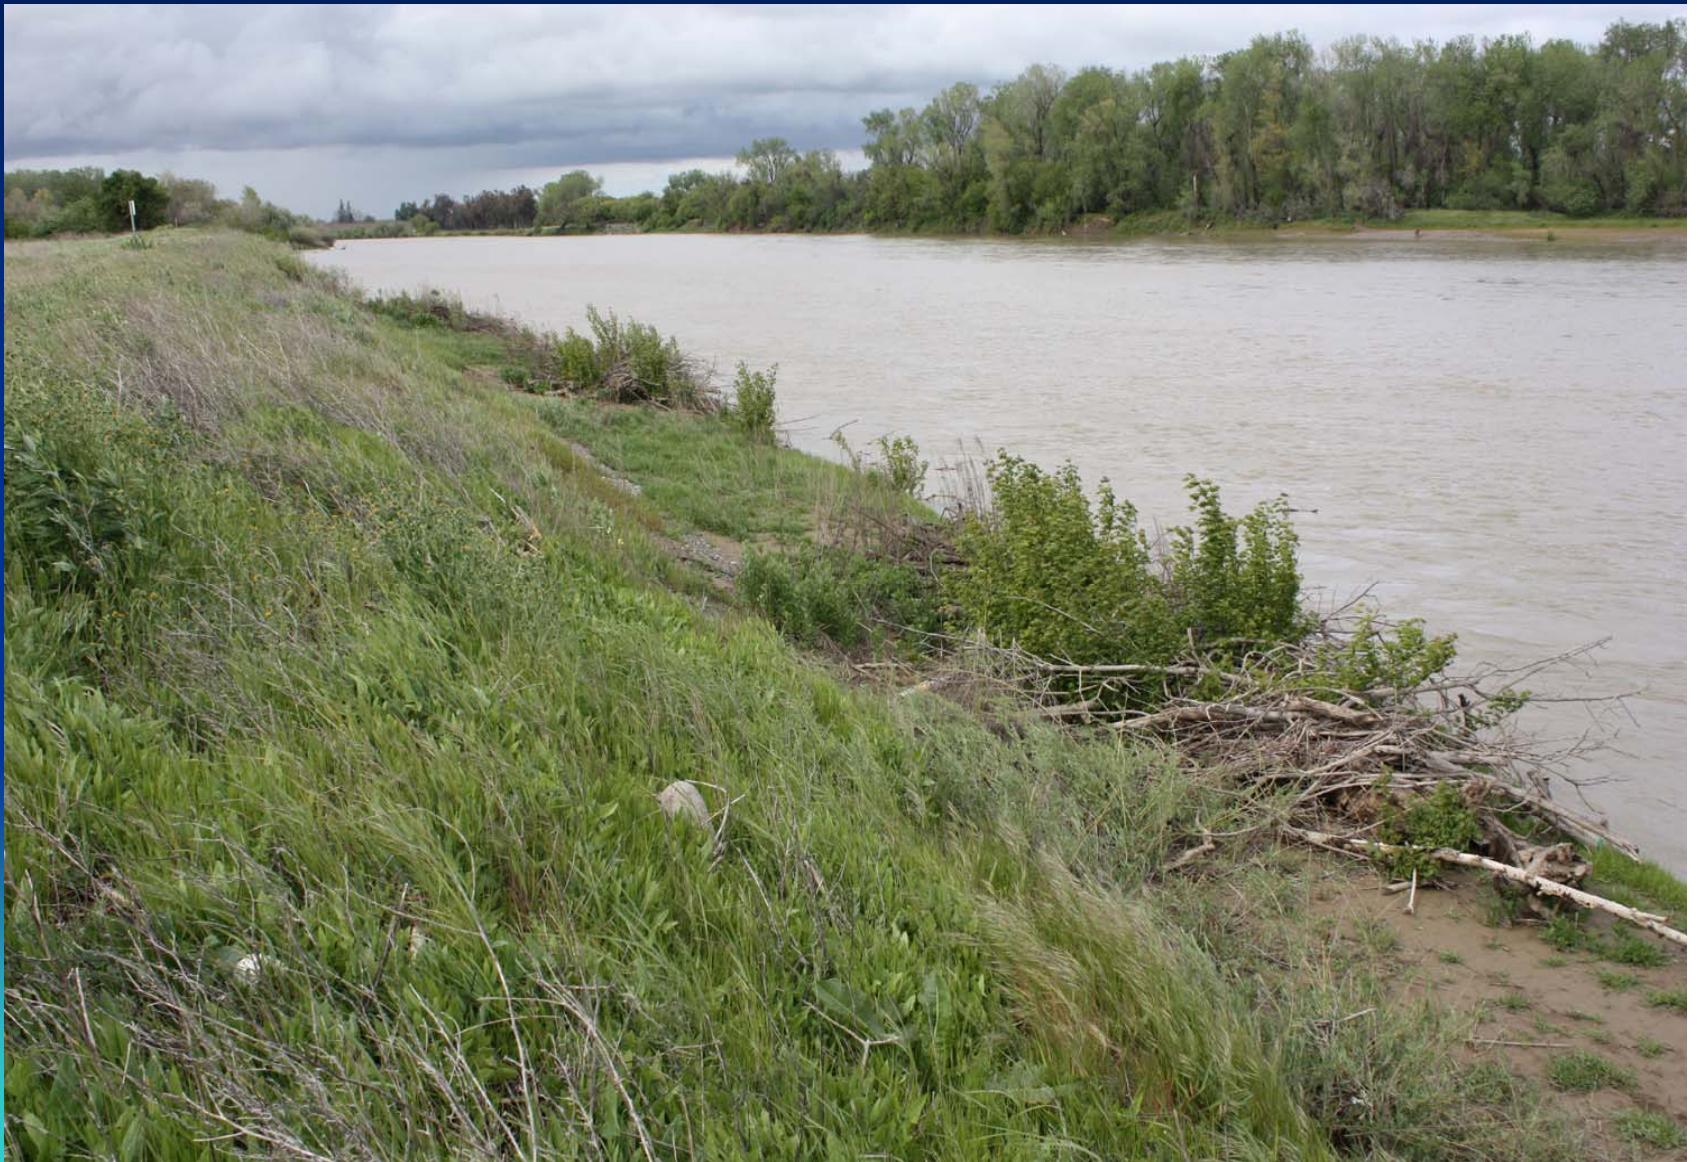
Woody debris piles on top of structure, 2010

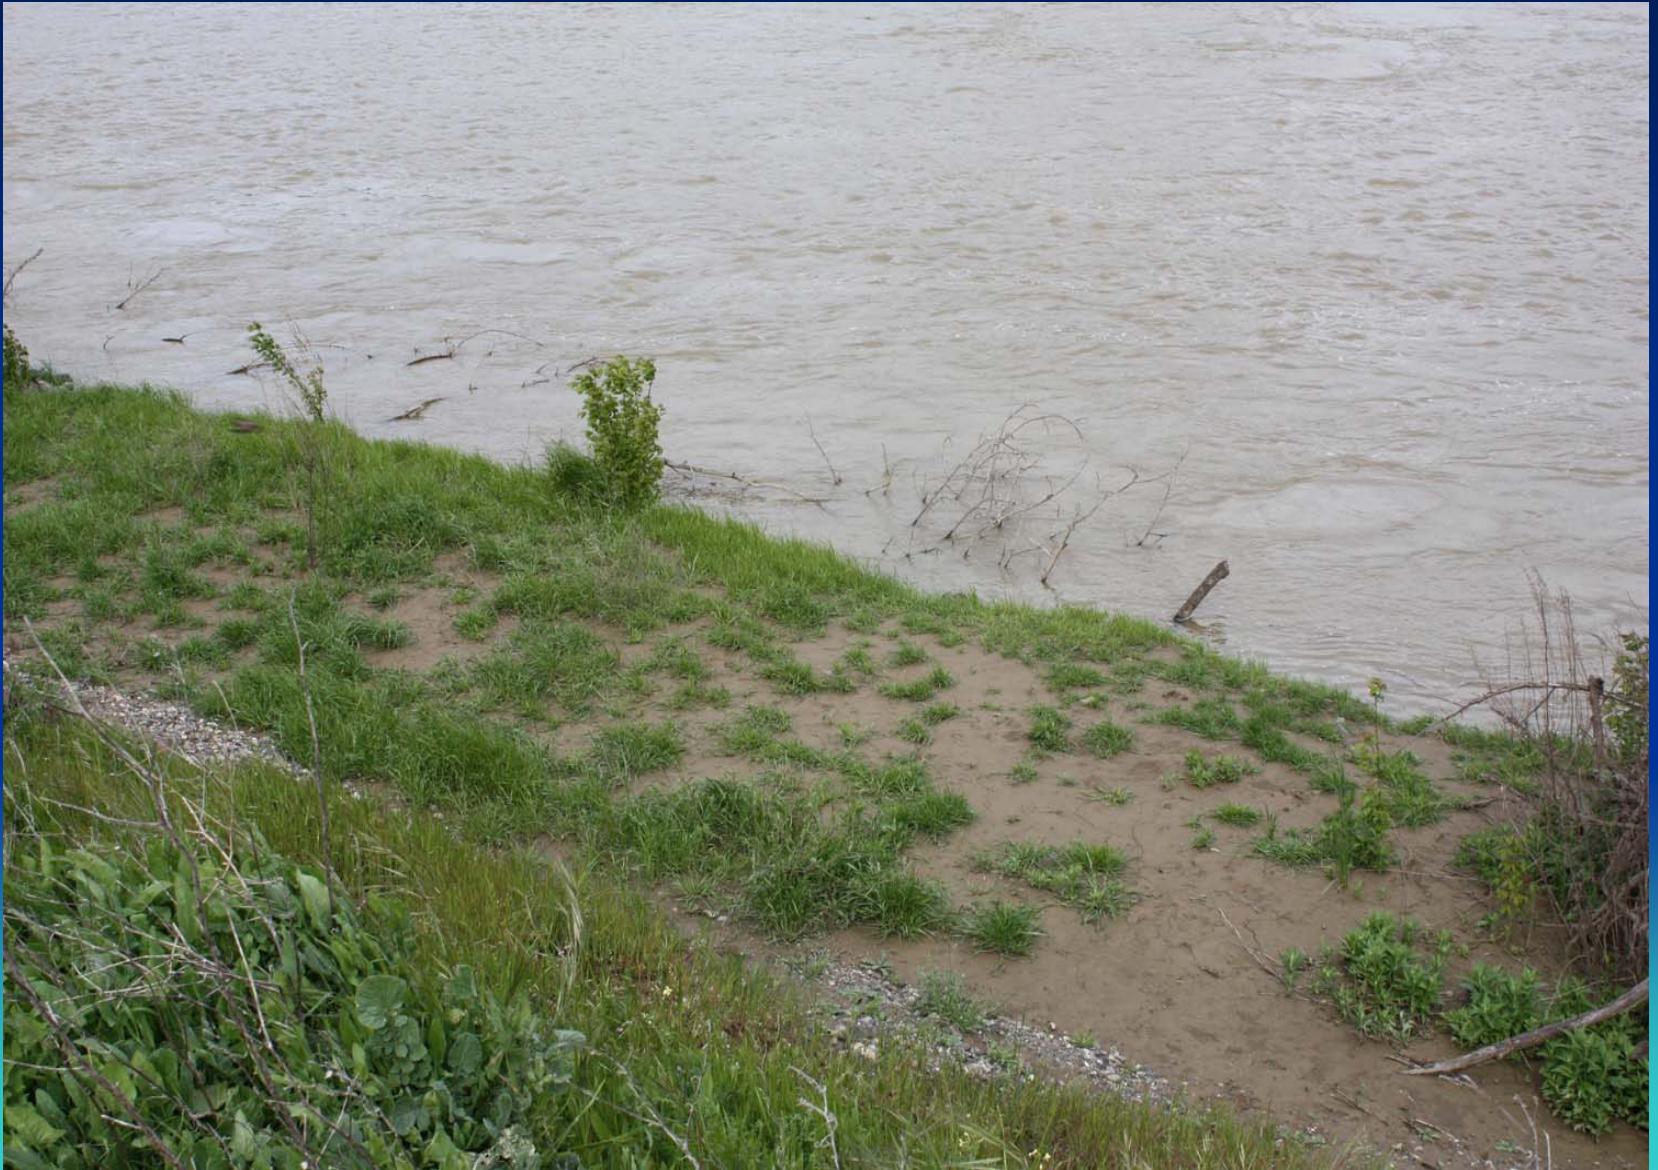
Submerged woody debris within the structure, 2010

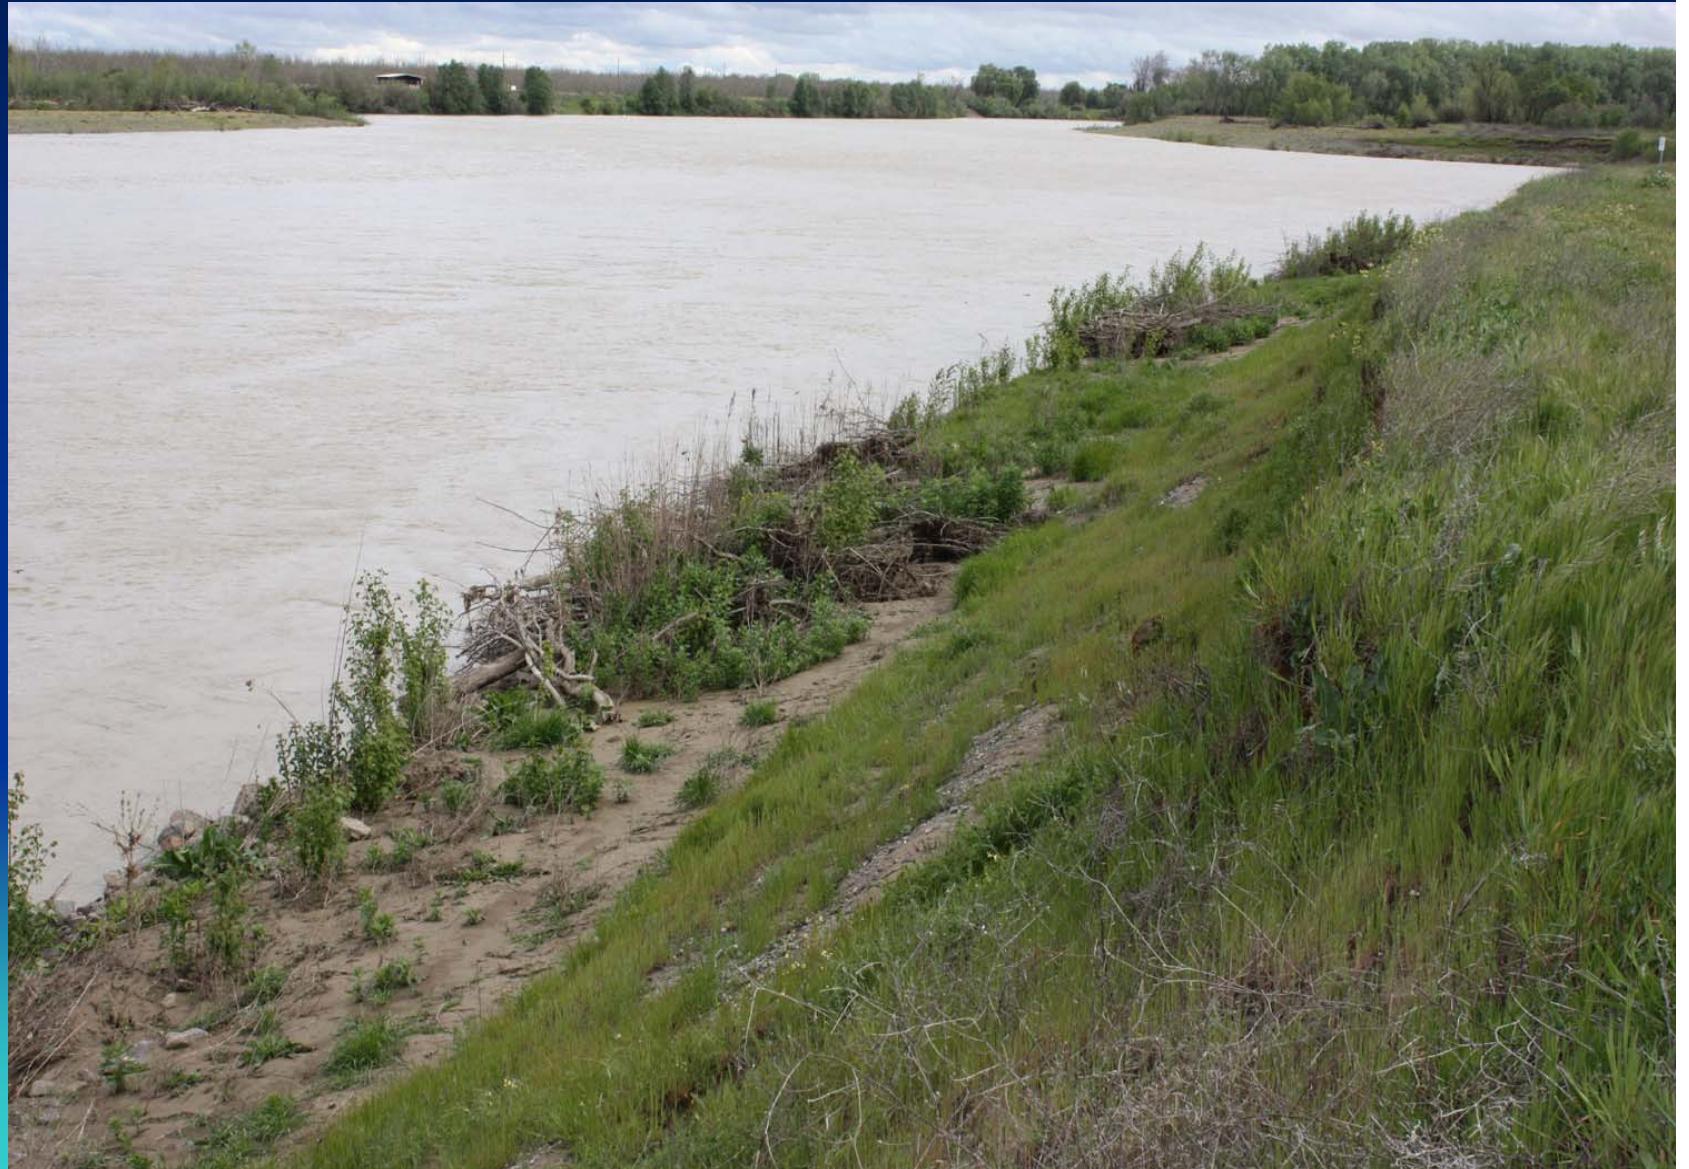
Woody debris piles on top of structure, 2010

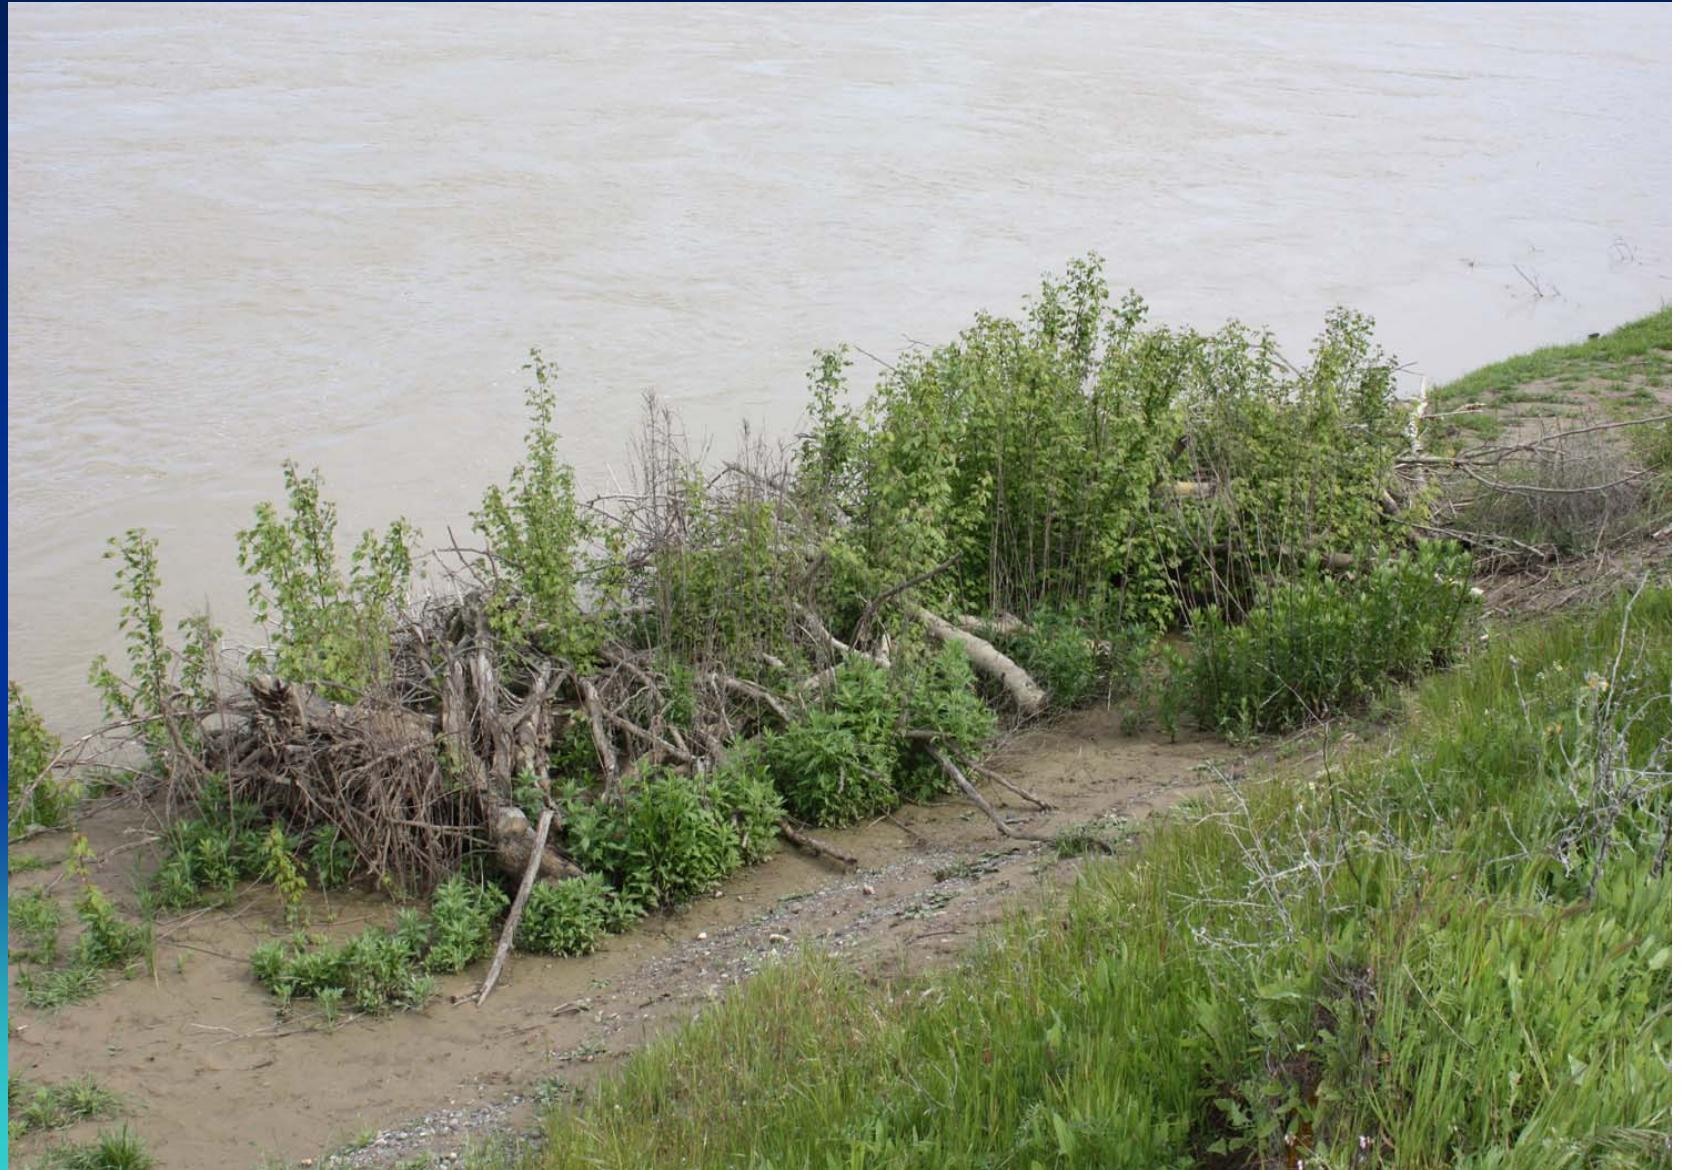
Woody debris pile and new vegetation growth

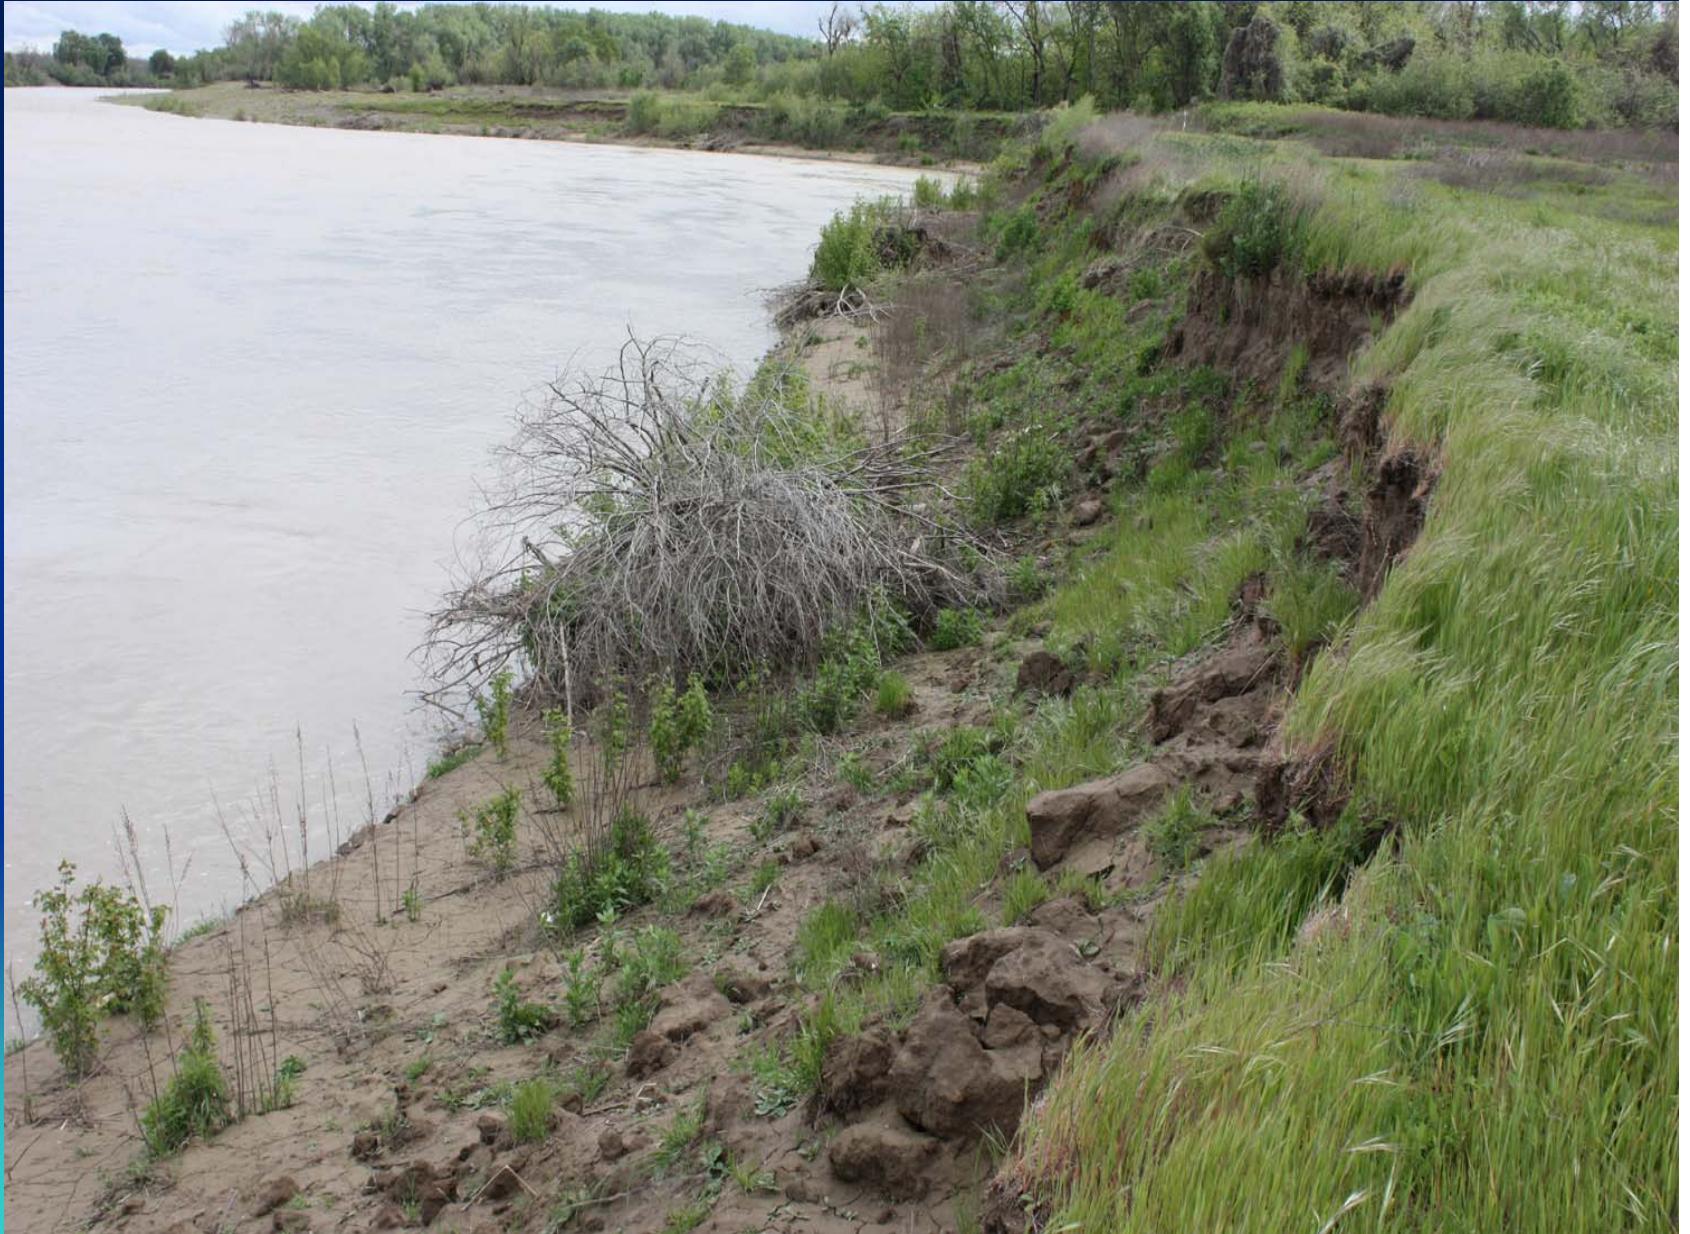
Upper bank erosion, 2010

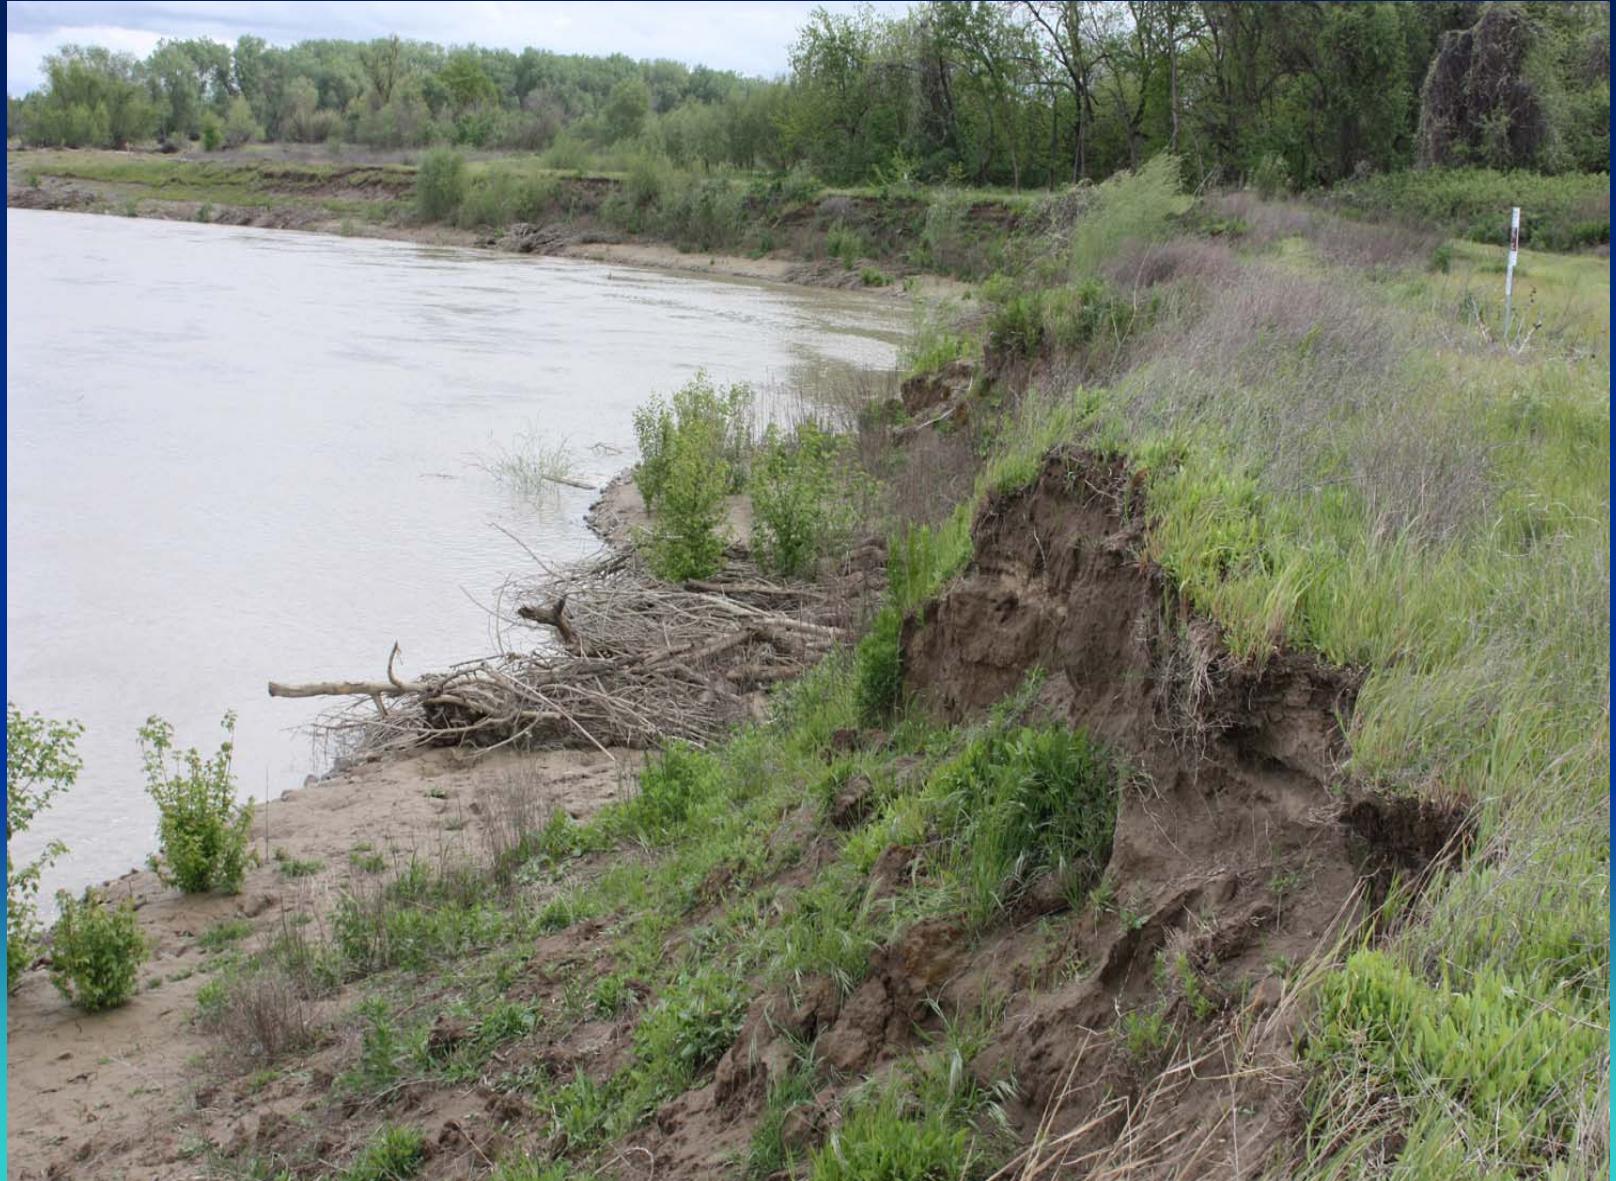
Upper bank erosion, but no backfill scour, 2010

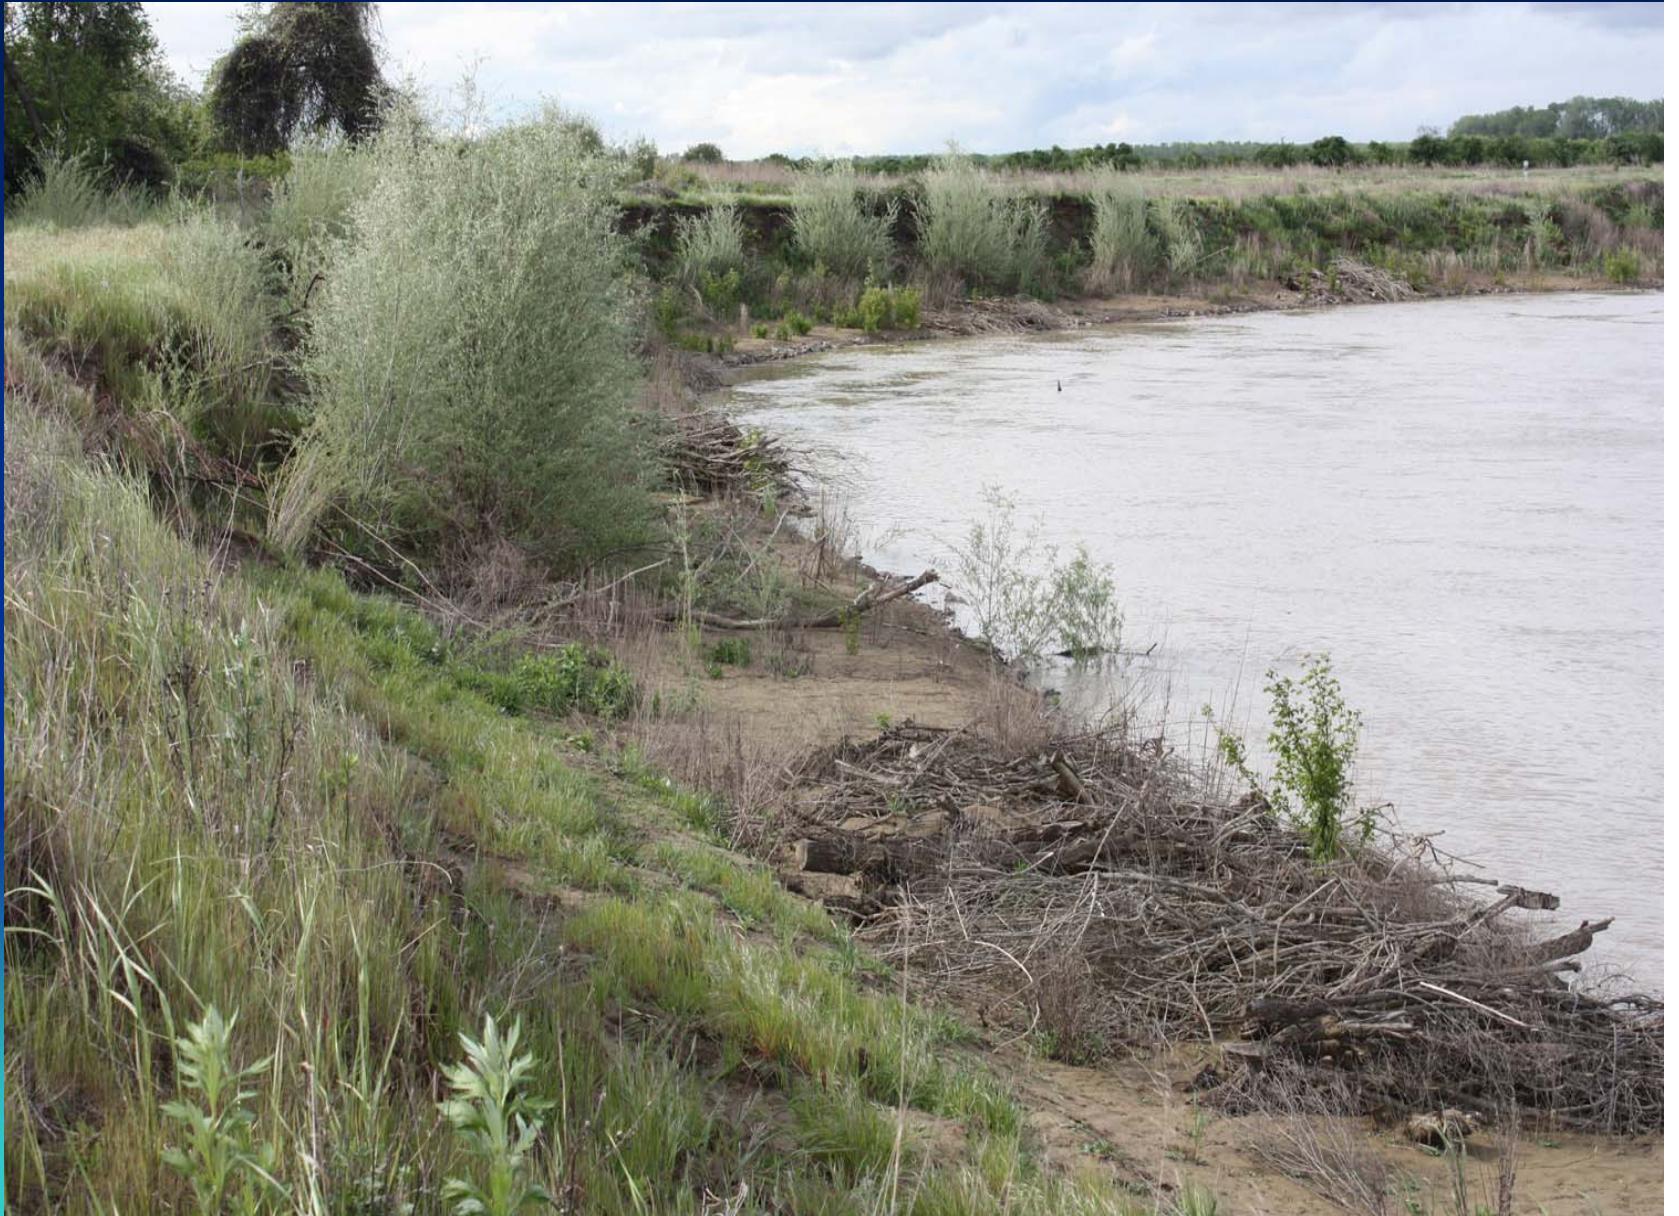
Volunteer willow growth, 2010
