## **M&T/LLANO SECO PUMPING PLANT RIPARIAN VEGETATION MITIGATION MONITORING REPORT**

Monitoring was conducted on December 3-4, 2009, by Northern California Regional Land Trust (NCRLT) biologist Breanna Owens, at the Capay Unit of the US Fish and Wildlife Service (USFWS) Sacramento National Wildlife Refuge Complex (SNWRC) and at Doe Island on the Llano Seco Rancho (**Figures 1 and 2**). Monitoring was performed to determine the status of riparian plantings completed as mitigation for the *M&T Chico Ranch/Llano Seco Rancho Pumping Plant Maintenance of Channel Alignment Sacramento River Mile 192.5 Project* (Project).

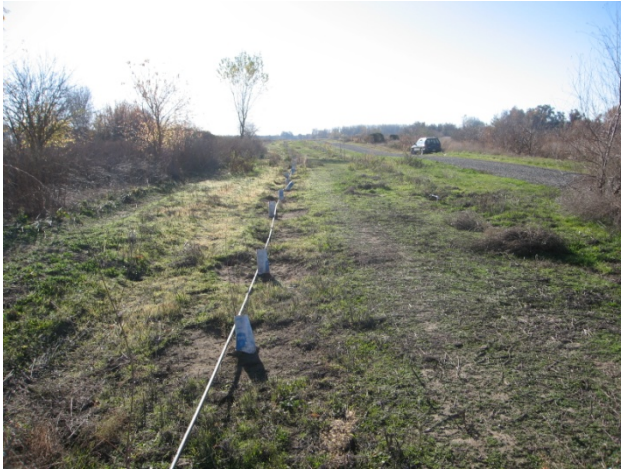
Photo Point C01, Direction of View – 230 degrees  
UTM's – 590373 east, 4395319 north  
Surveyor – B. Owens, Date – 12/3/09

clear, north wind (slight), morning frost, 1-2" green understory vegetation, irrigation lines are good, no fence

Sample	moisture at depth (cm)		Comments
	0	10	
C01	3	4	very sandy loam
C02	2	2	very sandy loam
C03	2	3	sandy loam
