## **M&T/LLANO SECO PUMPING PLANT RIPARIAN VEGETATION MITIGATION MONITORING REPORT**

"Capay" Mitigation Site  
December 2009 Monitoring

"Doe Island" Mitigation Site  
December 2009 Monitoring

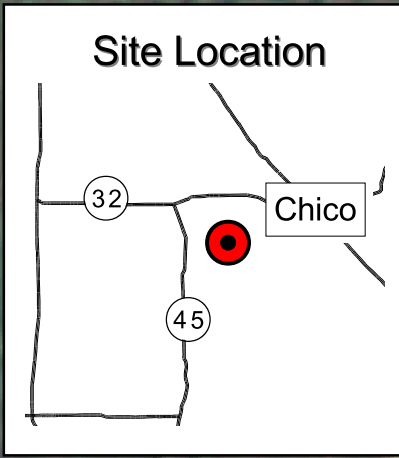
Figure 2. Doe Island

The Doe Island site was planted in order to connect a mature riparian corridor resulting from a historical river oxbow. Plantings were completed in 14 rows, alternating overstory species (trees/large shrubs) and understory species (small shrubs/grasses) in each row. Overstory species include valley oak, western sycamore, mule fat, box elder, elderberry, coyote brush, California rose, and California blackberry. Understory species include deer grass, creeping ryegrass, mugwort, California goldenrod, hoary nettle, evening primrose, California pipevine, and clematis. The site includes a total of 2058 plantings and 29 volunteer plants.
