APPENDIX A

**M&T/Llano Seco Long-Term Water
Reliability Study**

**These photos are examples of rock spurs
in use throughout the United States**

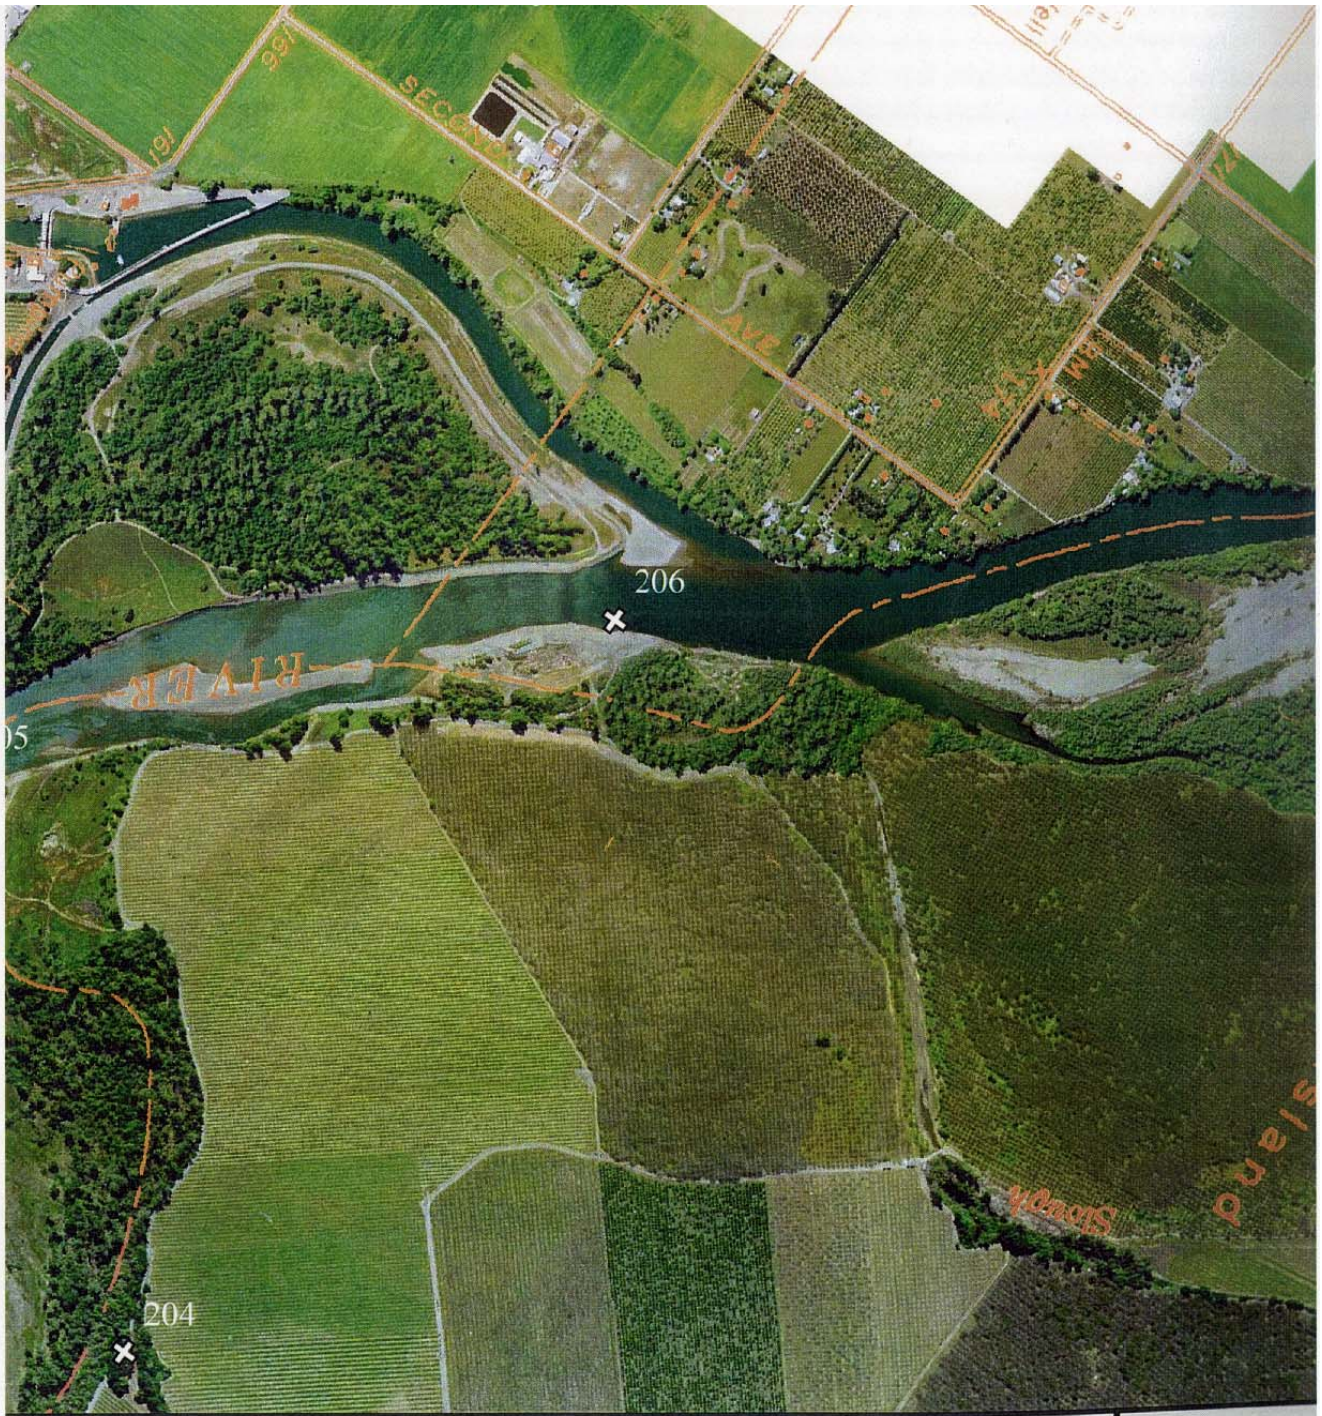
Glenn Colusa Irrigation District completed a Sacramento River project in 2002-2003. One phase of their project included five spur dikes immediately upstream and on the opposite bank of their pump intake channel. These spur dikes were 75 feet long and 150 feet apart. They were installed to maintain the river in its current location. They are barely visible immediately upstream of the RM 206 X.

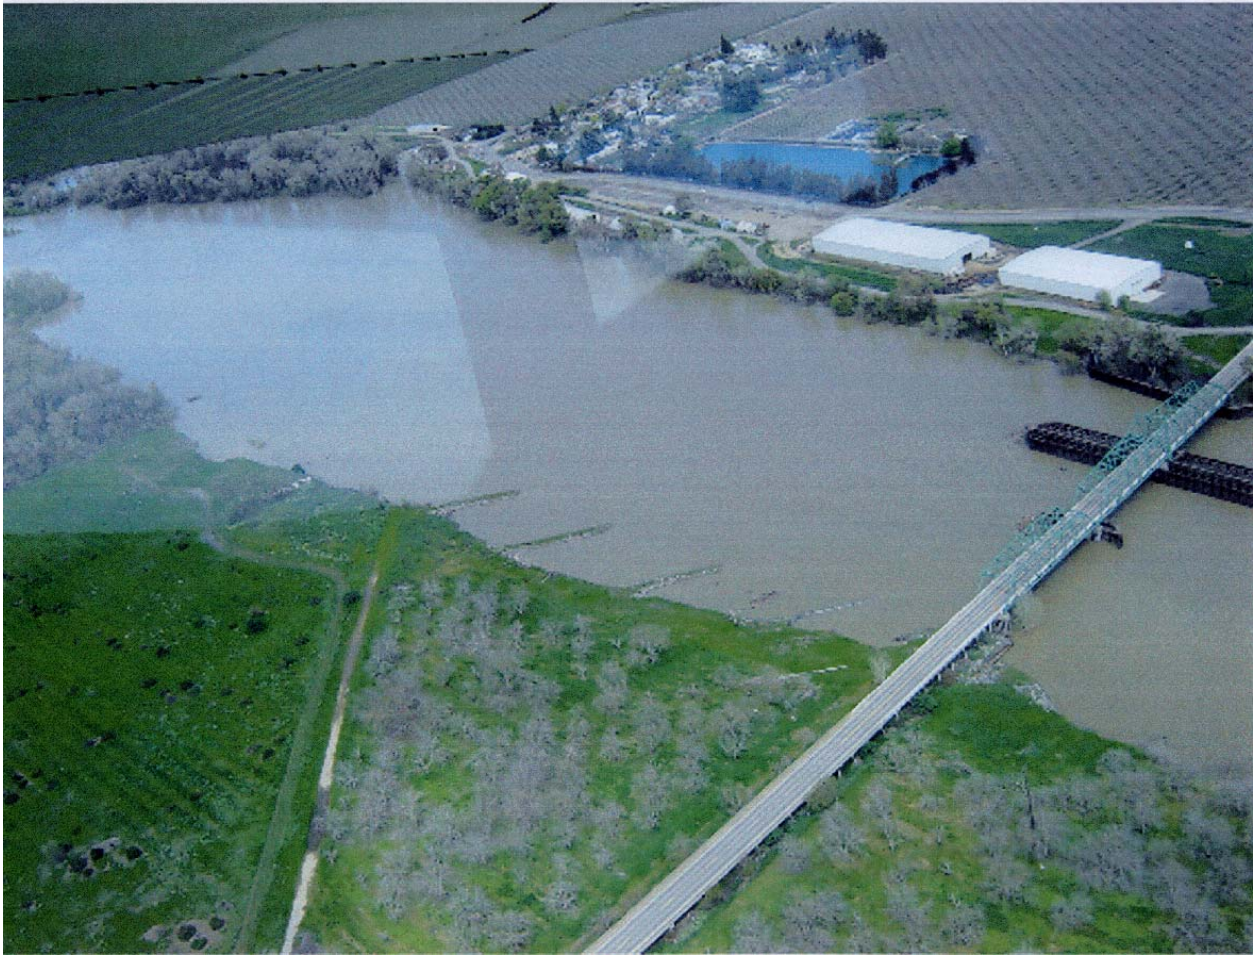
This is a photo taken April 6, 2006, of the Butte City Bridge and State Highway 162. In 2004, CalTrans installed a series of four dikes upstream from the bridge on the west bank of the river. The gravel bar that had formed upstream of the bridge was forcing the main channel of the river into the west footing of the bridge. The total project cost was about \$3.4 million with the construction costs about \$2.4 million. The split of the costs is about \$600,000 per dike with the sheetpile cost of about \$400,000 and the rock at \$200,000.

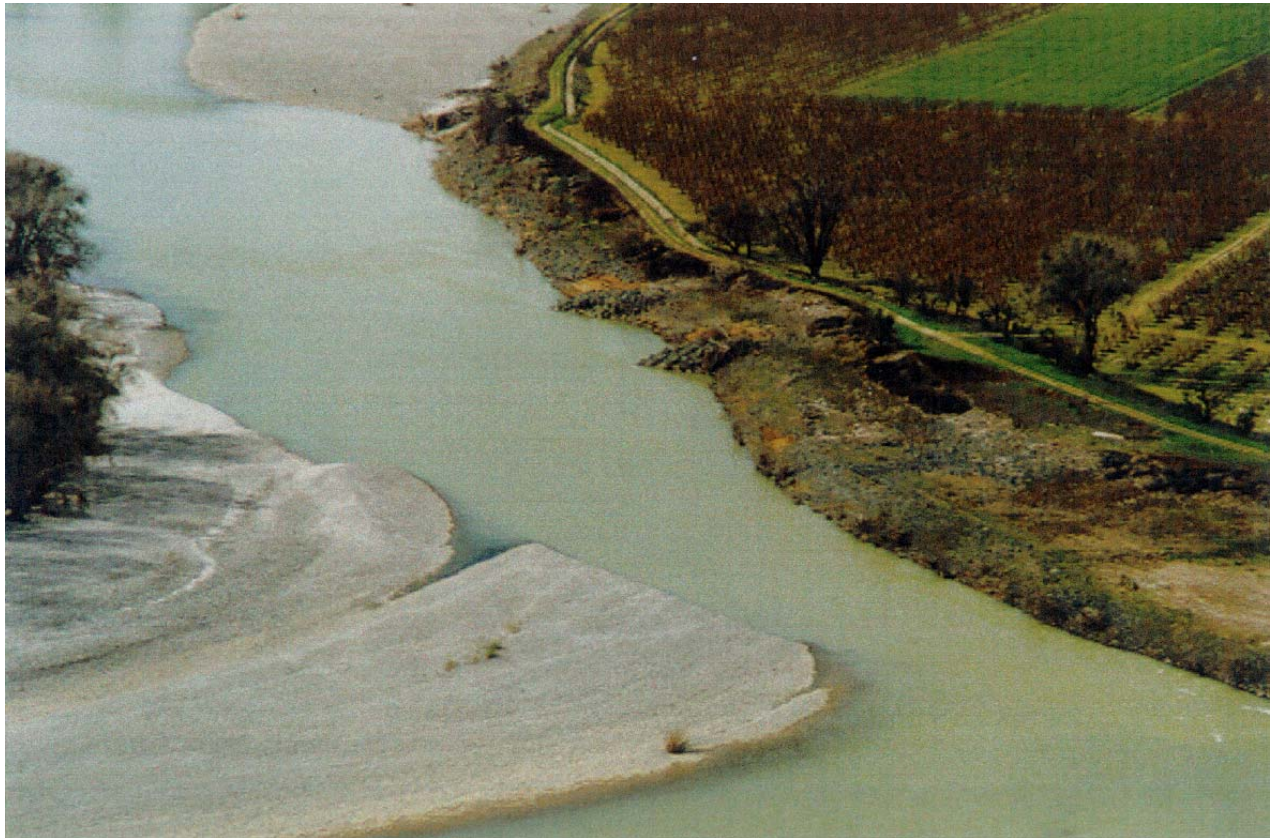
These spur dikes are on the Yuba River below the Daguerre Point Dam. The location is in Yuba County, east of Marysville and off of Highway 20. They were in place for the 1997 flood where the Yuba River had flood flows in excess of 150,000 cfs. They date back to the 1980s or before.

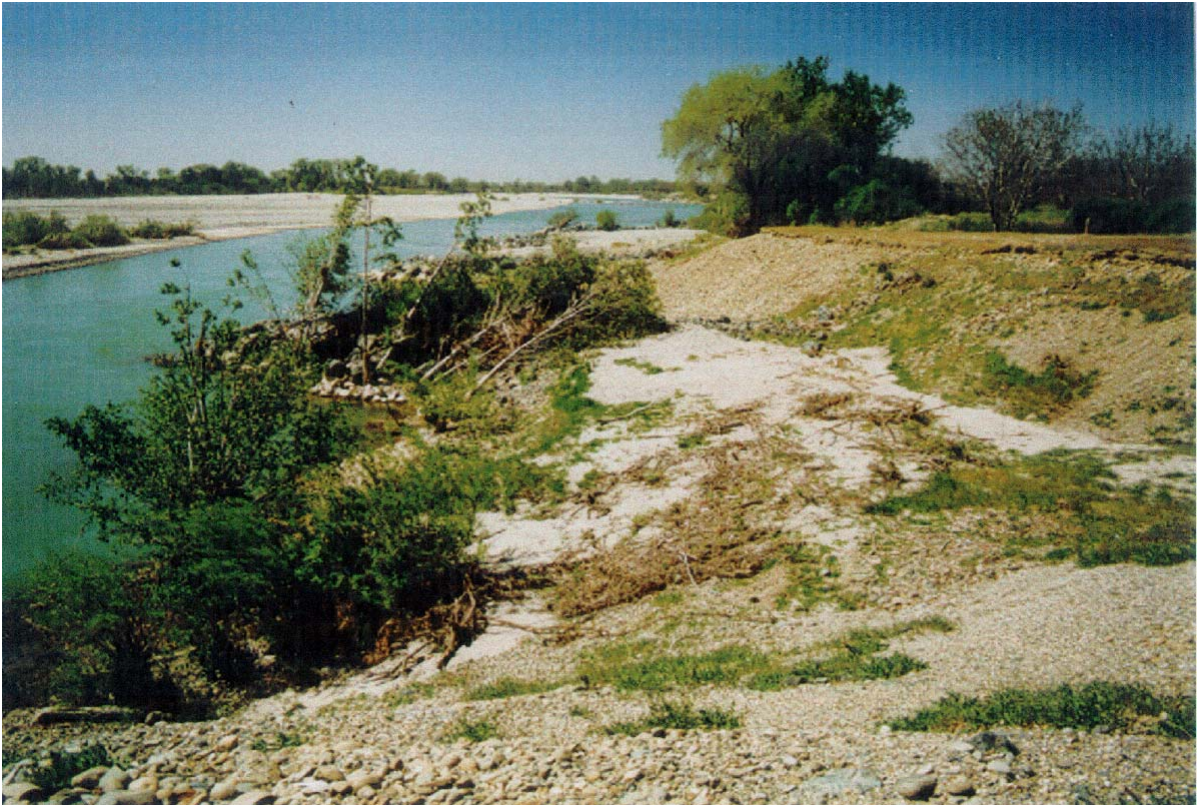
These spur dikes are on the Yuba River below the Daguerre Point Dam. The location is in Yuba County, east of Marysville and off of Highway 20. They were in place for the 1997 flood where the Yuba River had flood flows in excess of 150,000 cfs. They date back to the 1980s or before.

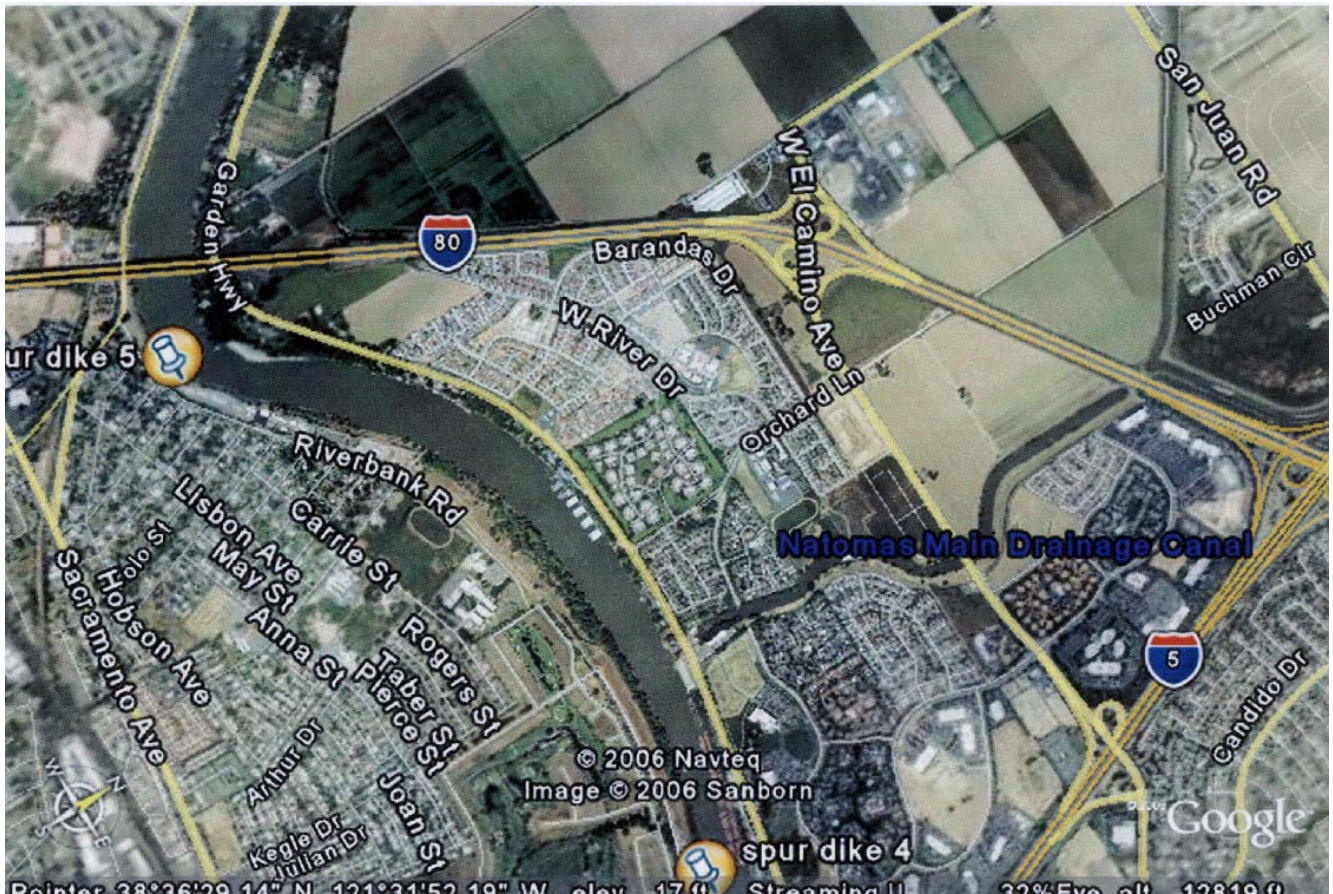
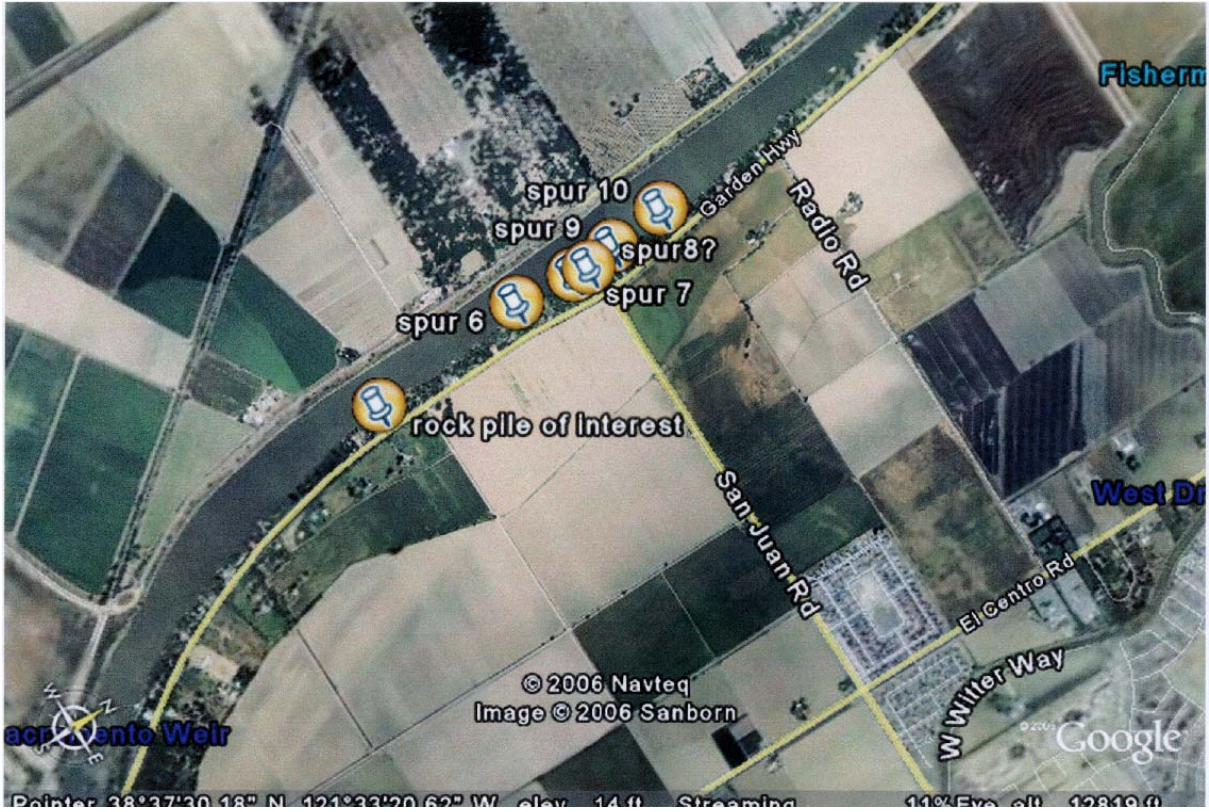
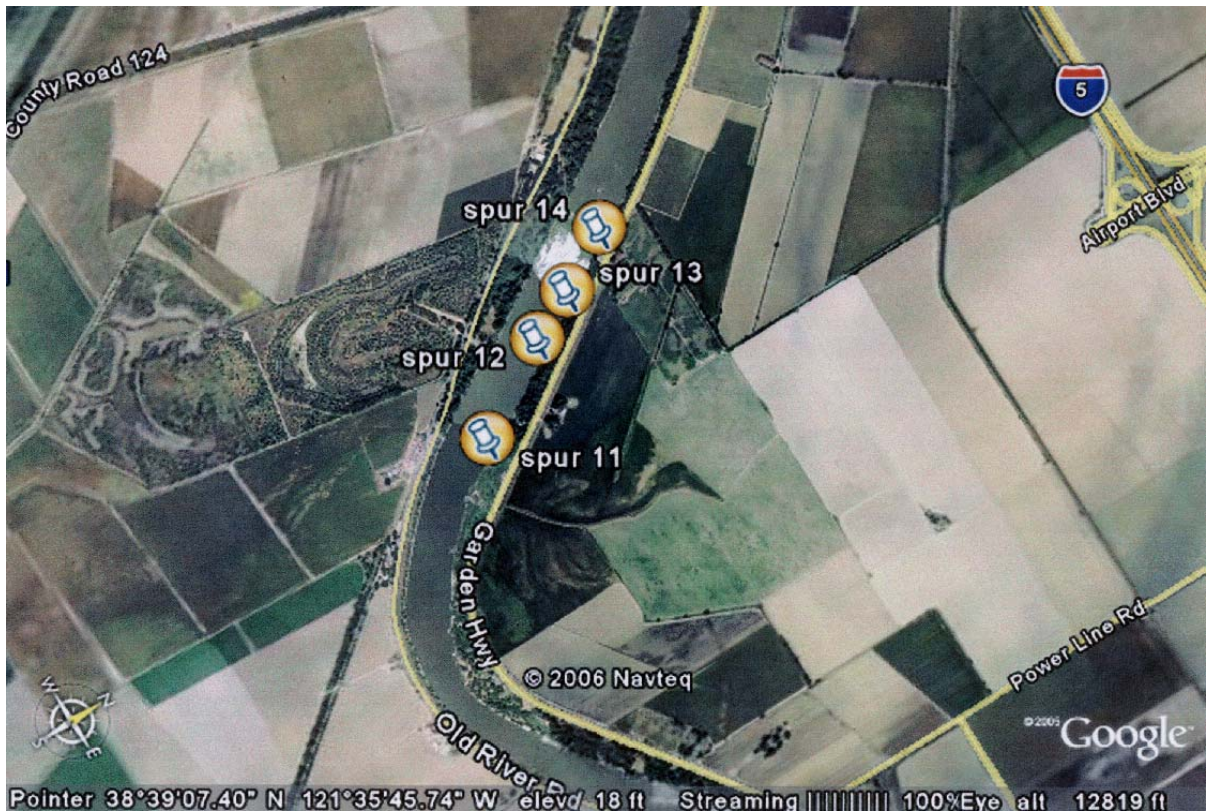
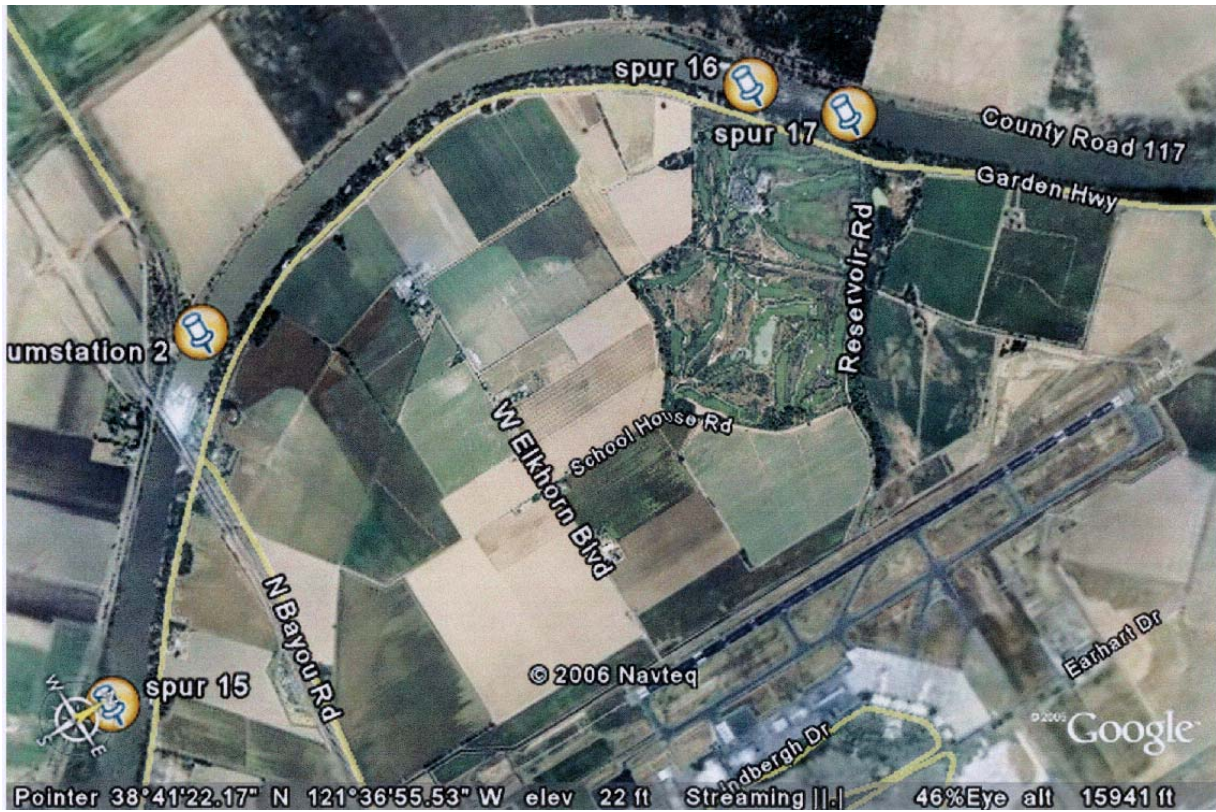
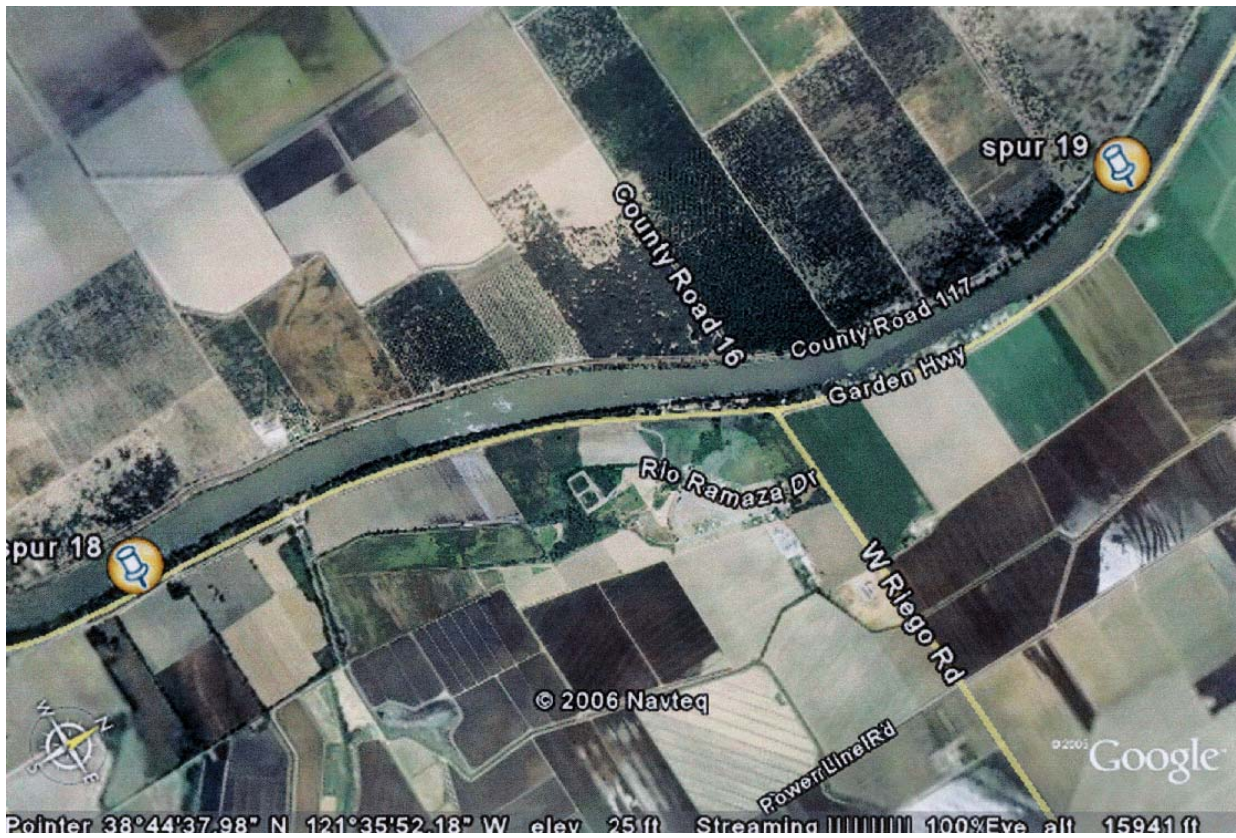
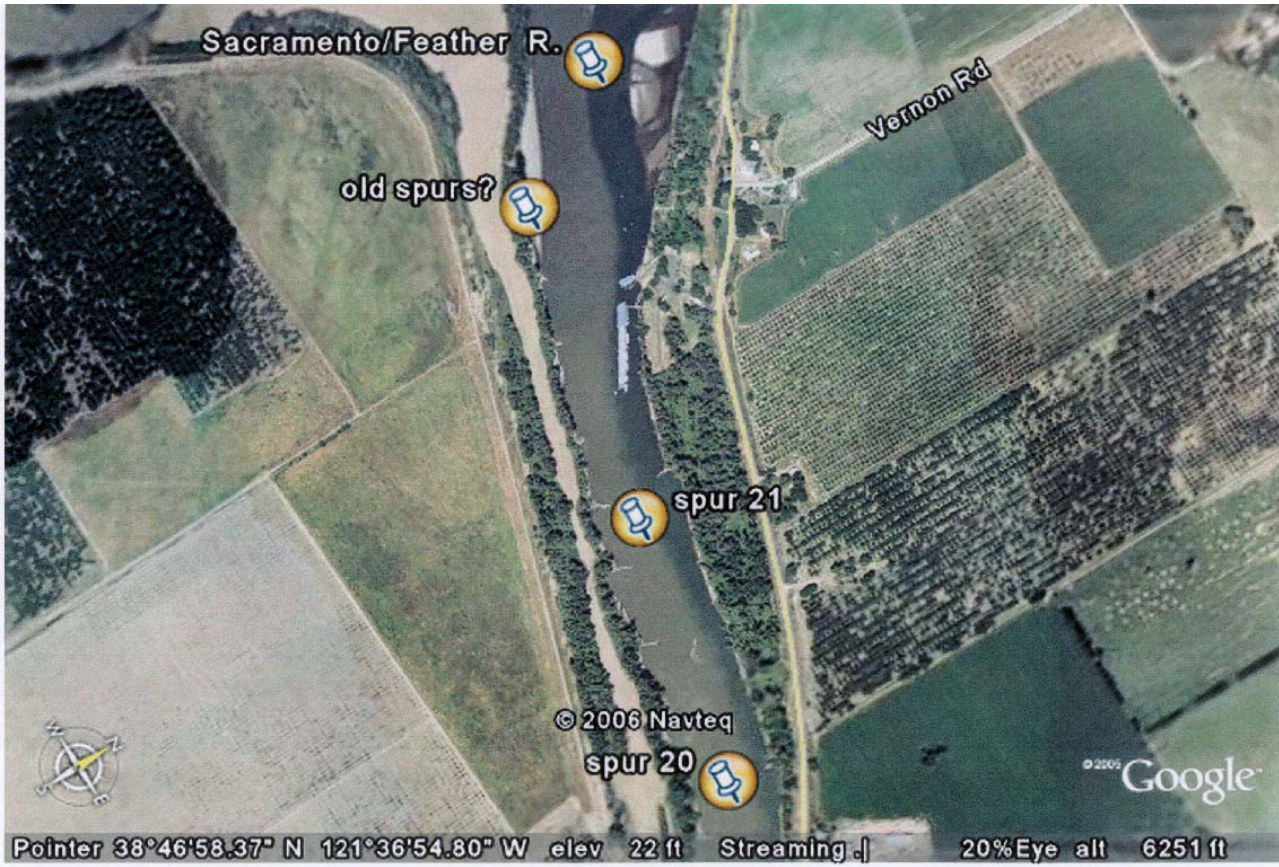
The next six photos show a number of spur dike locations from where the Feather and Sacramento Rivers meet, down to Sacramento. These are satellite photos so the locations may not be exact, but in any event, there are a great number of them. Spur dike location 21 was zoomed in on and they are very apparent. They were installed at least 60 years ago and are low-elevation features that were placed in the Sacramento River for two reasons: (1) to hasten degradation of the channel into the hydraulic mining, and (2) to provide a low-water navigation channel.

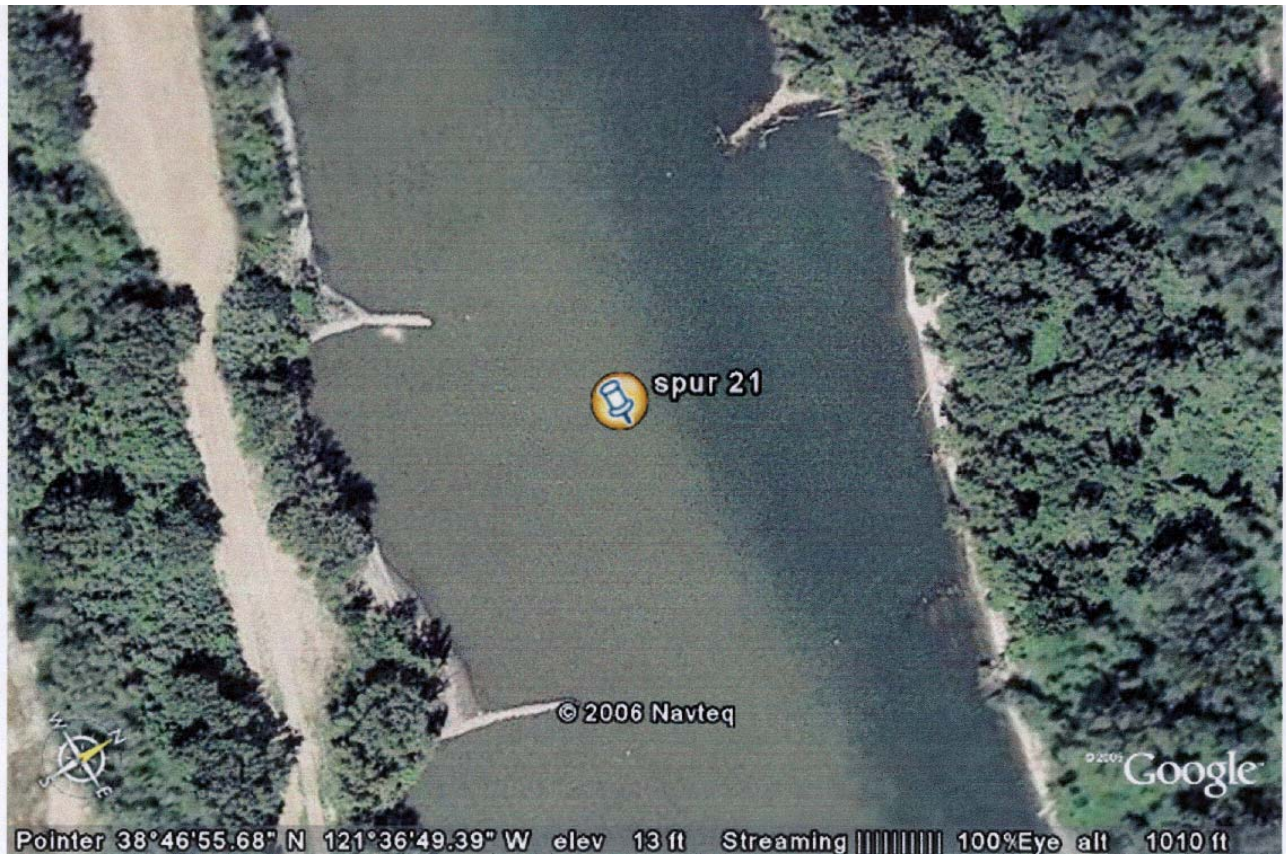
The Sacramento River immediately down-river from where the Feather River empties into it. This is a close-up of the many spur dikes in this vicinity of the river.

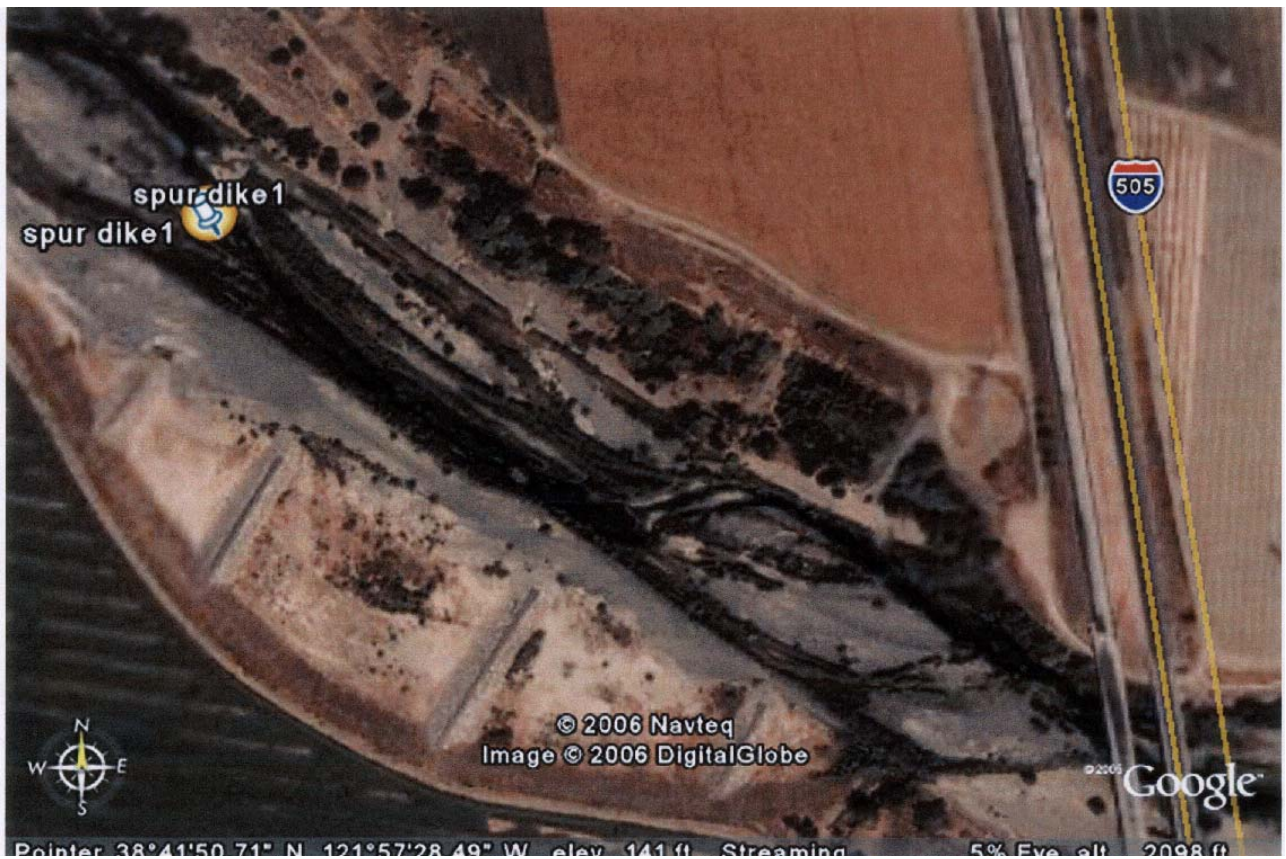
Cache Creek and I-505 in Yolo County. These dikes were installed by CalTrans and the gravel-mining operations in the area.

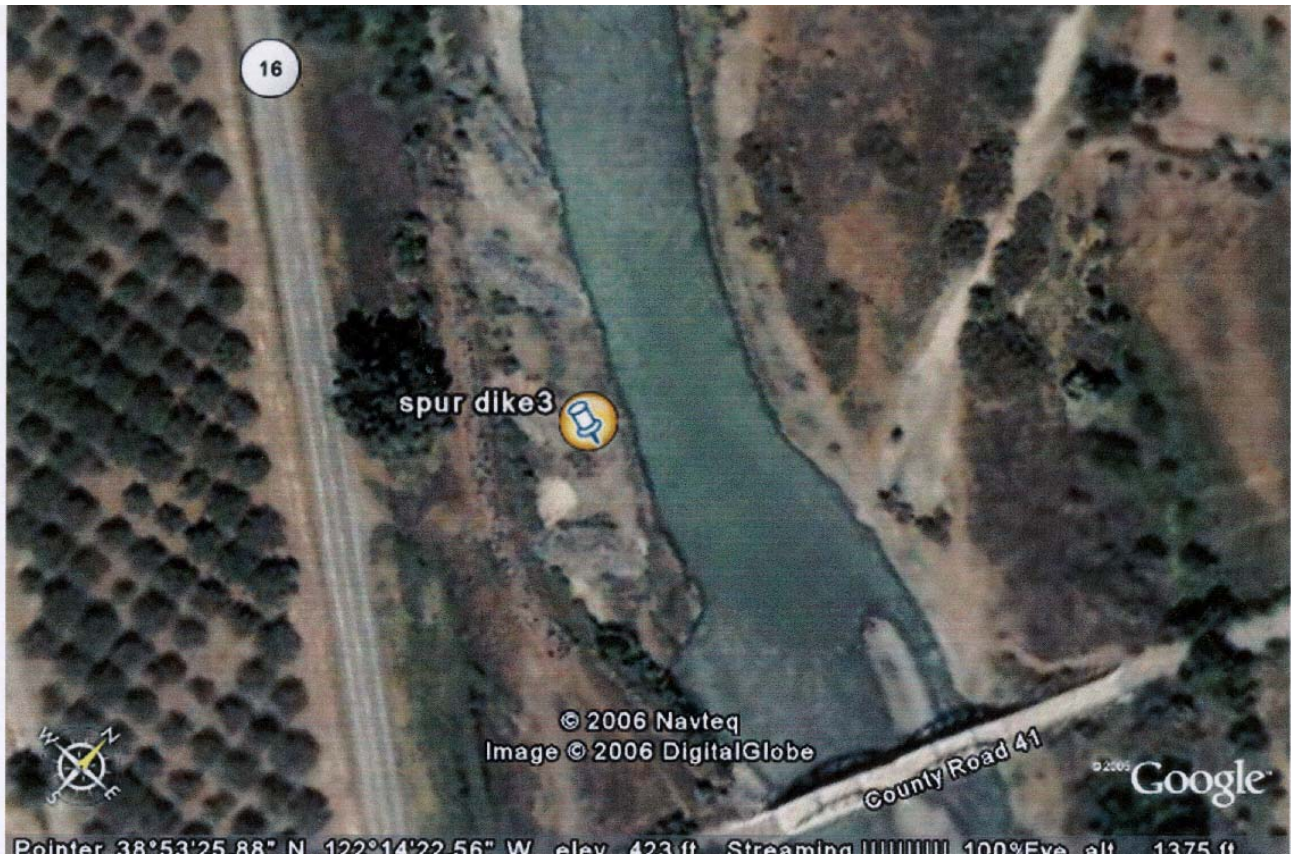
Cache Creek and State Highway 16 in Yolo County immediately north of the town of Rumsey. This was a CalTrans spur dike project completed in 1997.

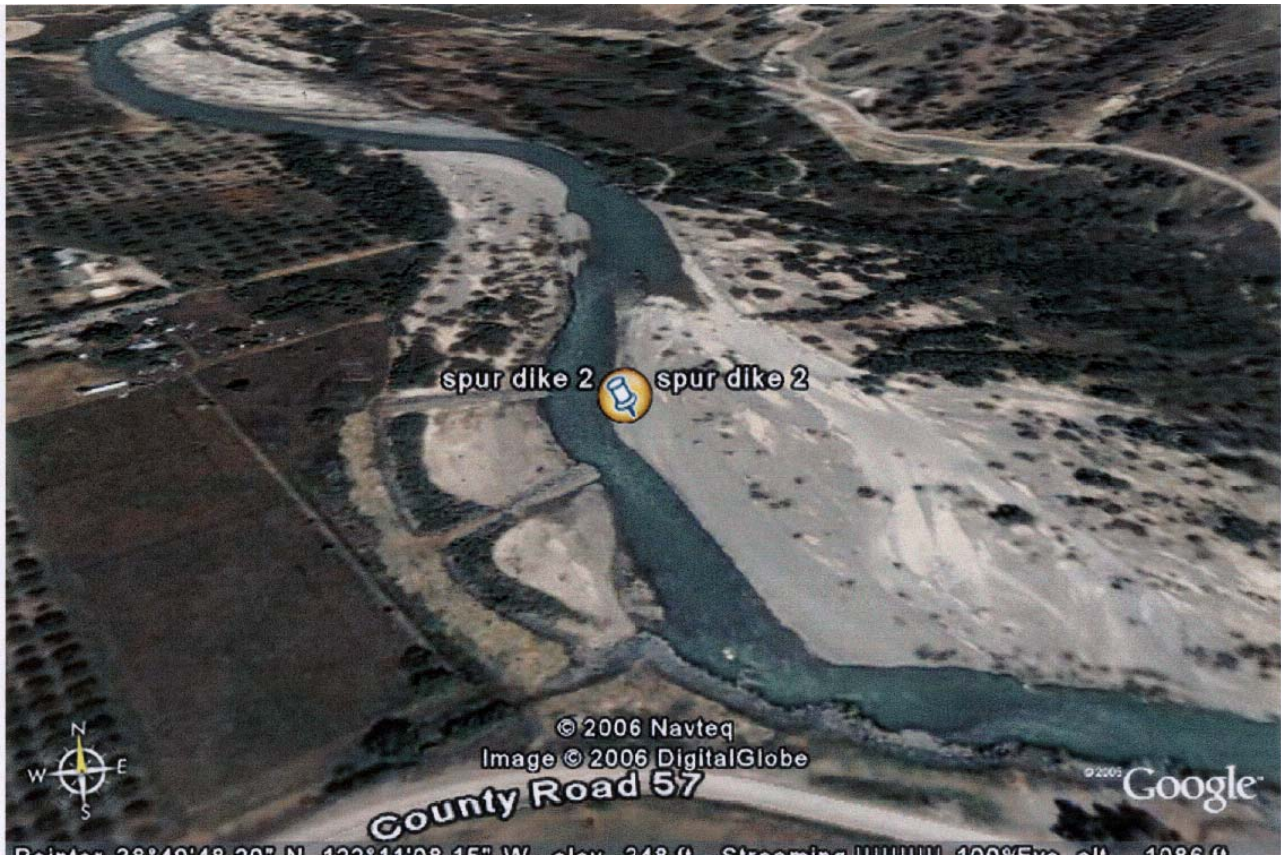
Cache Creek in Yolo County near State Highway 16 and County Road 57. This NRCS spur dike project was done in 1997 and was completed to protect homes, a park, and a bridge.

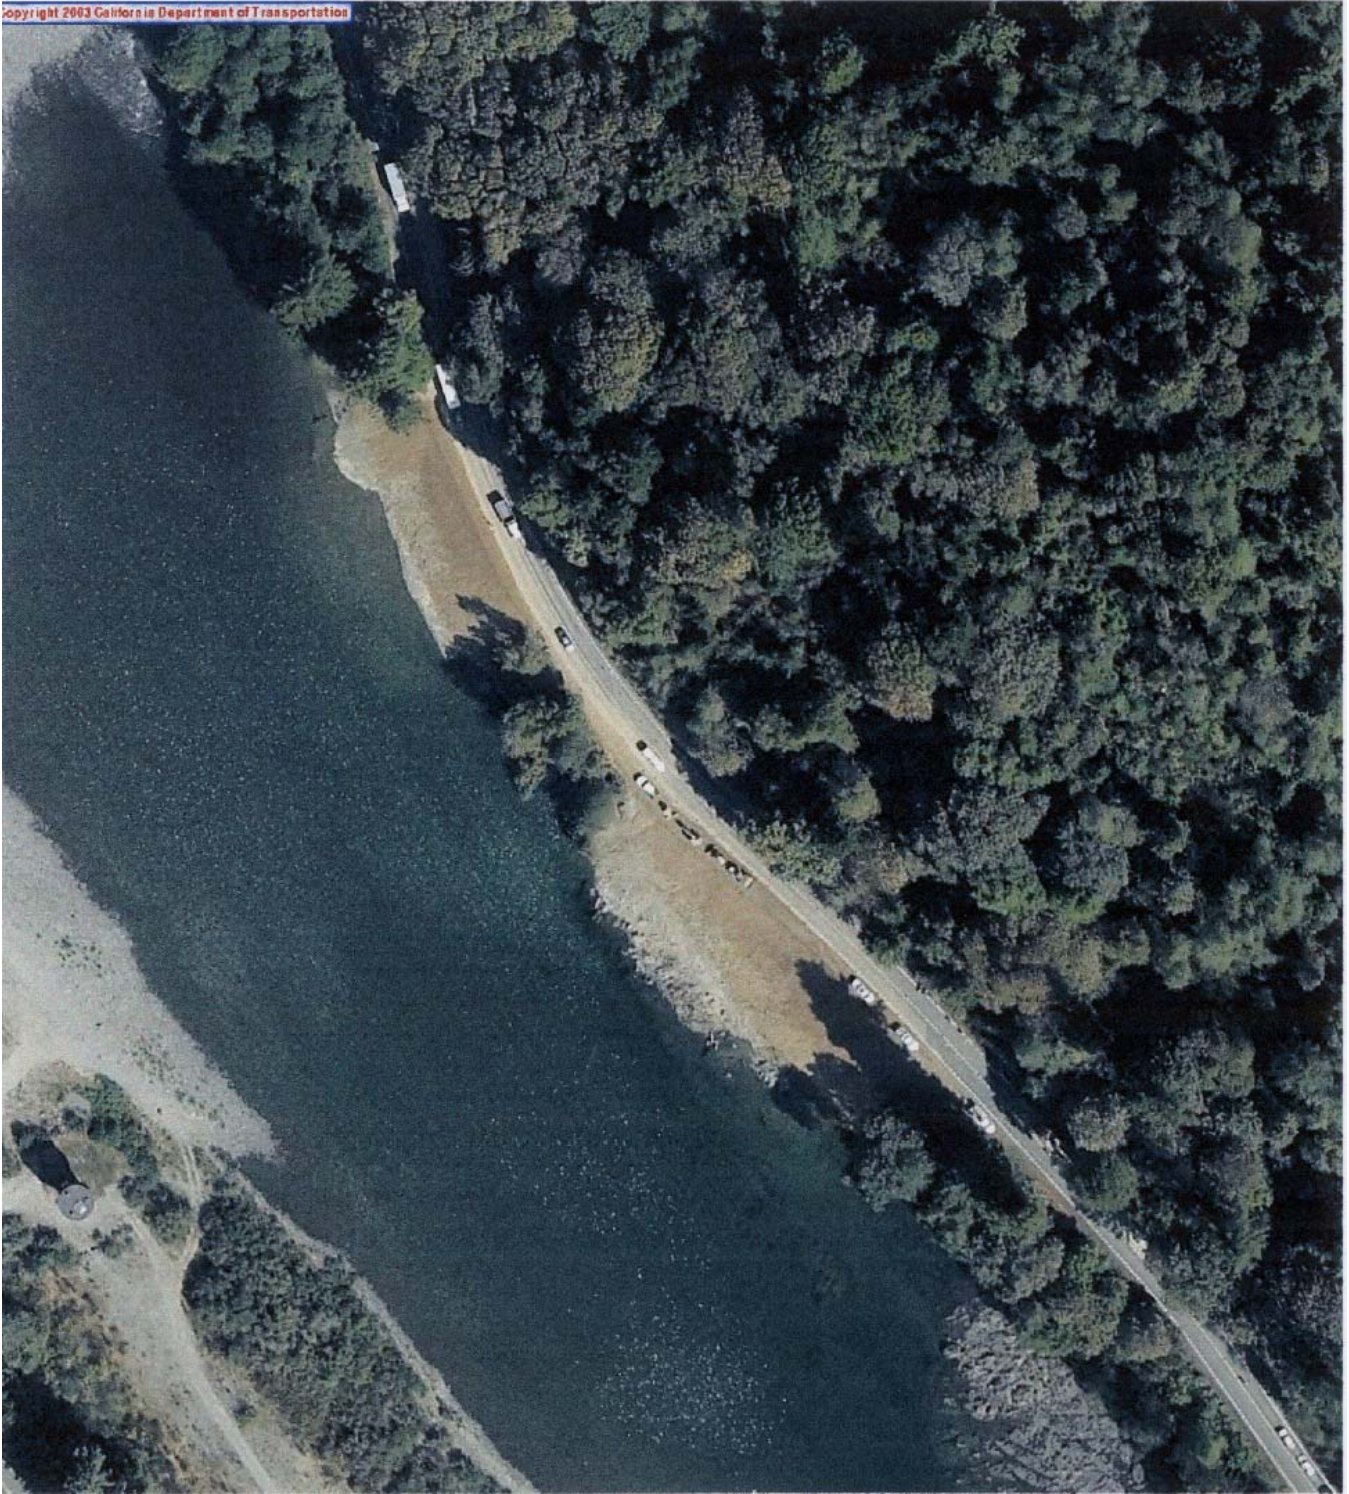
Smith River 2002 CalTrans Bank Stabilization Project. Location was State Highway 197, 1.6 km south of Highway 101. At the toe of the bank protection, 2-ton boulder clusters with root wads were installed.

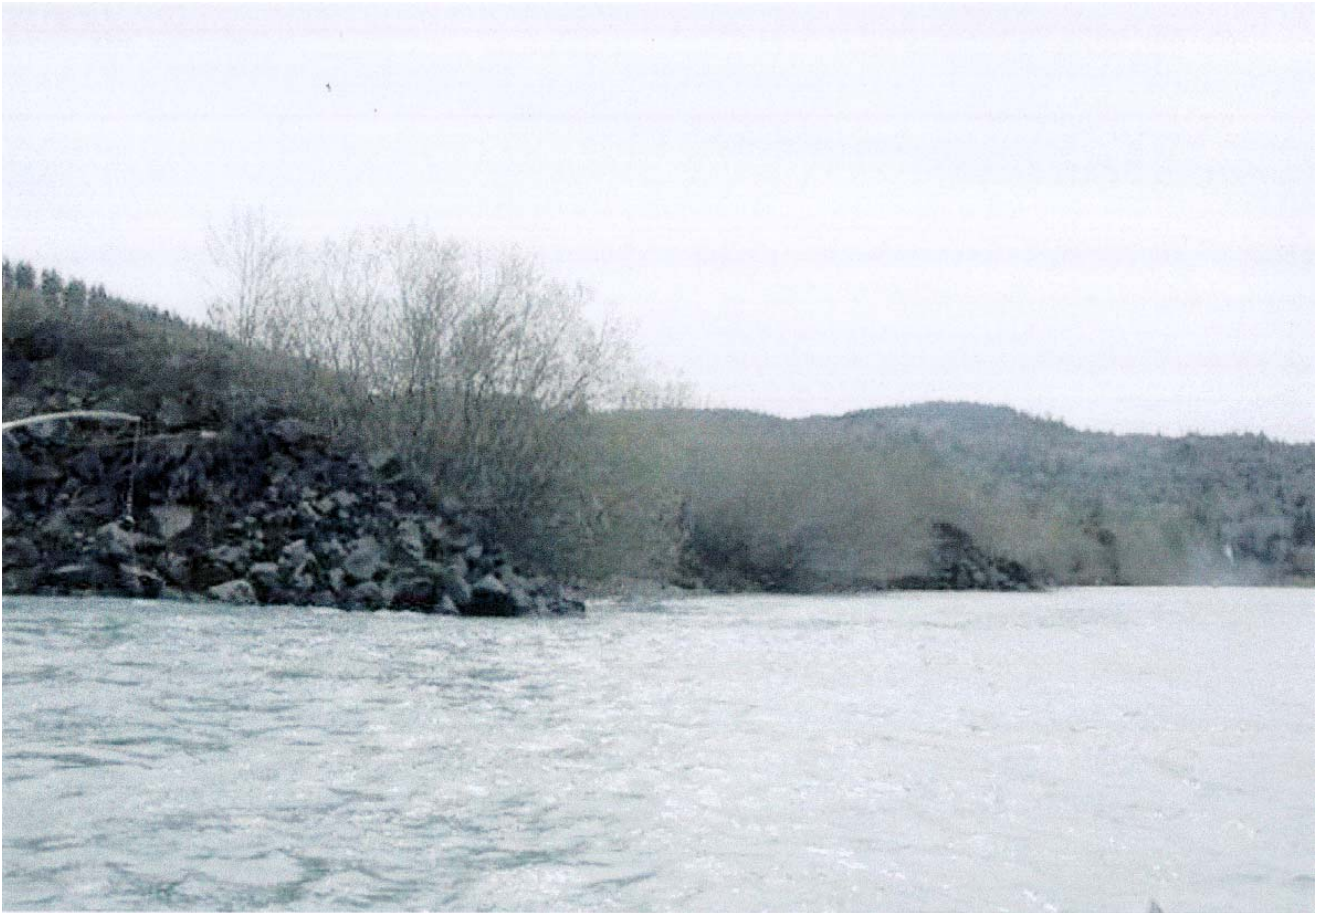
These rock dikes are located in the Chetco River in southwest Oregon. They are near Brookings, Oregon, and about four miles from the ocean. Notice the vegetation growing up in the dike.

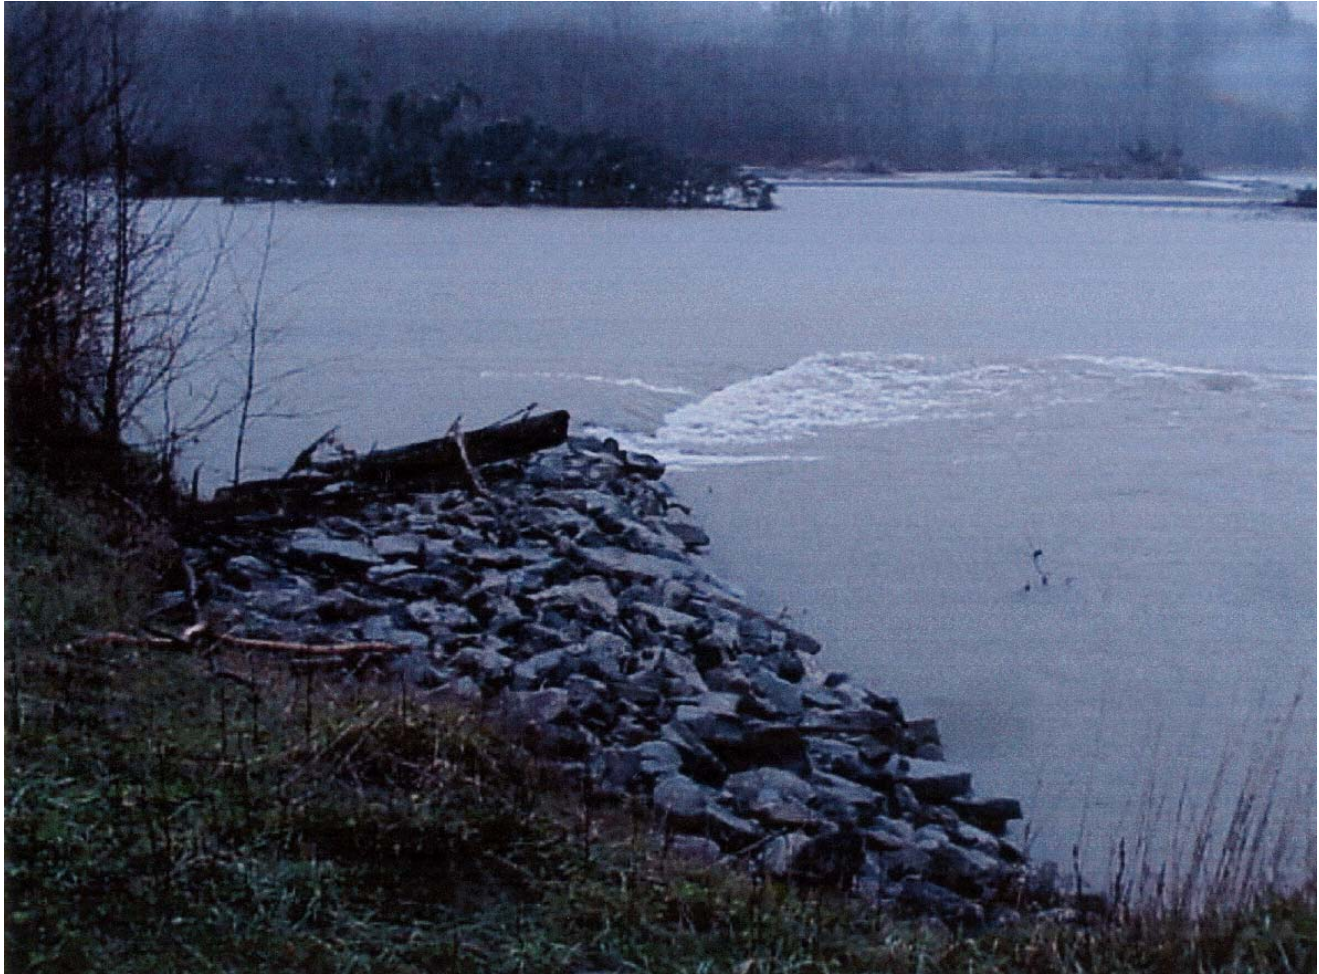
This photo is of rock groins installed on the Bogacheil River near Forks, Washington, in 1999. The Corps installed six rock groins on an outside corner of the river for an erosion project. The river had flooded up and over the bank in this area several times since 1999, but there has not been additional bank loss. Prior to the groins being installed, the river had moved 200 feet landward over two flood seasons.

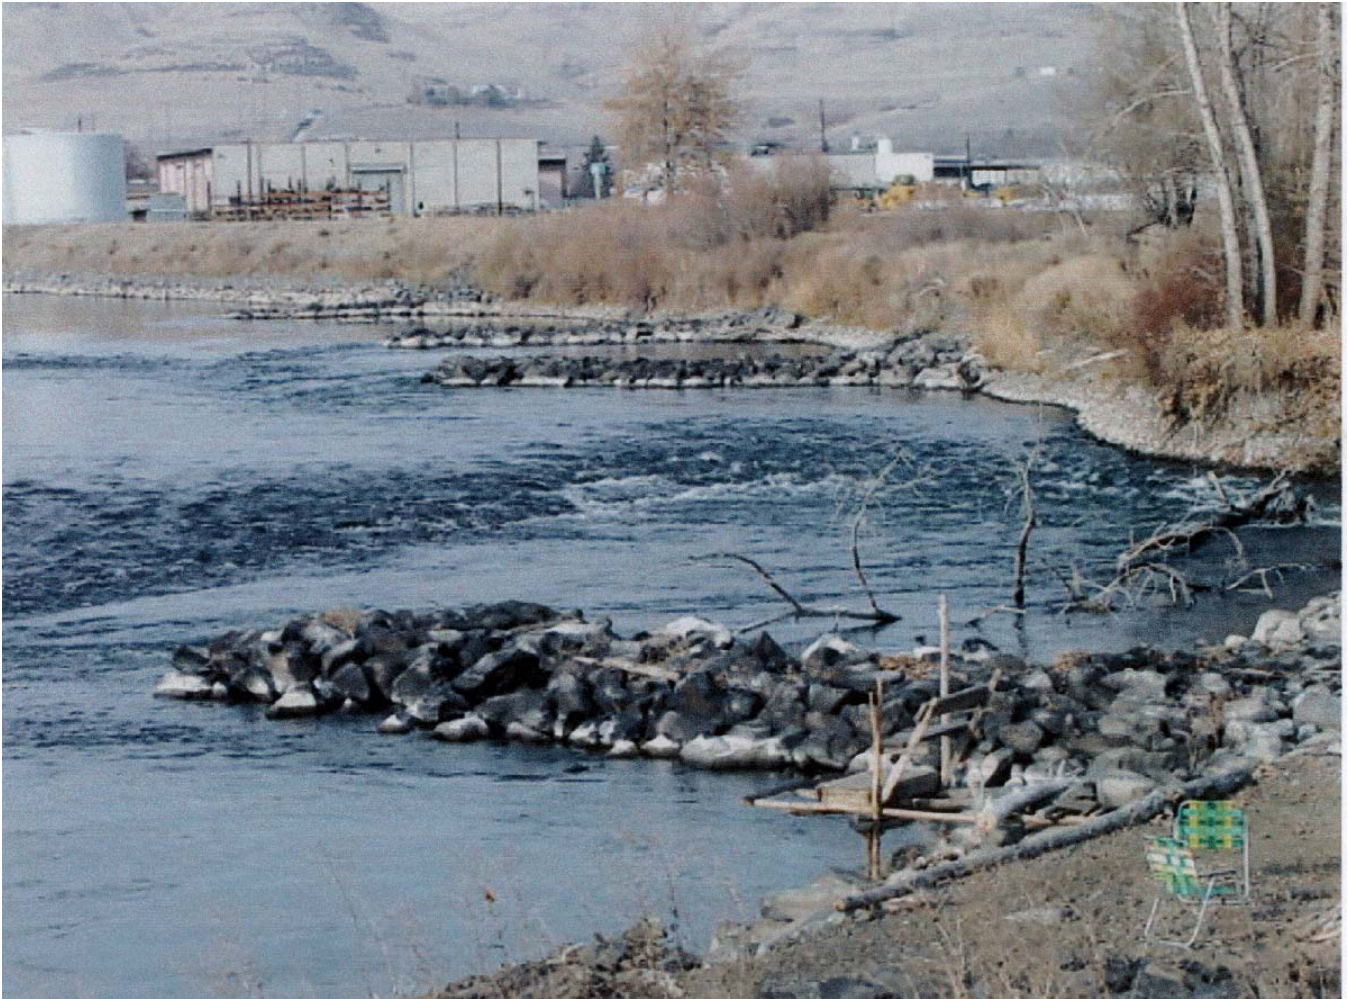
The groins were installed on the Yakima River near the City of Yakima, Washington in 1997. The river was eroding the toe of the levee and the groins were installed as erosion protection. There have been several floods on the Yakima since 1997 and the groins have held up well and are still functioning as designed.
