APPENDIX A

**M&T/Llano Seco Long-Term Water
Reliability Study**

**These photos are examples of rock spurs
in use throughout the United States**

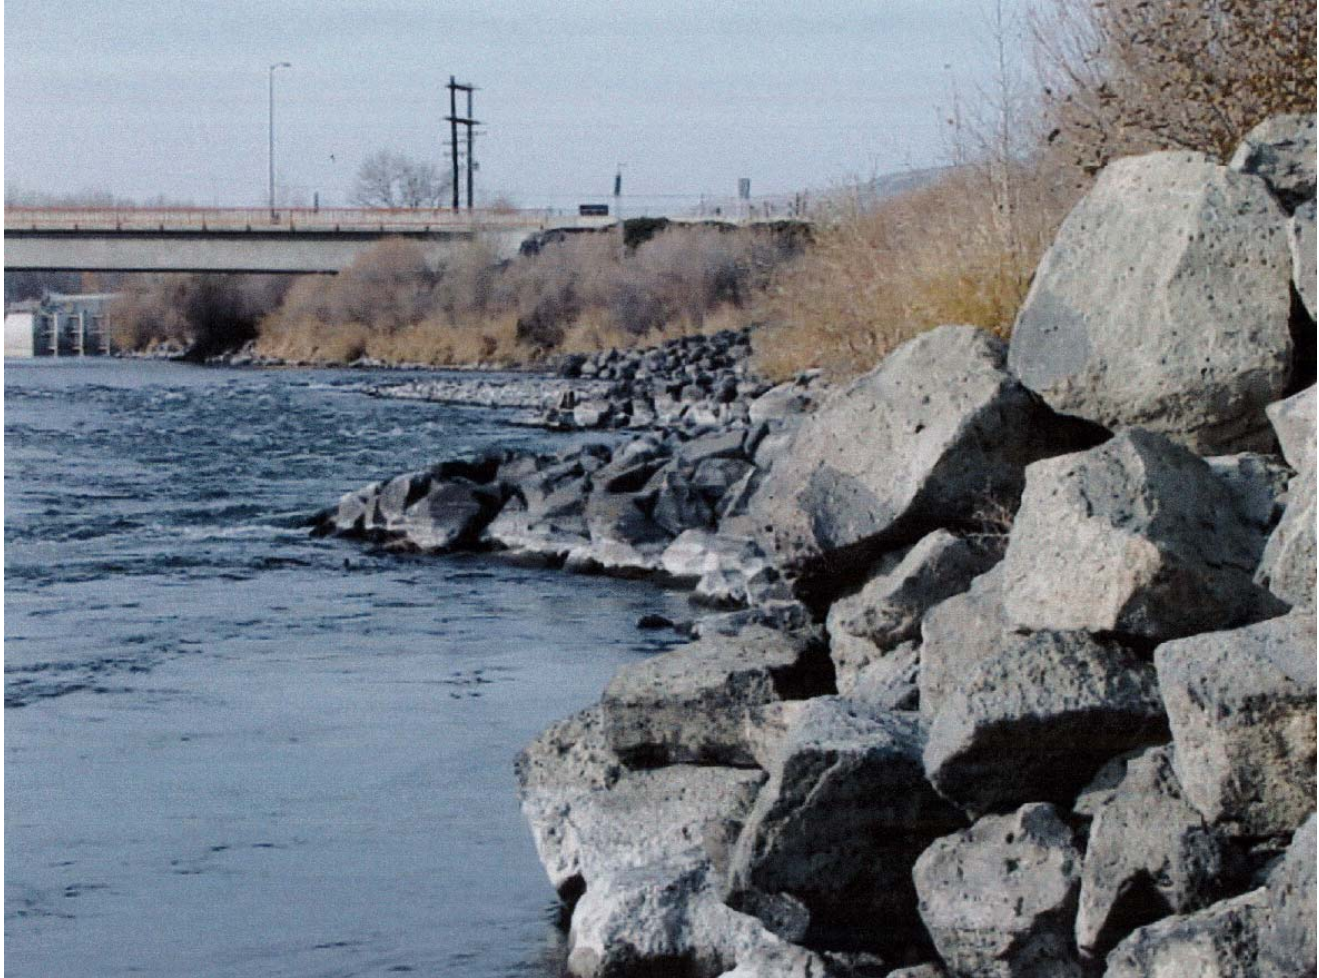
The groins were installed on the Yakima River near the City of Yakima, Washington in 1997. The river was eroding the toe of the levee and the groins were installed as erosion protection. There have been several floods on the Yakima since 1997 and the groins have held up well and are still functioning as designed.

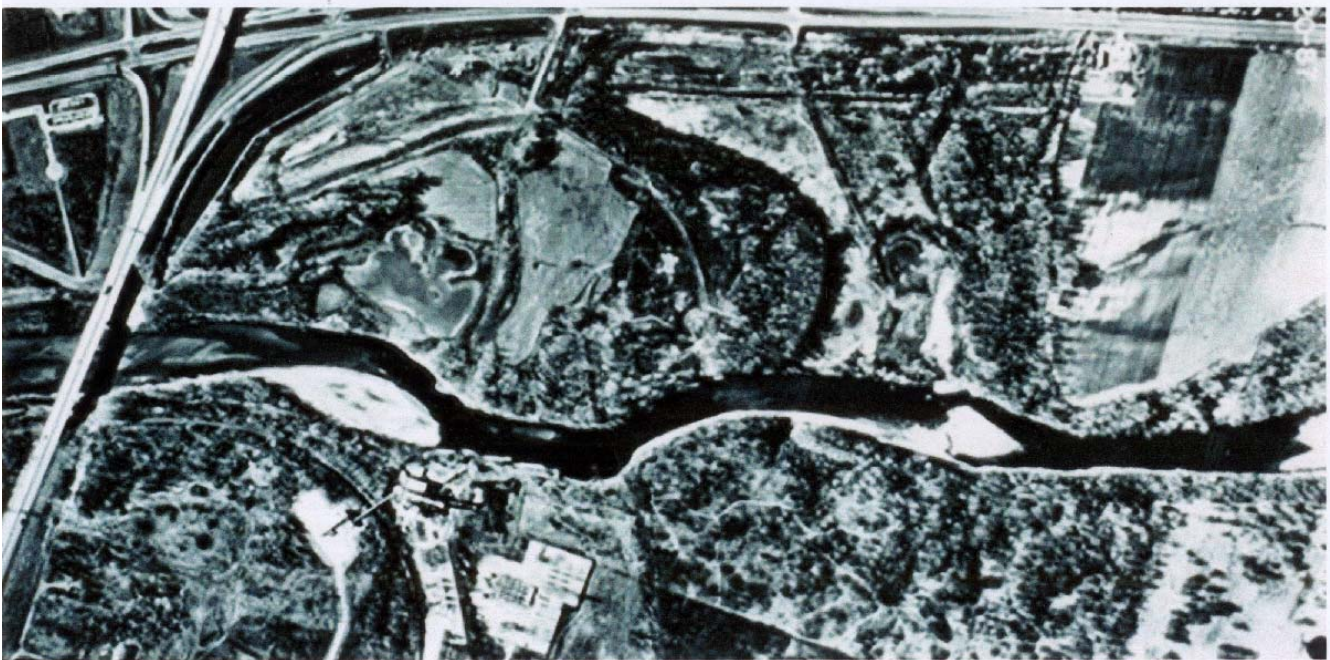
This spur dike location is the Wilmarth Powerplant on the Minnesota River, downstream from Mankato. The gravel bar was threatening to cover the powerplant's cooling water intake. In 1988, a study was commissioned by the Northern States Power Company and was completed by the University of Minnesota. A total of eight alternatives were tested in detail. As a result of the study, three spur dikes were installed on the opposite bank of the river and have performed as designed

This photo was taken in 1989 and the next photo was taken after the spurs were constructed.

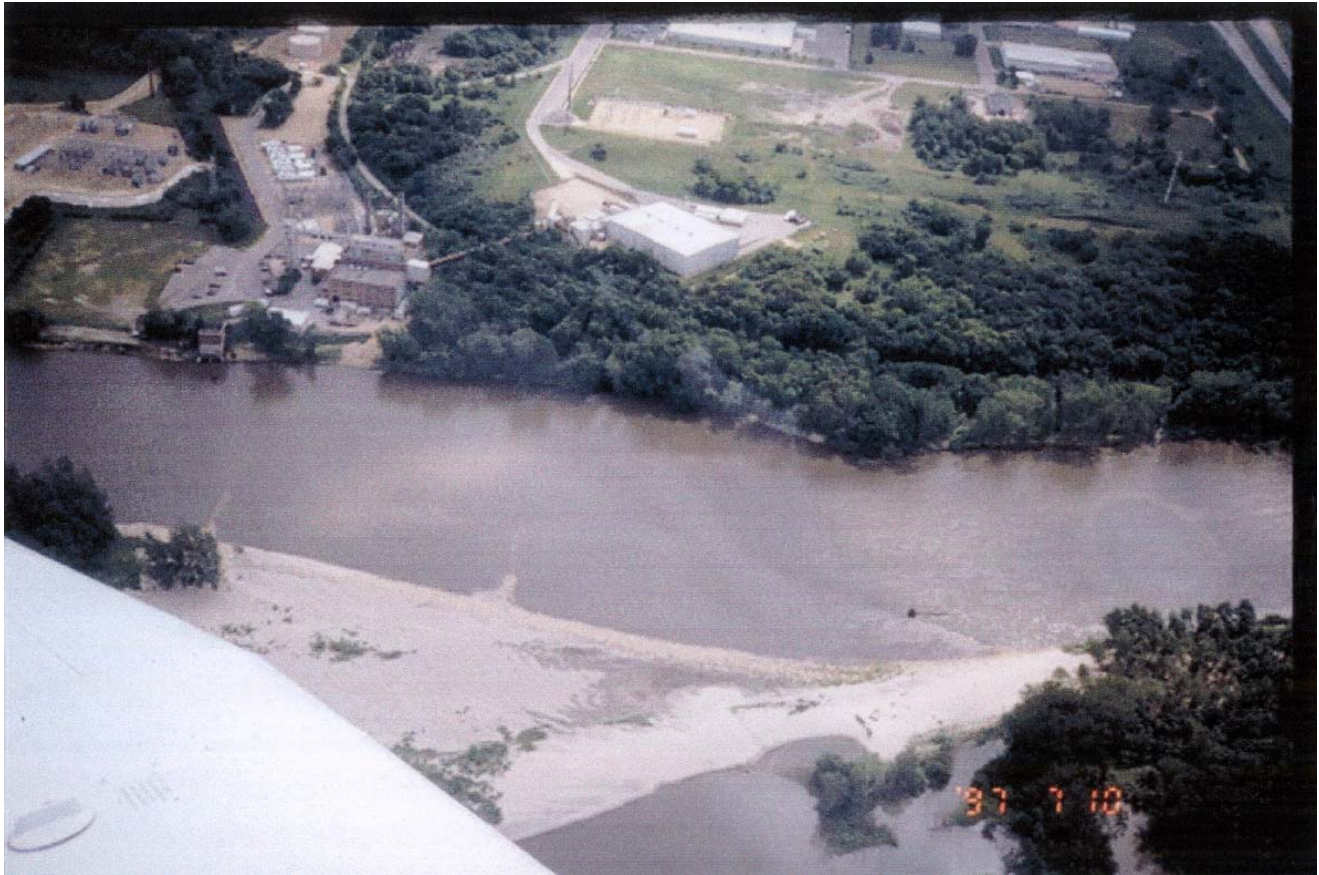
Wilmarth Powerplant on the Minnesota River with rock spurs barely visible on the bank opposite the Powerplant. 1997 photo.
