MEMORANDUM

TO: Jim Well, Ducks Unlimited
FROM: Dai Thomas, PE, and Mike Harvey, PhD., PG
SUBJECT: **May 8, 2013 Resurvey of M&T/Llano Seco Pumping Plant and City of Chico Outfall Reach of the Sacramento River
M&T/Llano Seco Fish Screen Facility Long-term Protection Project, Phase IV, Project No. US-CA-62-6**
DATE: June 11, 2013

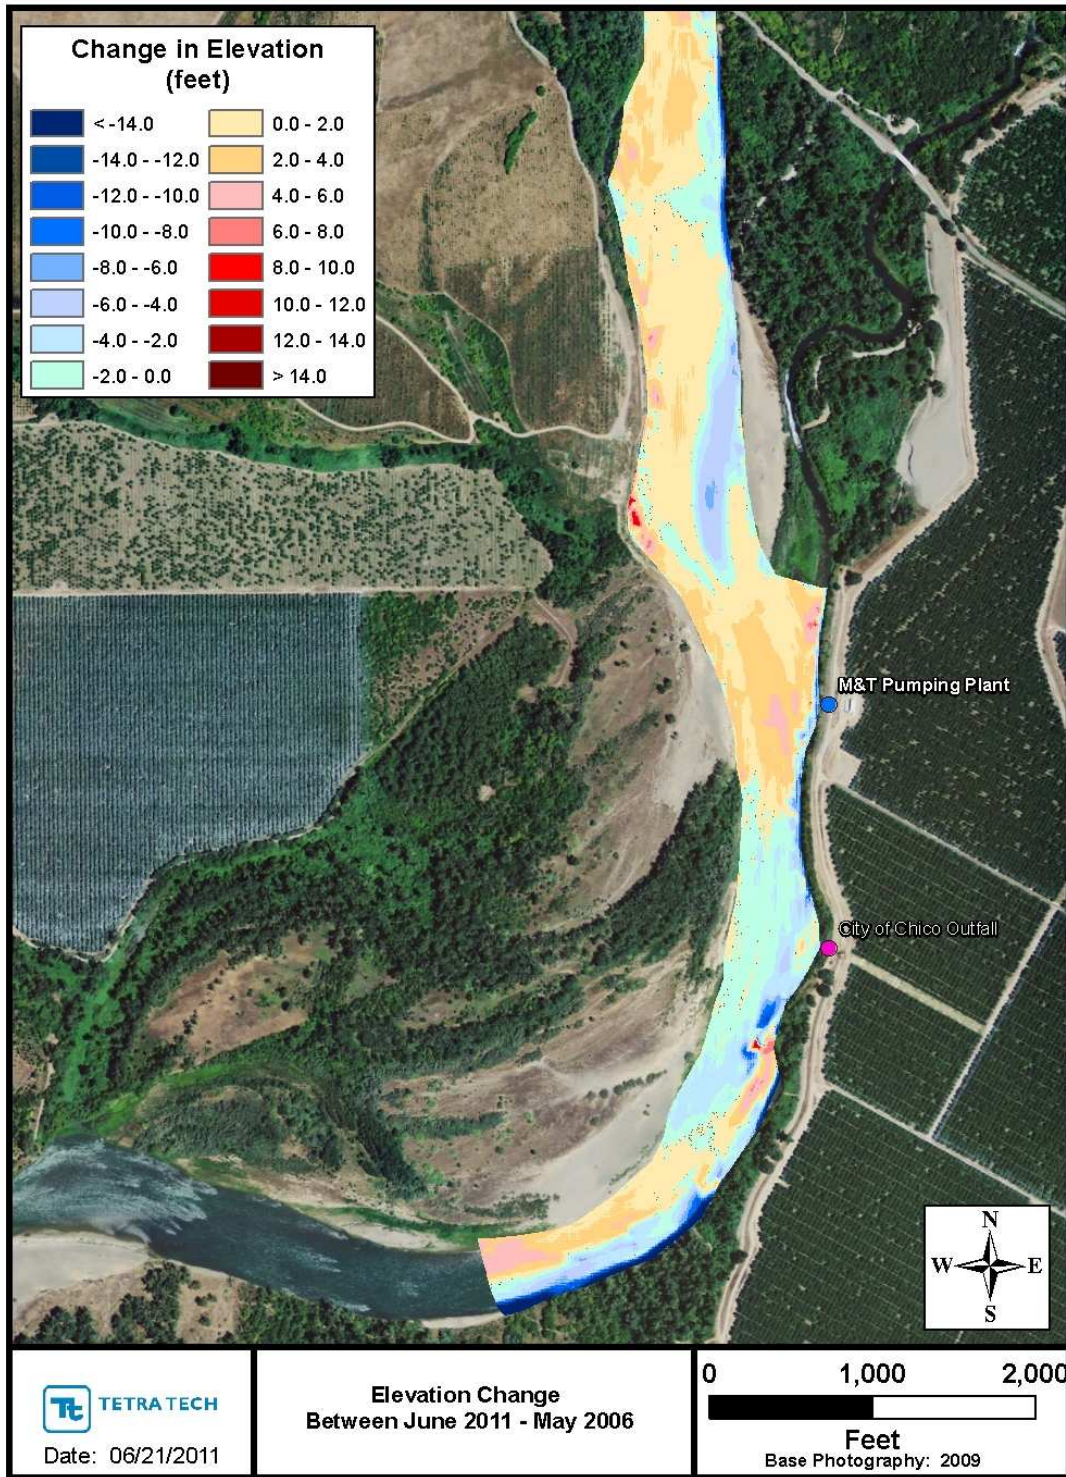
Figure 3. Elevation changes in the M&T/Llano Seco reach between the June 2011 and May 2006 surveys.

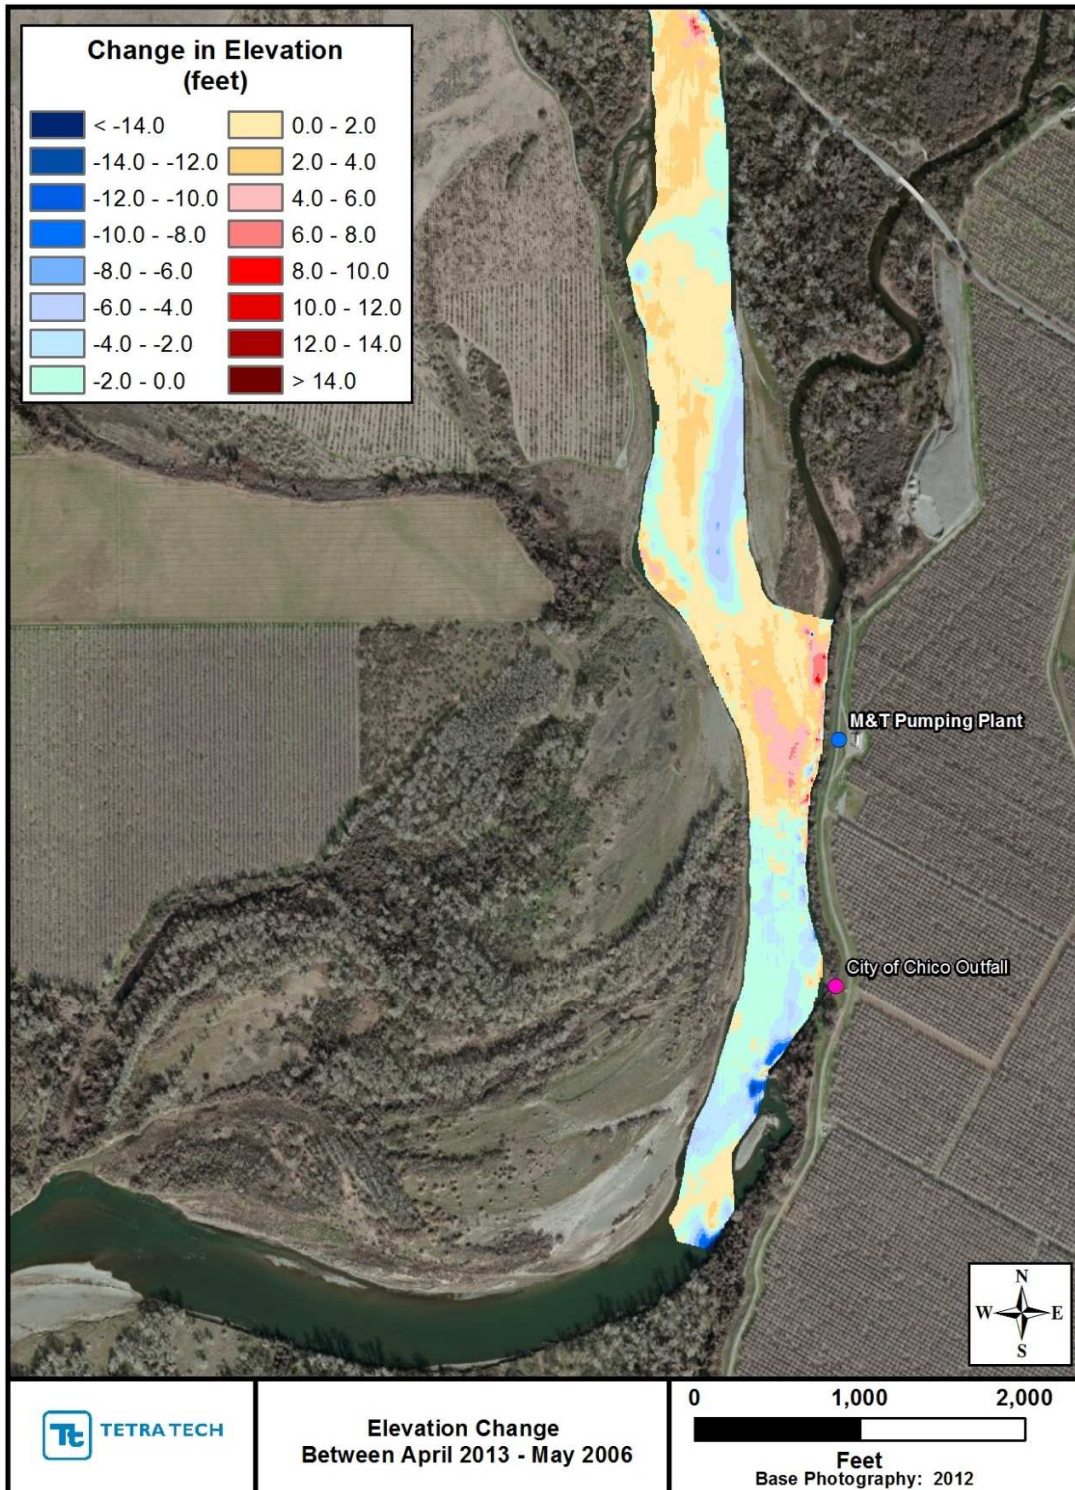
and 2013 surveys with the majority of the values in the -2 to 0 or the 0- to 2-foot categories. The range of these categories has been kept consistent with the previous survey report (Tetra Tech, 2012); in general, most of the values range between -0.5 and 0.5 feet, which represents little change in bed elevation. **Figure 7** presents the differences in elevation of the bed of the river between the 2013 and 2006 surveys, and demonstrates that the site is still net aggradational.

Figure 7. Elevation changes in the M&T/Llano Seco reach between the May 2013 and May 2006 surveys.

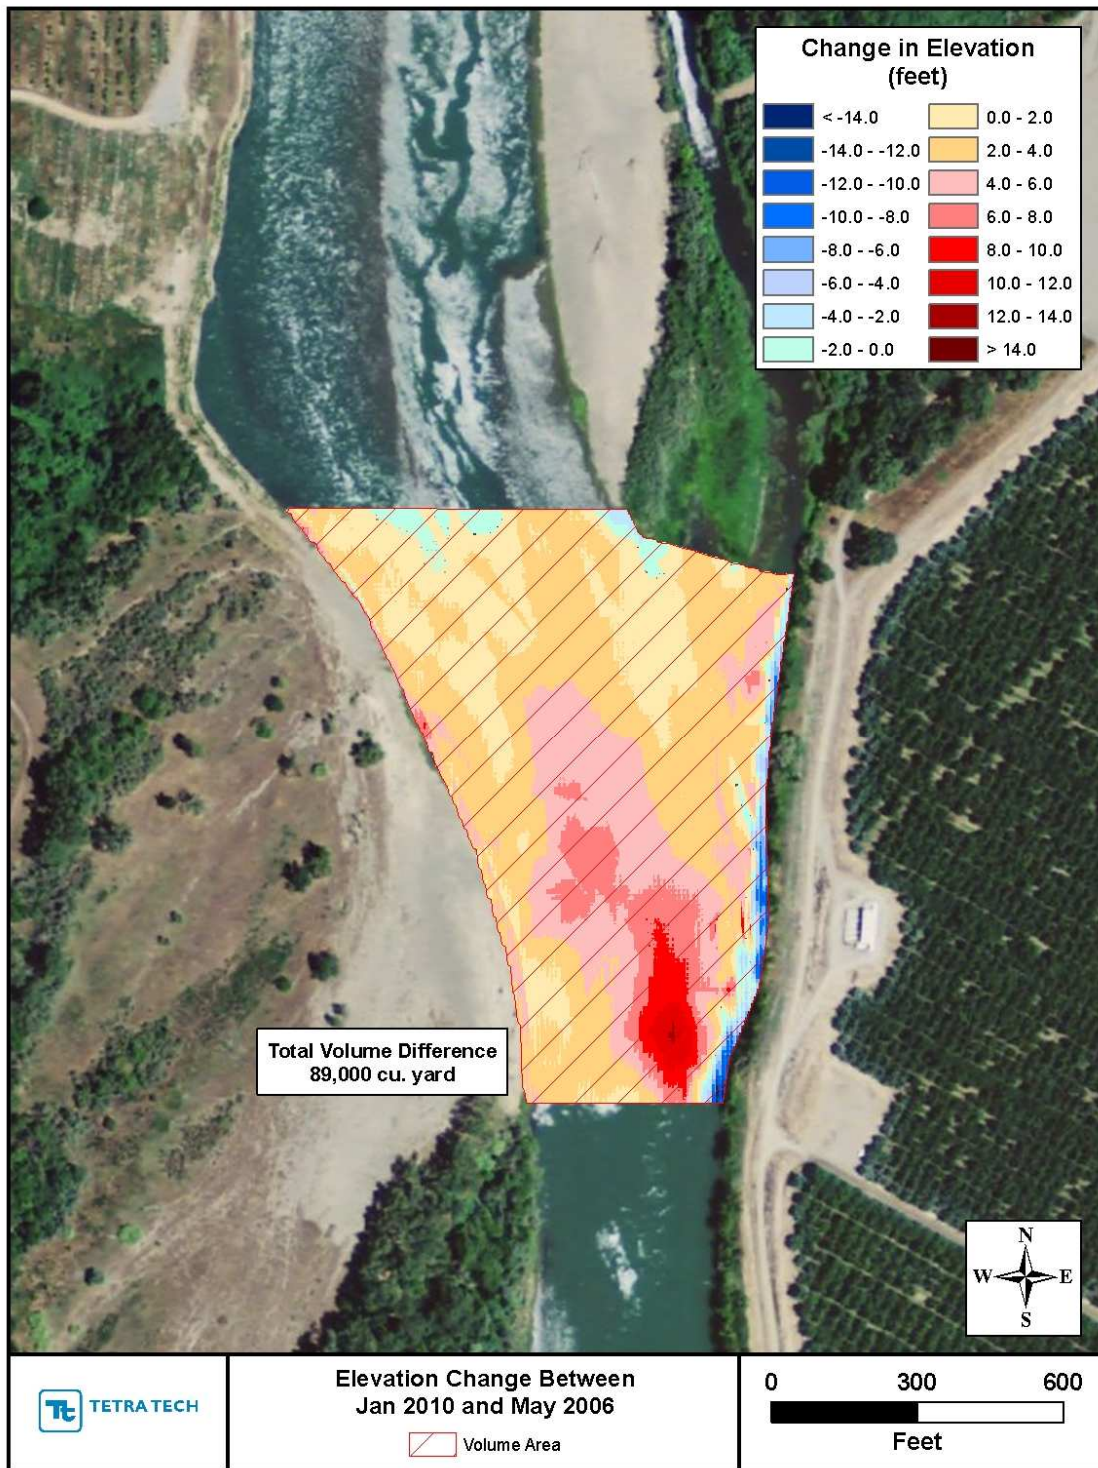
Figure 8. Volumetric calculation of the deposition in the 600- by 1,200-foot segment in the vicinity of the fish screens and pump inlets between the January 2010 and May 2006 surveys.

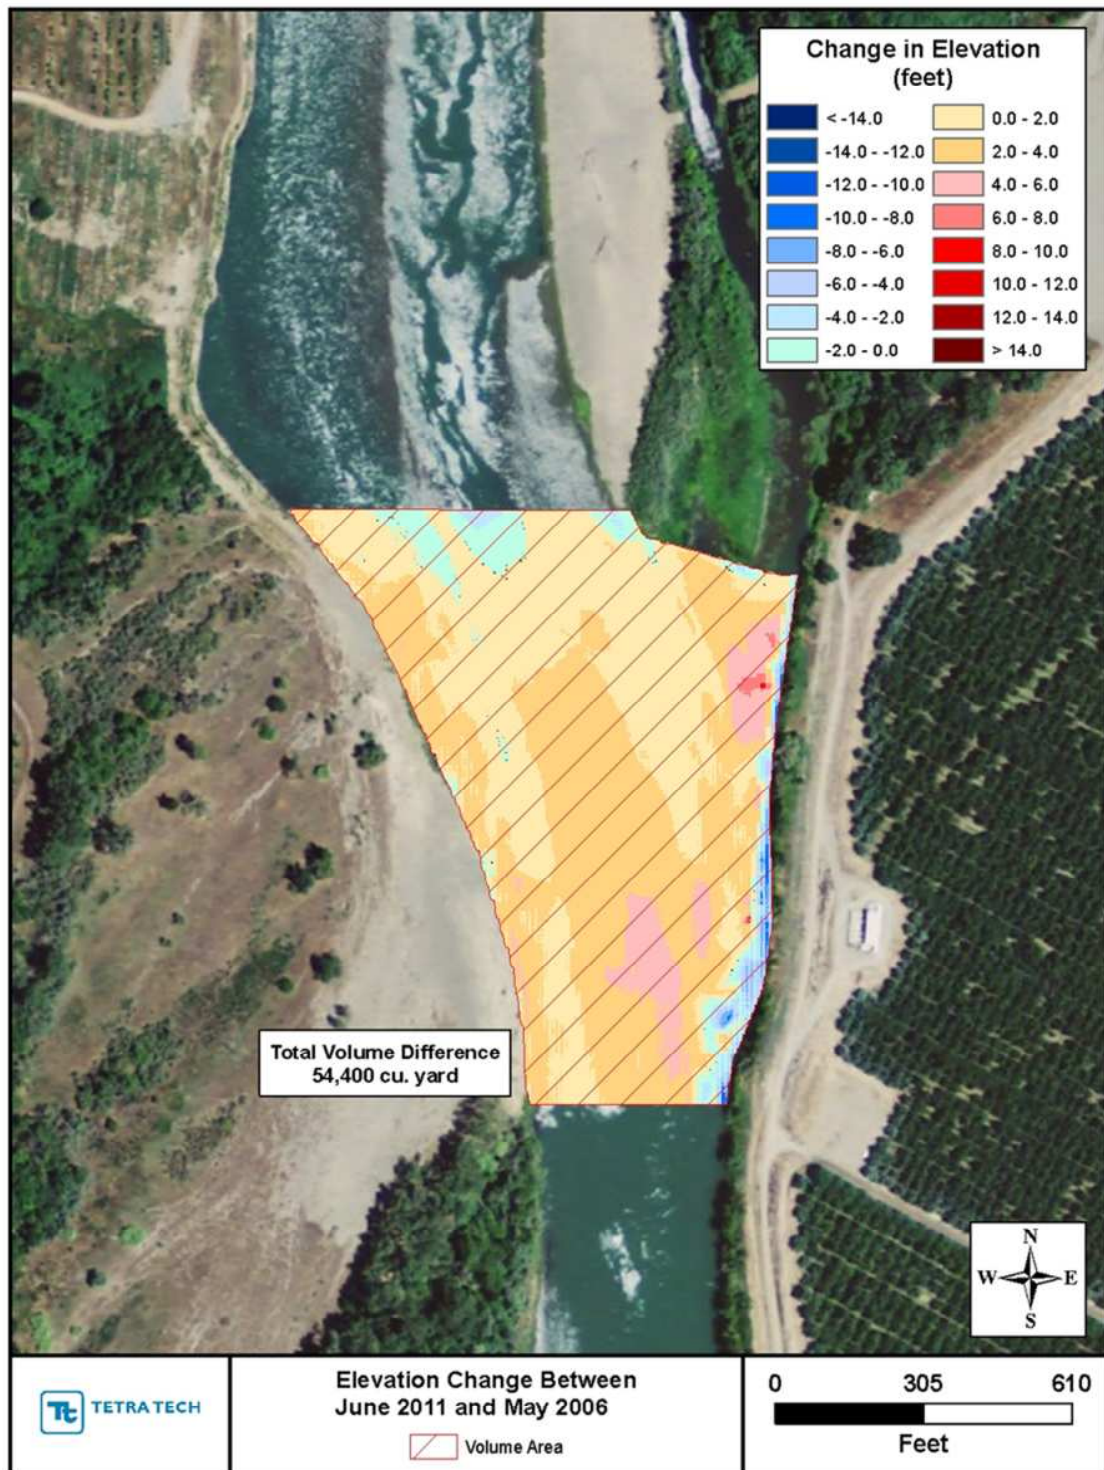
Figure 9. Volumetric calculation of the deposition in the 600 by 1,200-foot segment in the vicinity of the fish screens and pump inlets between the June 2011 and May 2006 surveys.

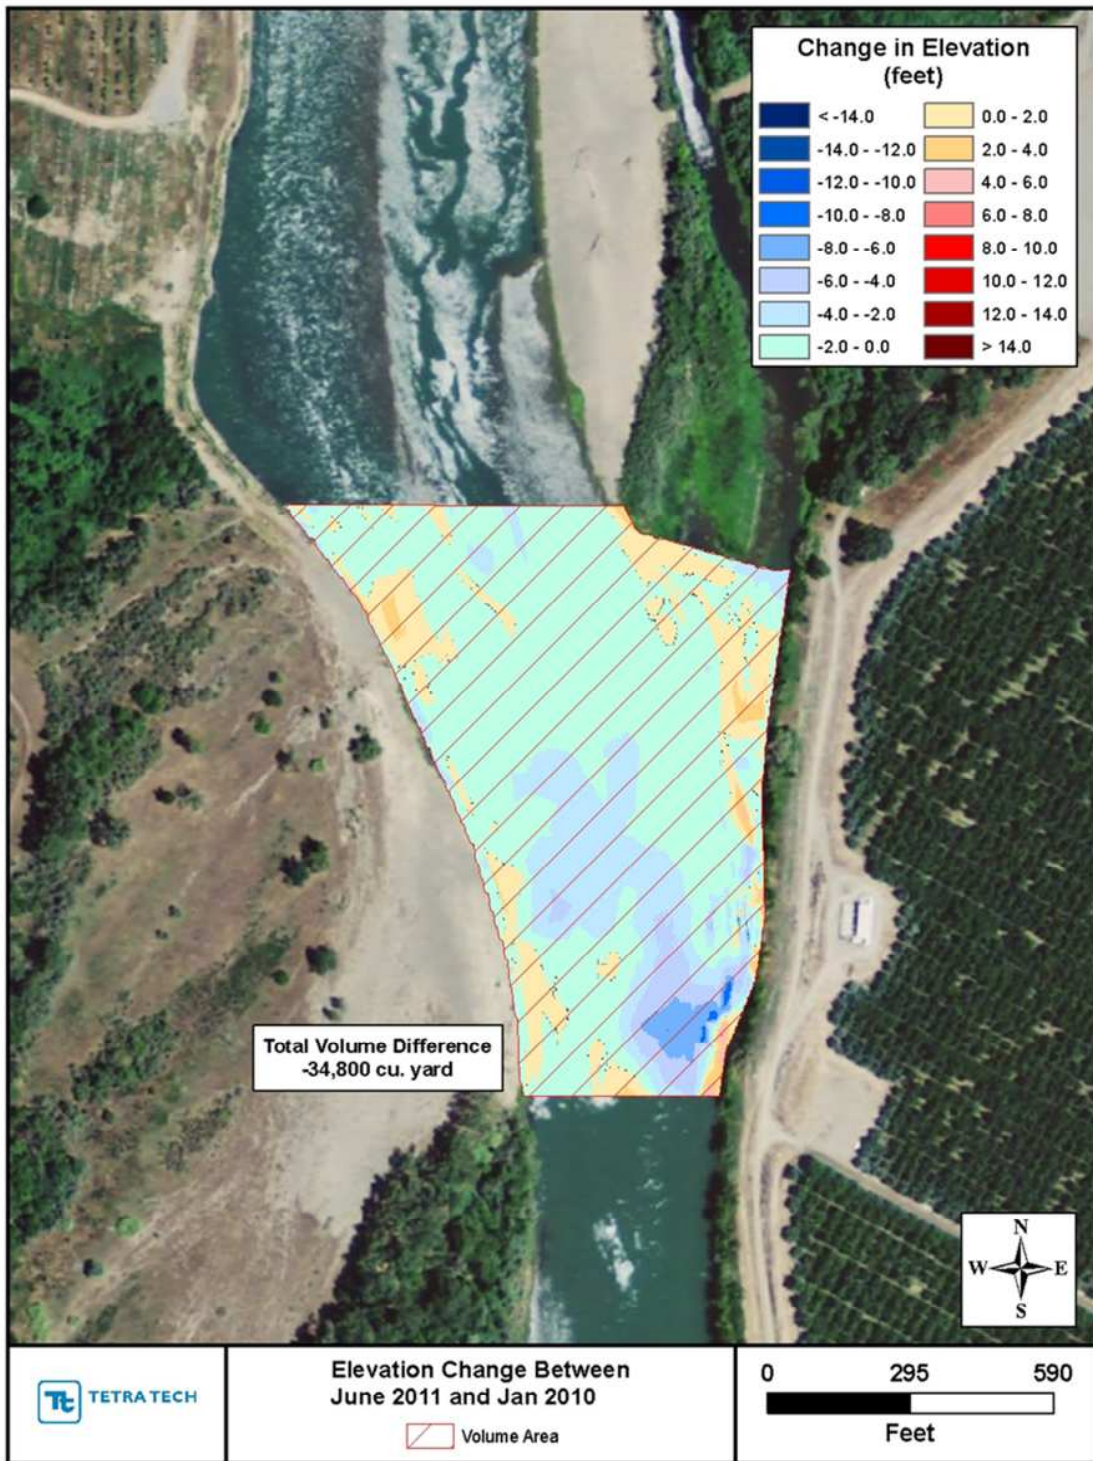
Figure 10. Volumetric calculation of the deposition in the 600- by 1,200-foot segment in the vicinity of the fish screens and pump inlets between the January 2010 and June 2011 surveys.

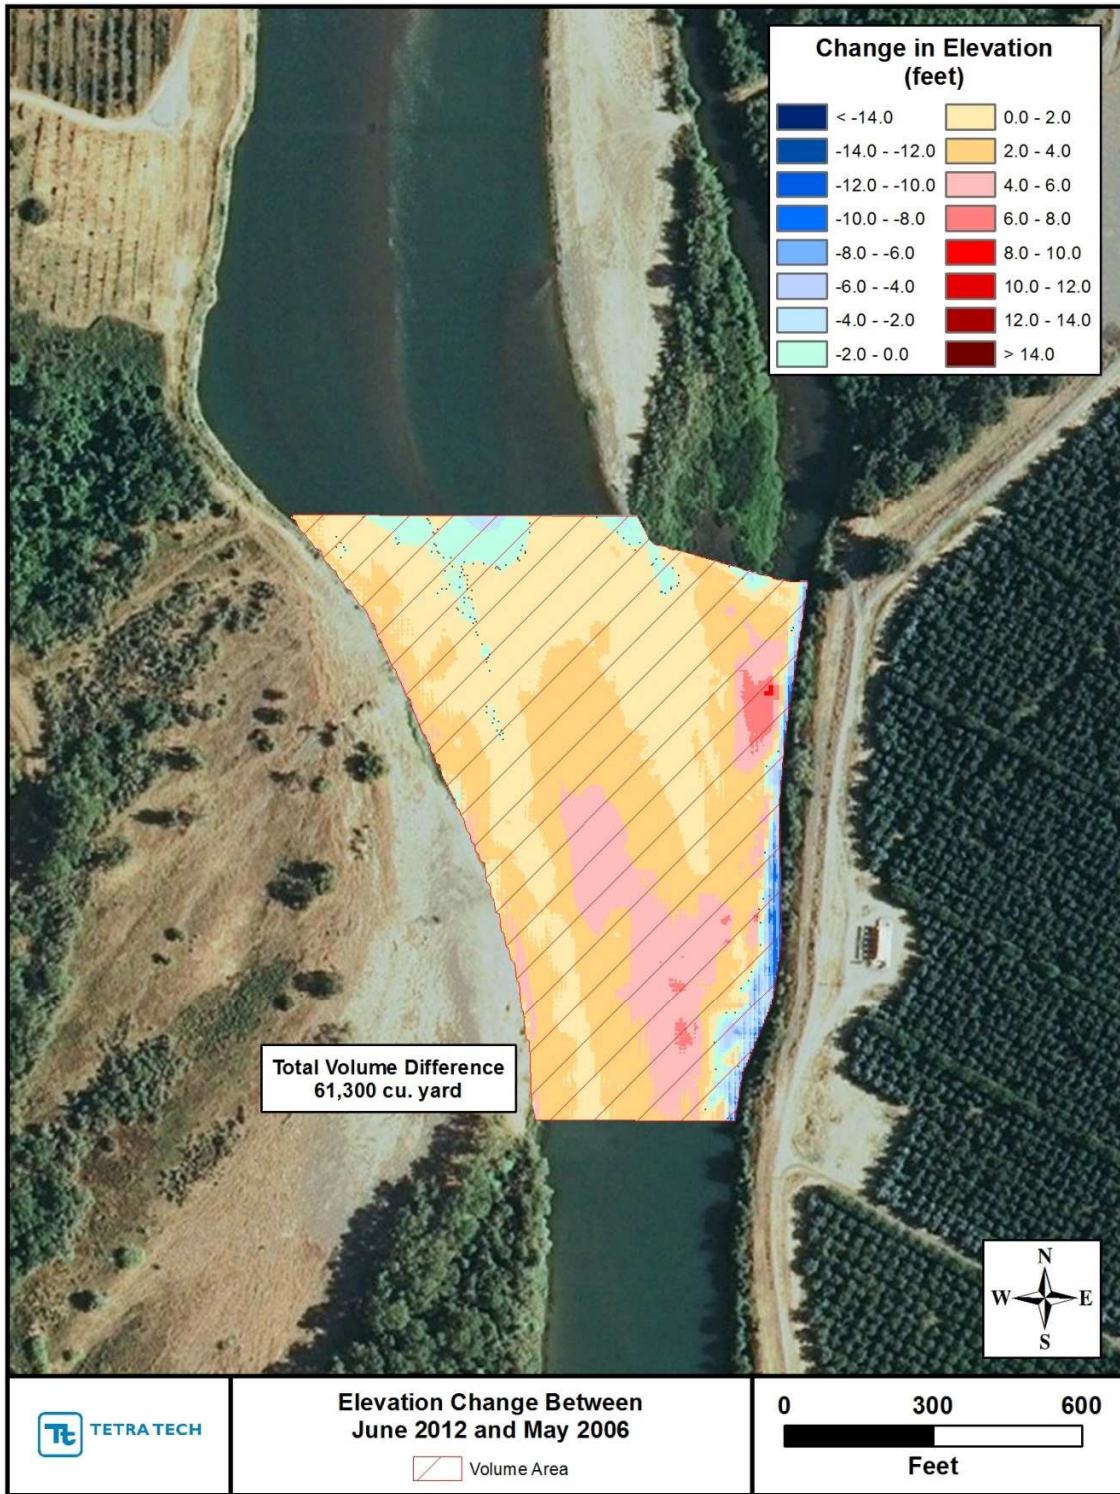
Figure 11. Volumetric calculation of the deposition in the 600- by 1,200-foot segment in the vicinity of the fish screens and pump inlets between the June 2012 and May 2006 surveys.

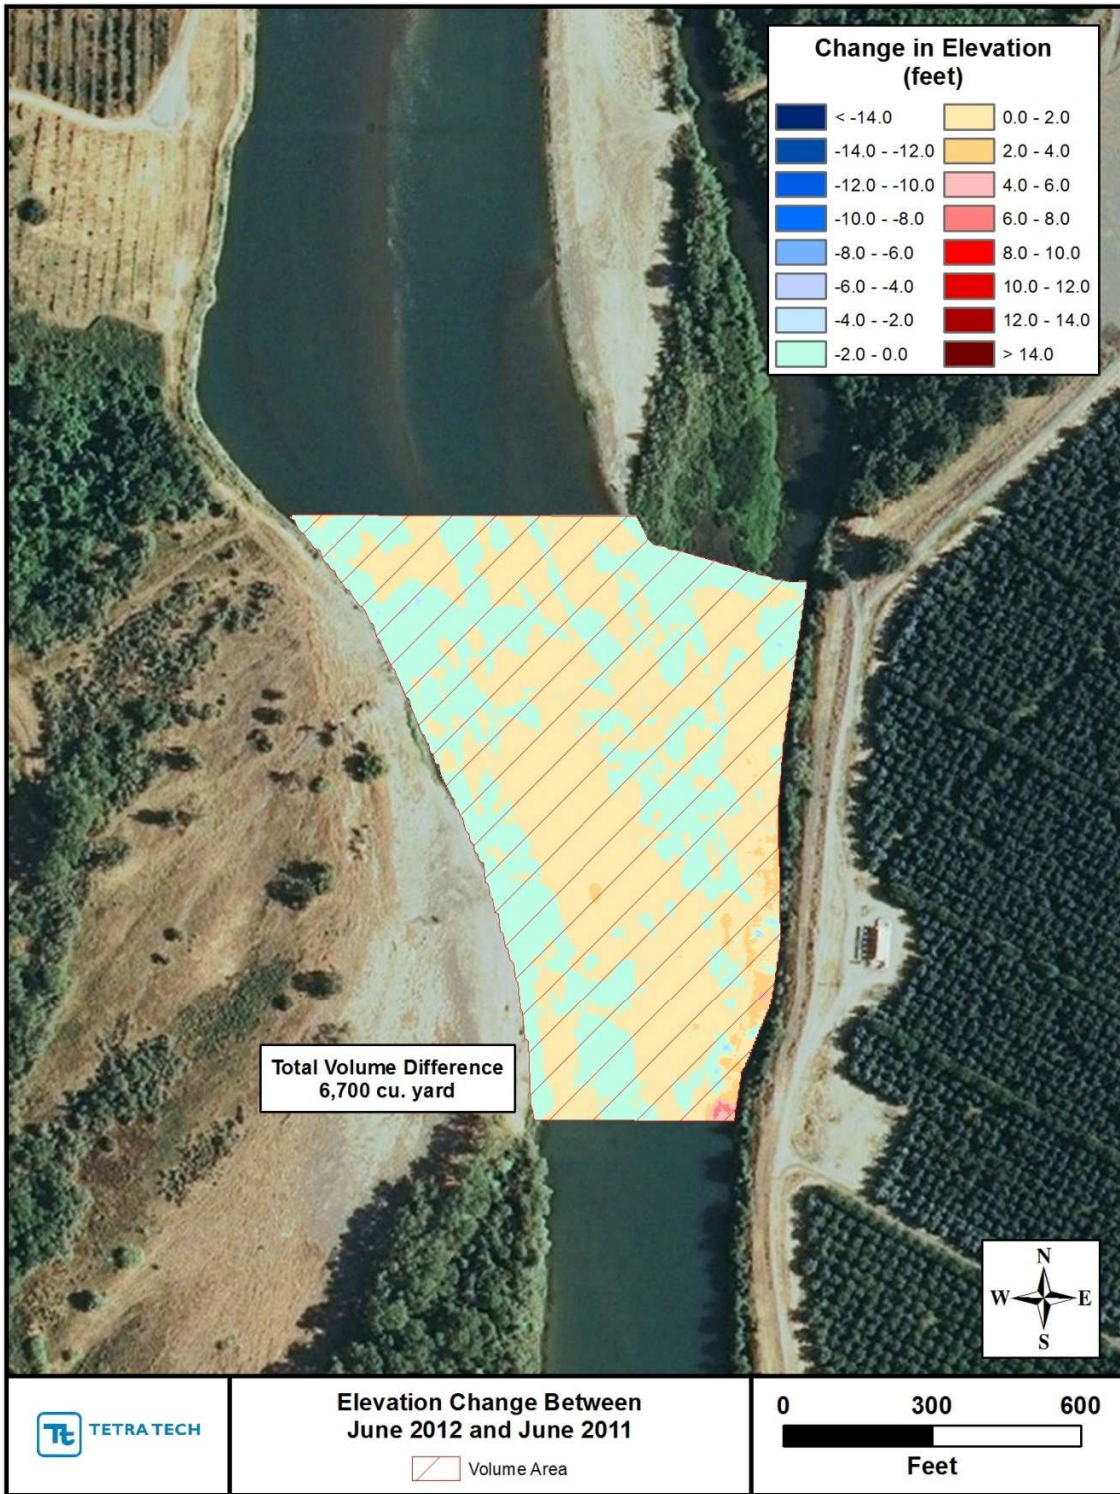
Figure 12. Volumetric calculation of the deposition in the 600- by 1,200-foot segment in the vicinity of the fish screens and pump inlets between the June 2011 and June 2012 surveys.

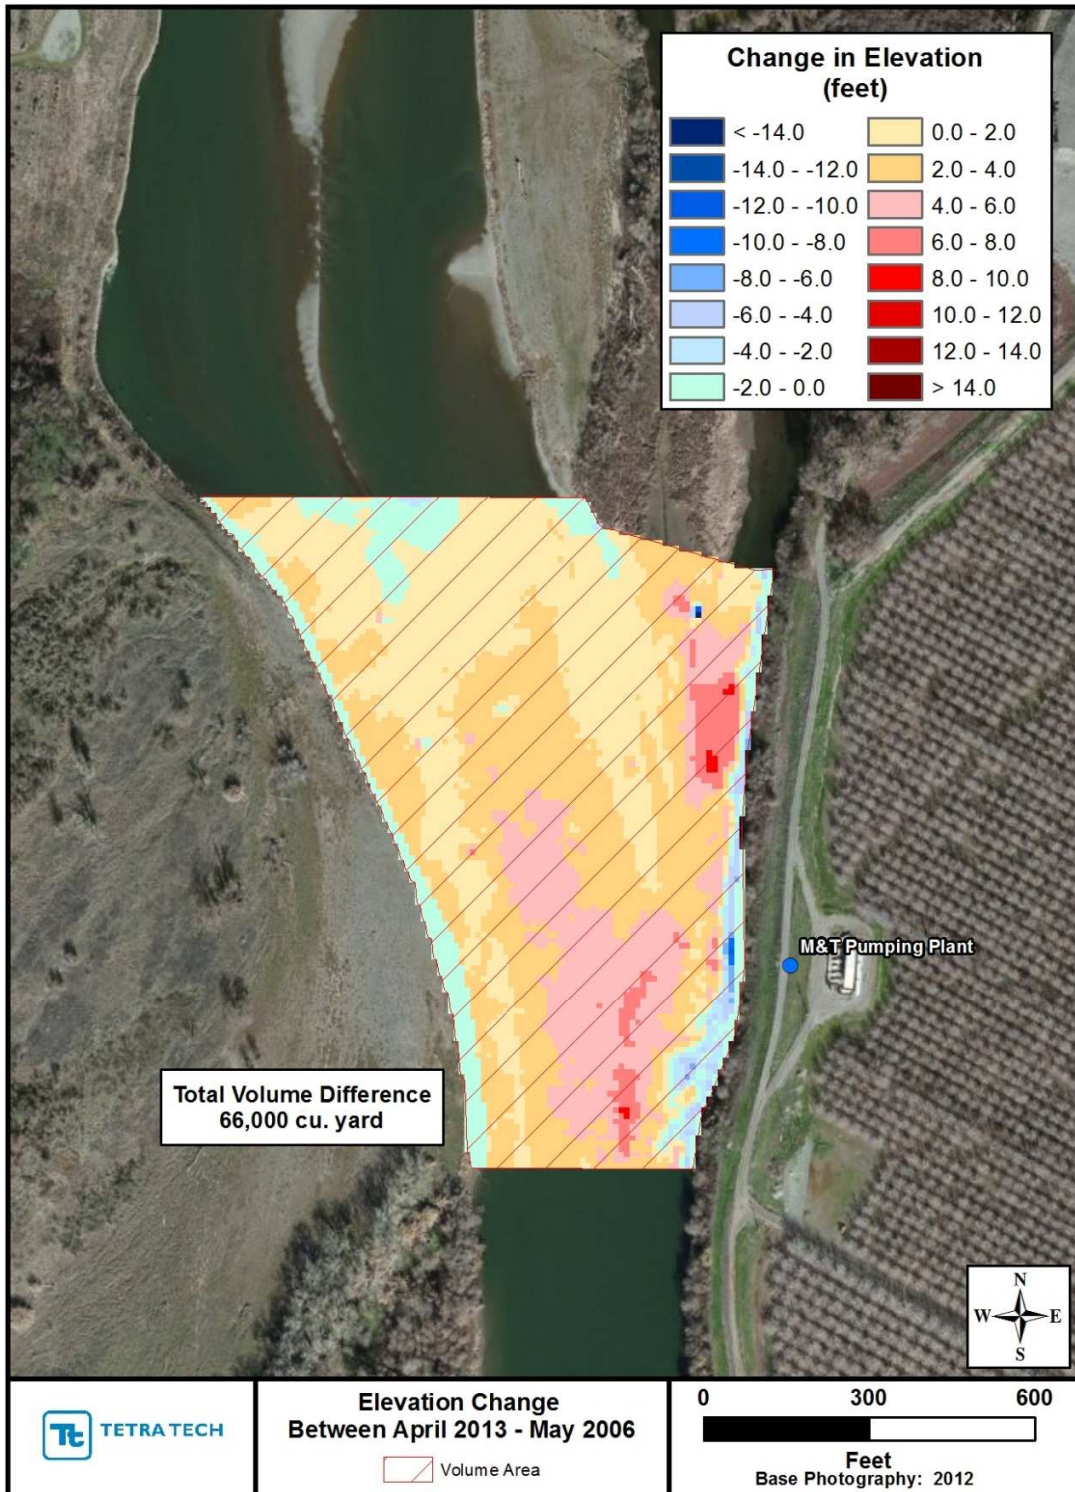
Figure 13. Volumetric calculation of the deposition in the 600 by 1,200-foot segment in the vicinity of the fish screens and pump inlets between the June 2013 and May 2006 surveys.

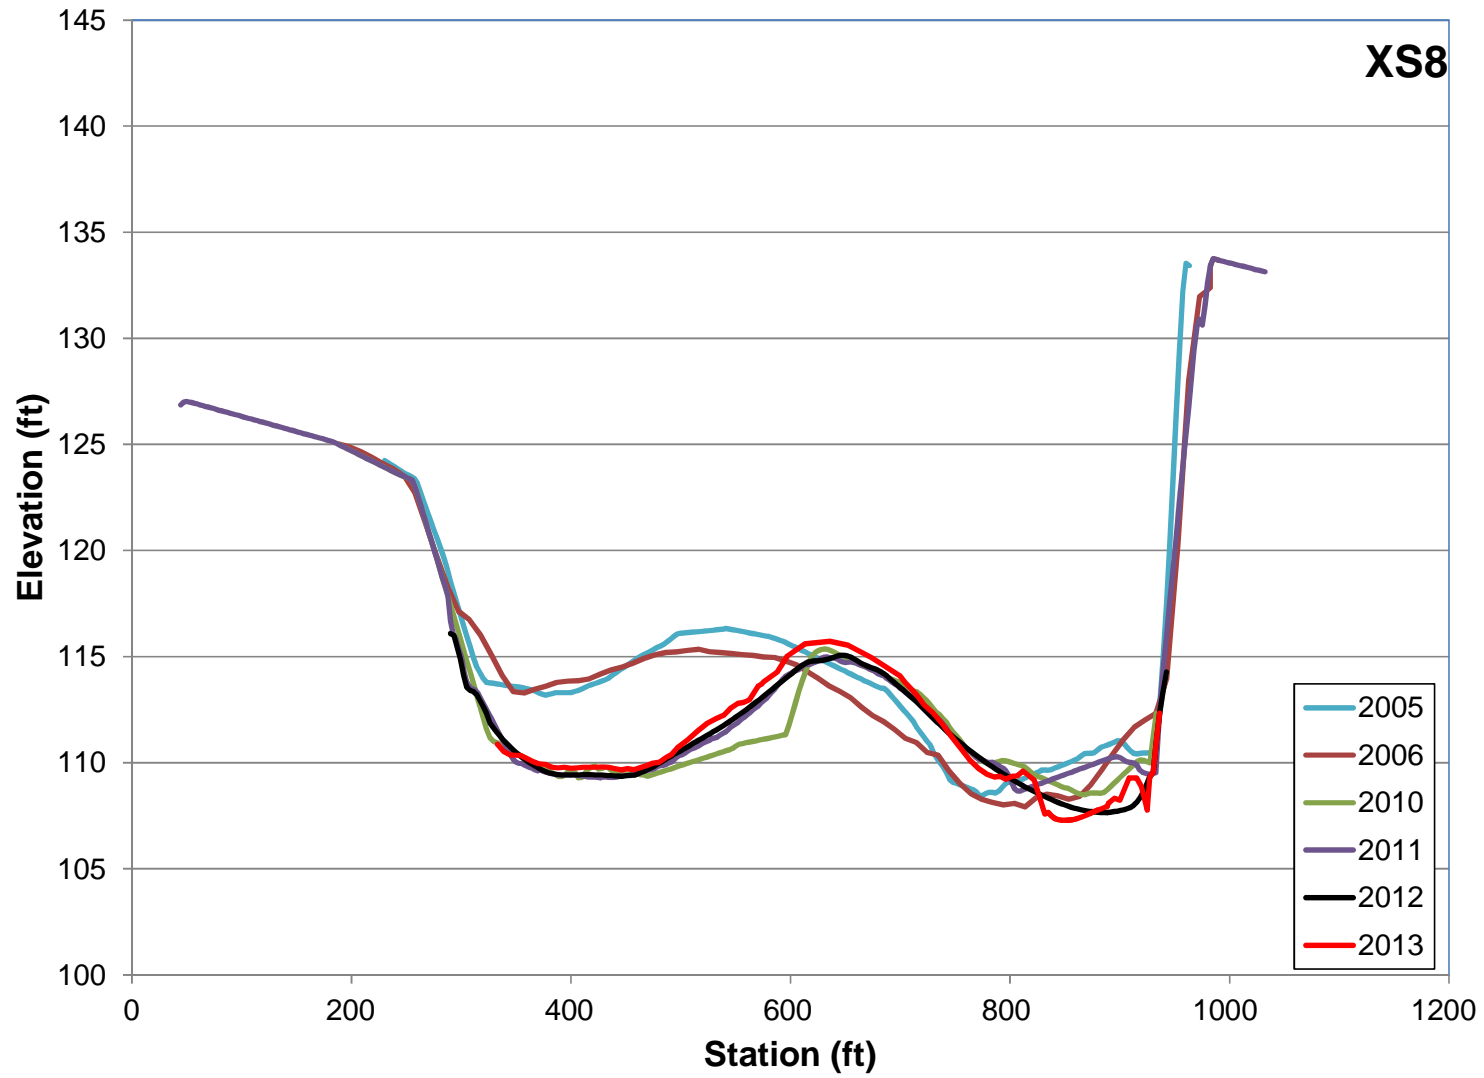
The comparative cross sections indicate that there has been up to 1 foot of aggradation on the mid-channel bar at Sta 635. The 2013 survey shows there has been little or no change in bed elevation in the channel located to the left of the mid-channel bar compared to 2012 (**Figure 28**). The 2013 show small bed changes near the right bank, with approximately 0.5 feet of degradation in the vicinity of Sta 850 and approximately 0.5 feet aggradation near the right bank (~Sta 910).

Figure 28. Comparative cross-section plots, 2005 to 2012 across the area that was dredged in 2007.
