MEMORANDUM

TO: Jim Well, Ducks Unlimited
FROM: Mike Harvey, Ph.D., P.G.
SUBJECT: **M&T/ Llano Seco Fish Screen Facility Short-Term/Long-Term Protection Project (Project No. US-CA-62-2)**
Maintenance Inspection and Reports (Subtask 14.1)
Inspection Report No.1

Cc:
DATE: November 29, 2010

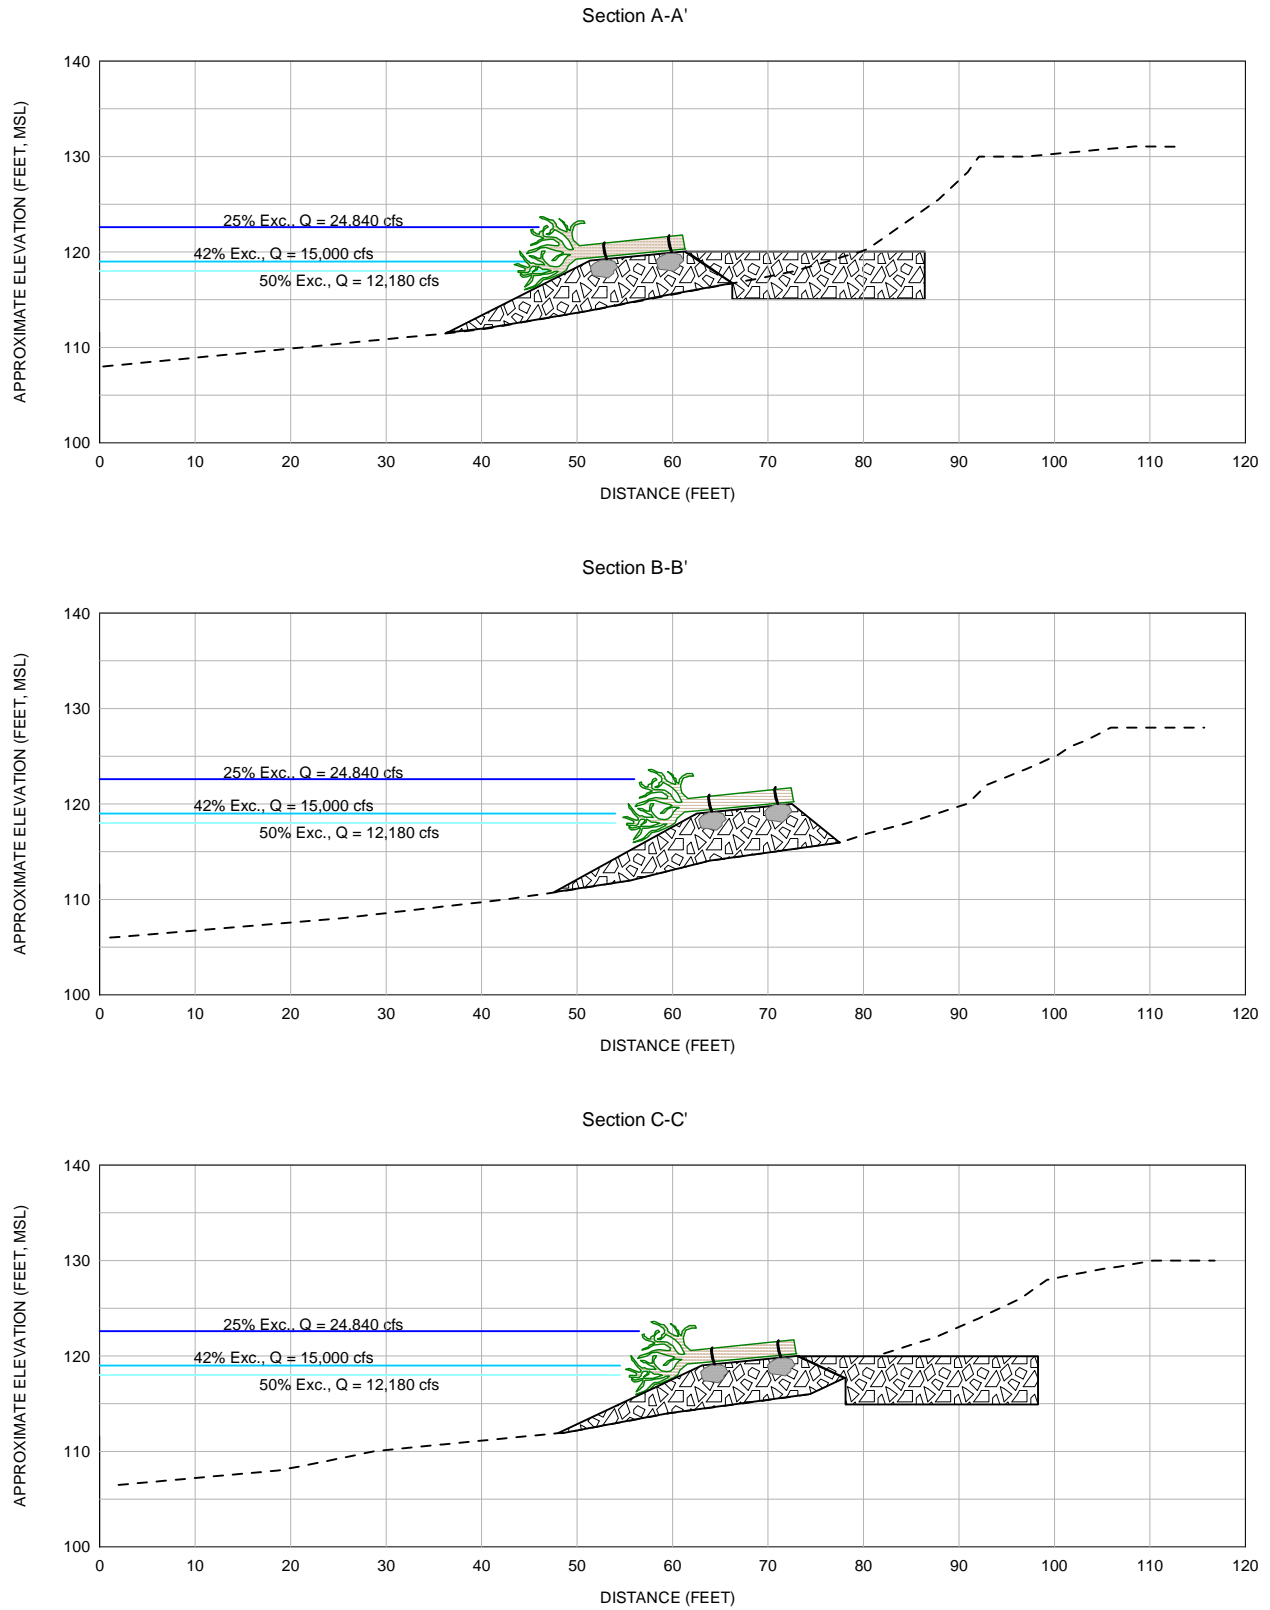
Figure 6. Typical sections of the rock-toe/brush revetment showing design flows and elevations.

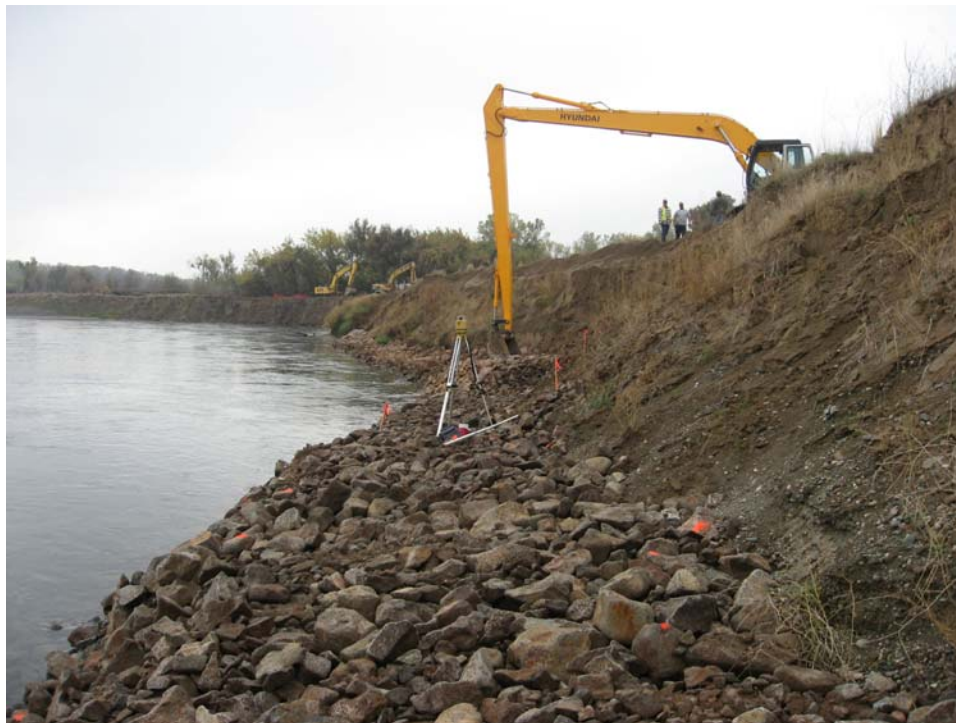
Figure 7. View downstream of the rock toe being emplaced during construction of the revetment. The top of the rock is at Elevation 119 feet (Photo taken on 10/30/2007).

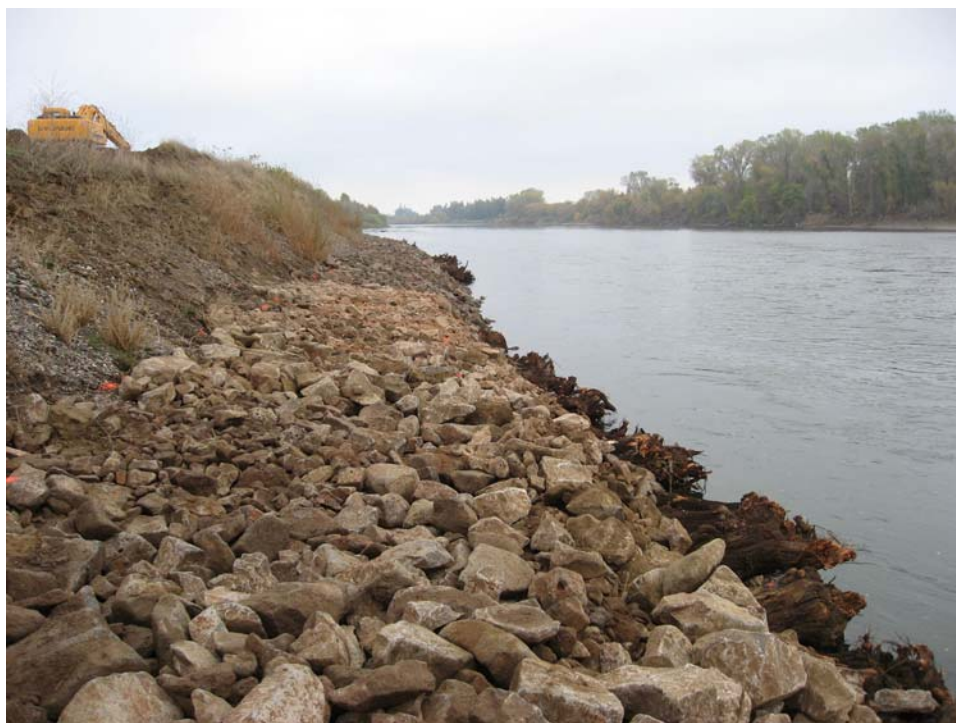
Figure 8. View upstream of the rock toe being emplaced during construction of the revetment. Note the woody material incorporated into the revetment at about Elevation 117 feet (Photo taken on 10/30/2007).

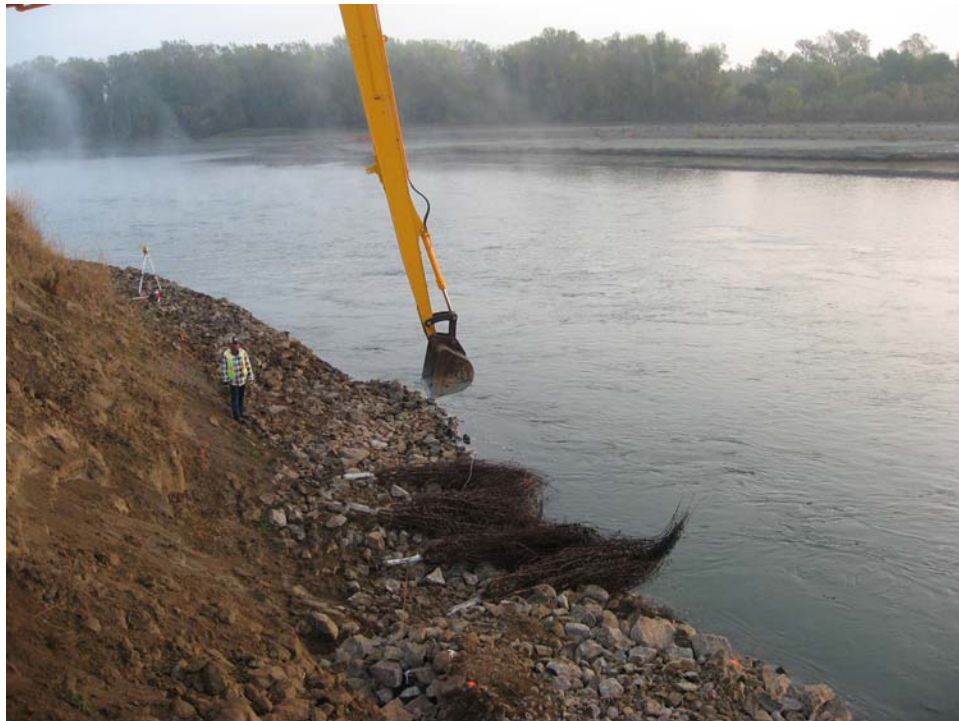
Figure 9. View of woody material being placed on the top of the revetment at about Elevation 119 feet during construction of the revetment (Photo taken on 10/30/2007).

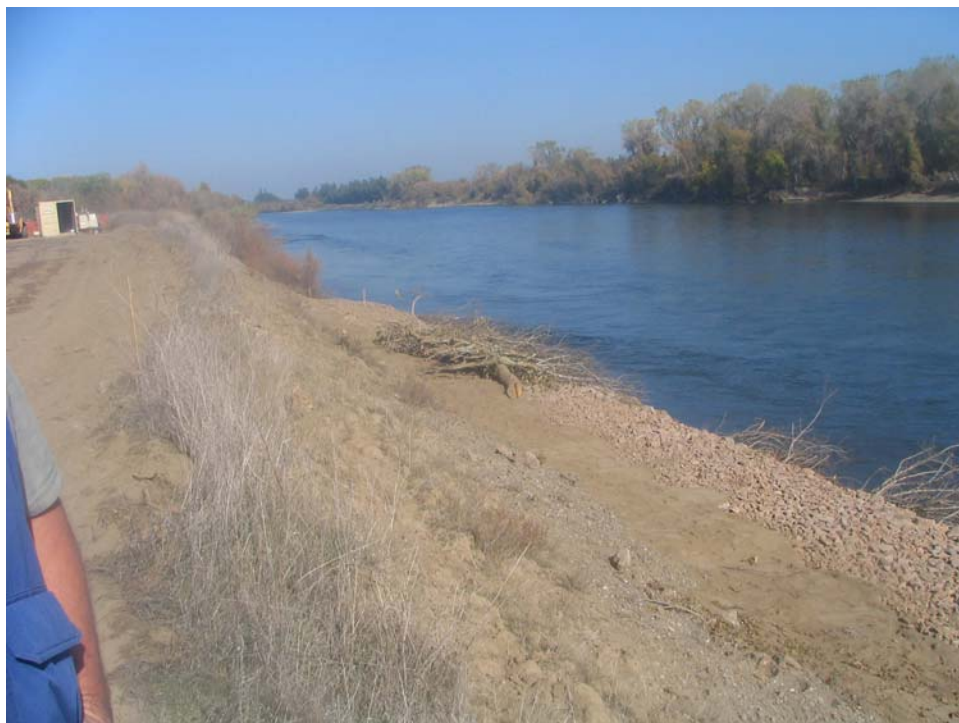
backfilled with spoils from the tie-back excavations to prevent any entrapment of fish (**Figures 7 through 10**).

Figure 10. View upstream of backfill in place between the rock revetment and the bank slope during construction (Photo taken 10/30/2007).
