TO: Jim Well, Ducks Unlimited
FROM: Mike Harvey, PhD, PG
SUBJECT: **M&T/ Llano Seco Fish Screen Facility Short-Term/Long-Term Protection Project (Project No. US-CA-62-2)**
Maintenance Inspection and Reports (Subtask 14.1)
Inspection Report No.2

DATE: May 8, 2012

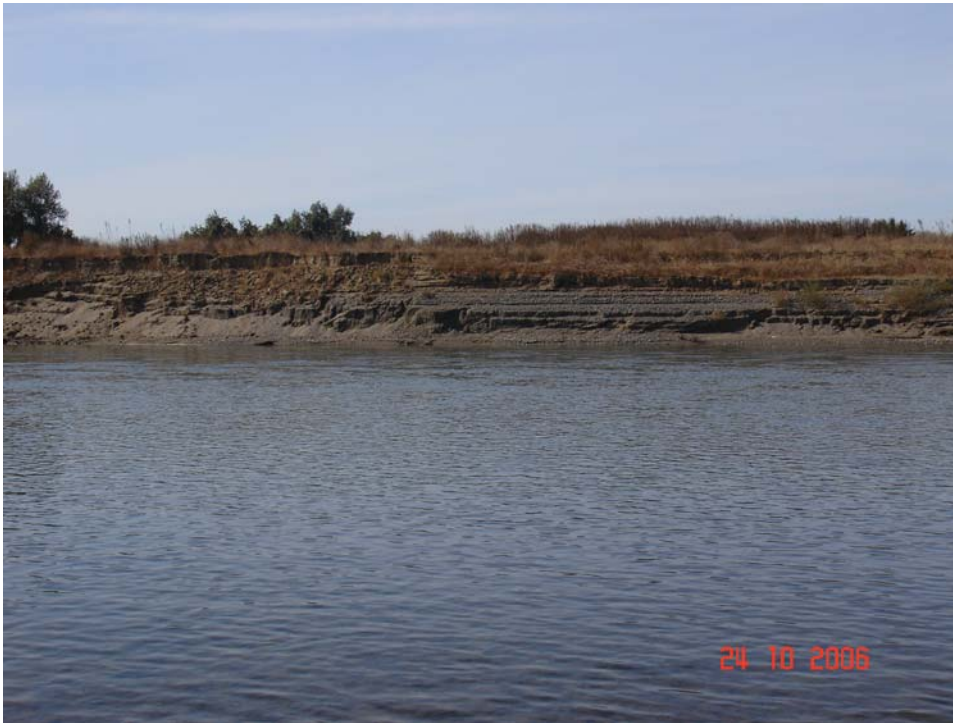
Figure 1. Photograph of the upstream end of the site prior to construction of the rock-toe/brush revetment (Photo taken on 10/24/2006).

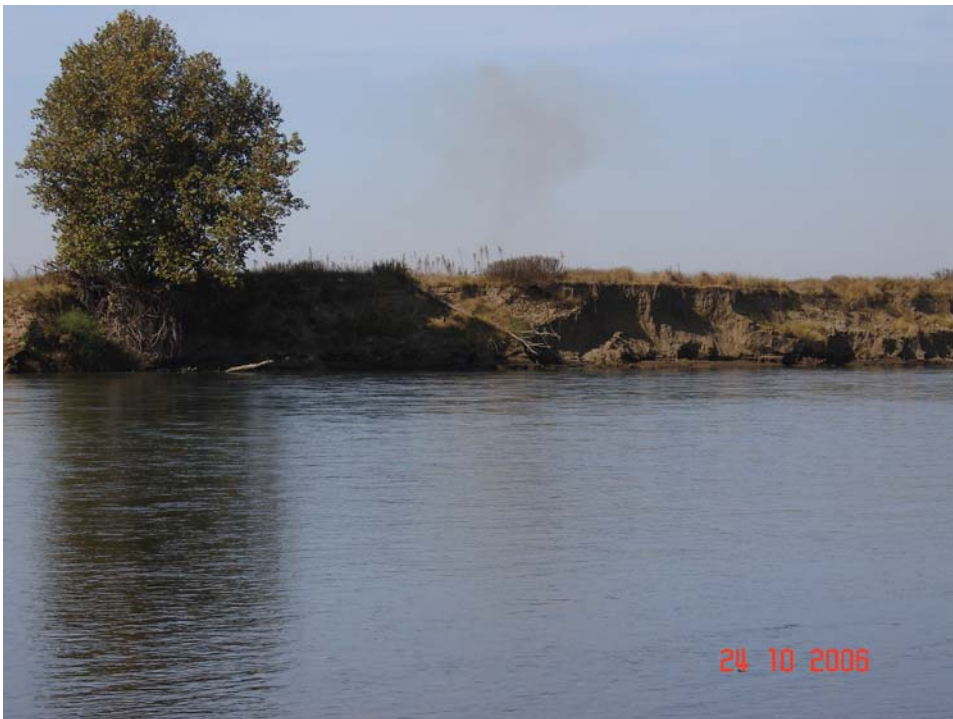
Figure 2. Photograph of the middle part of the site prior to construction of the rock-toe/brush revetment (Photo taken on 10/24/2006).

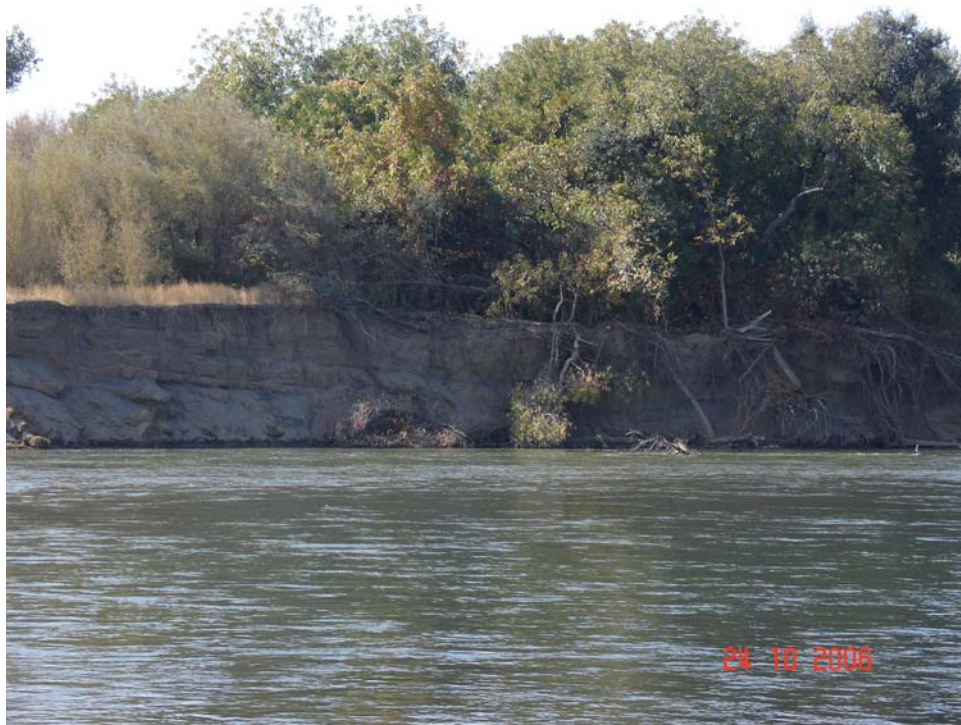
Figure 3. Photograph of the apex of the eroding bend prior to construction of the rock-toe/brush revetment (Photo taken on 10/24/2006).

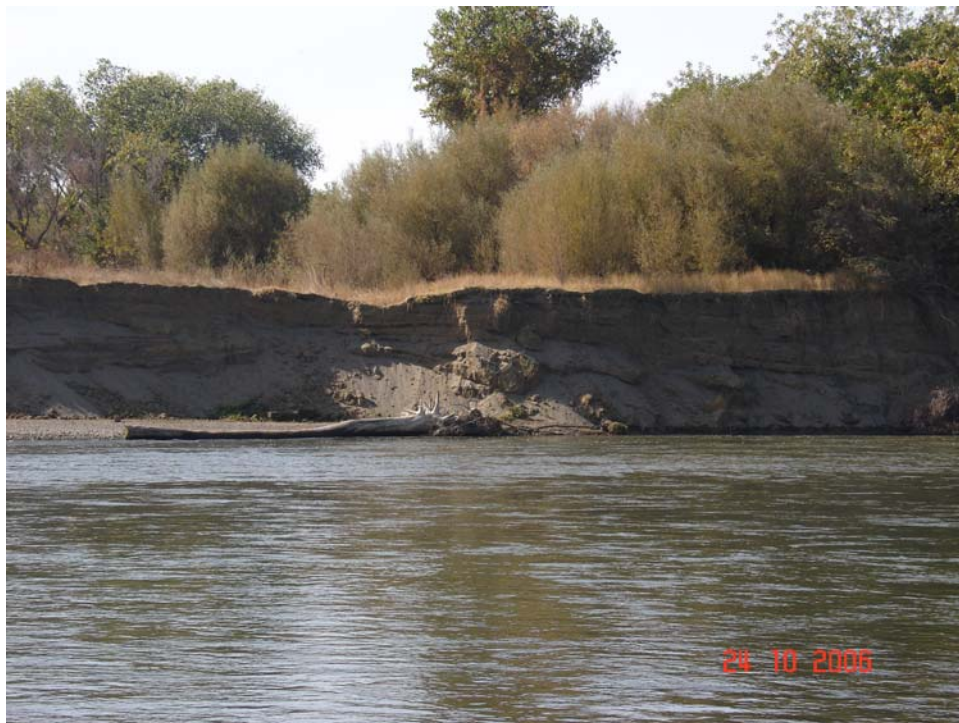
Figure 4. Photograph of the middle part of the downstream part of the site prior to construction of the rock-toe/brush revetment (Photo taken on 10/24/2006).

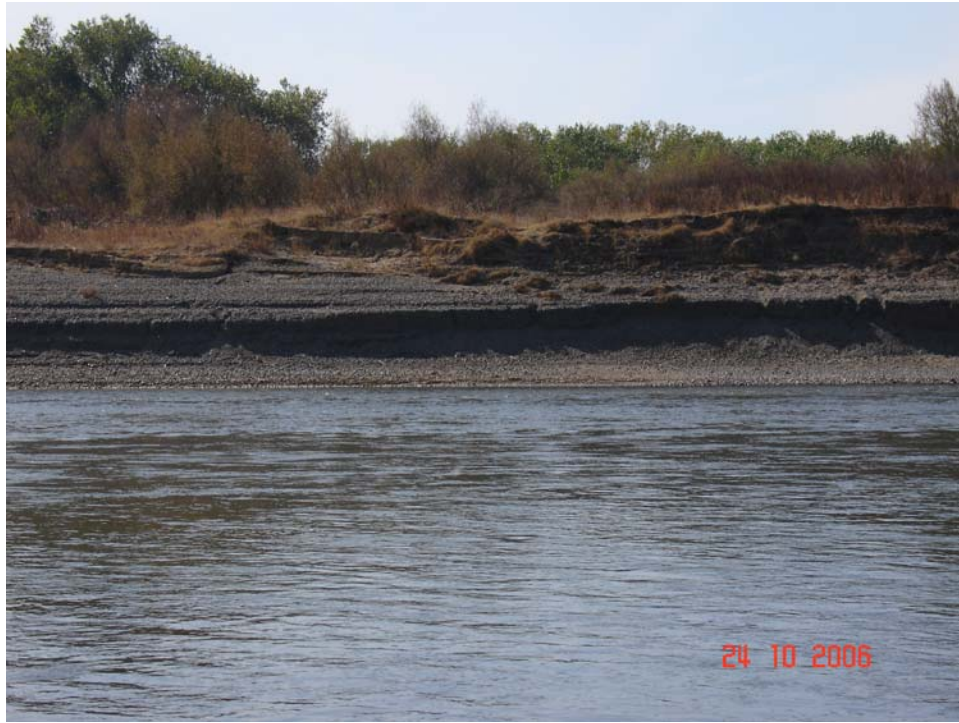
Figure 5. Photograph of the downstream end of the site prior to construction of the rock-toe/brush revetment (Photo taken on 10/24/2006).

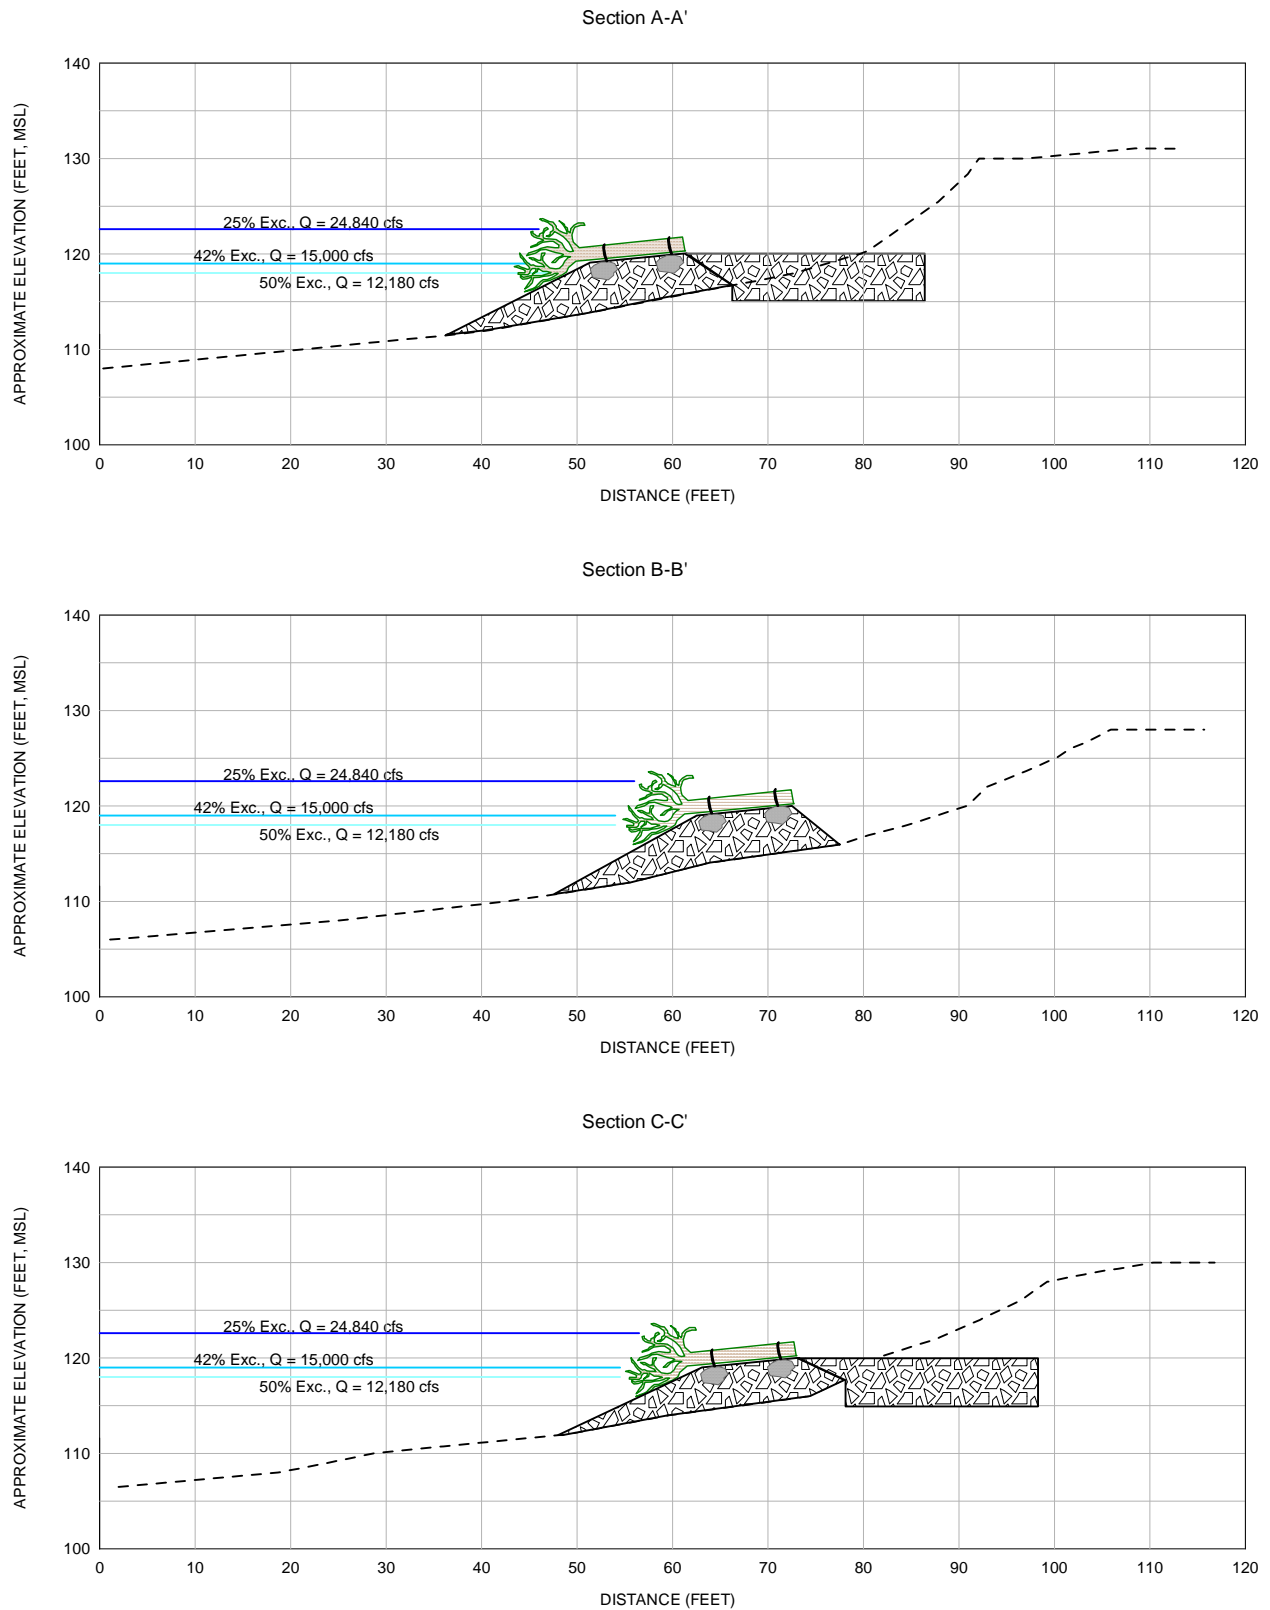
Figure 6. Typical sections of the rock-toe/brush revetment showing design flows and elevations.

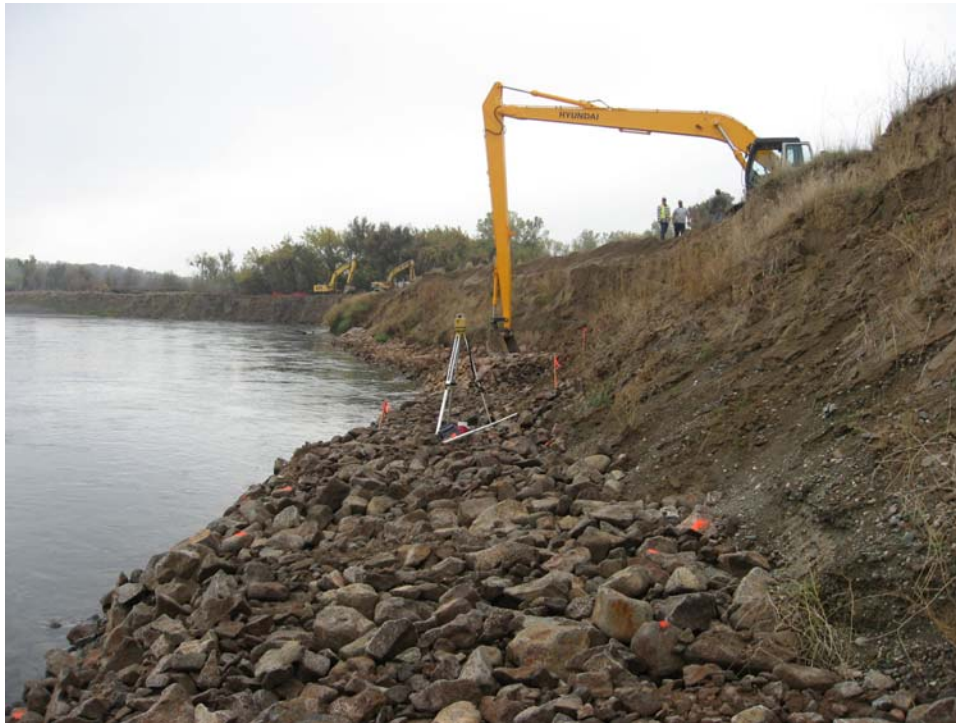
Figure 7. View downstream of the rock toe being emplaced during construction of the revetment. The top of the rock is at Elevation 119 feet (Photo taken on 10/30/2007).

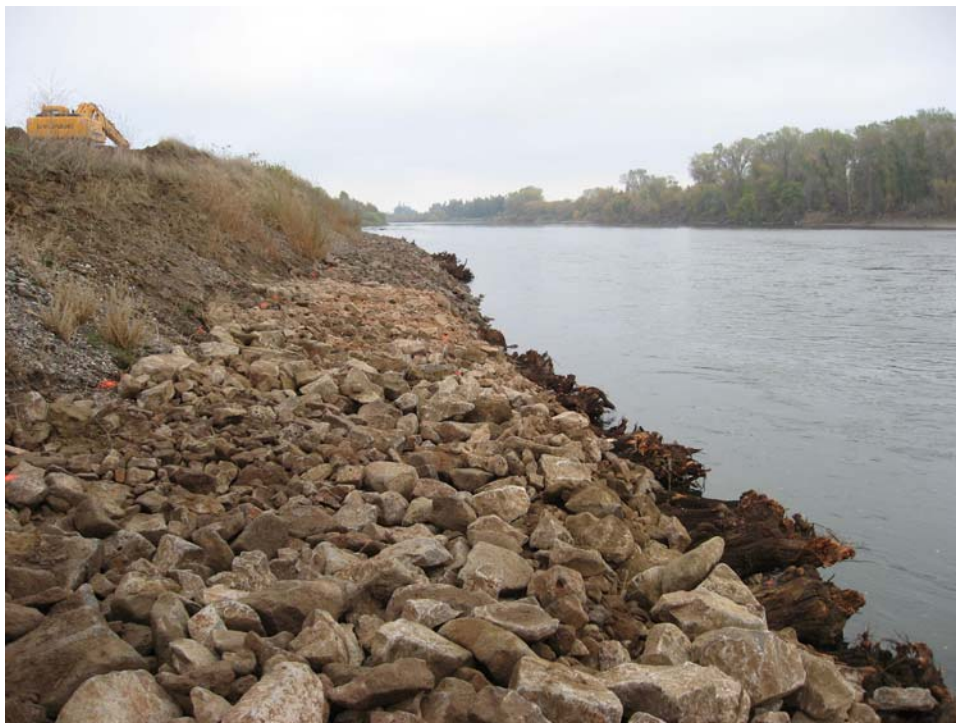
Figure 8. View upstream of the rock toe being emplaced during construction of the revetment. Note the woody material incorporated into the revetment at about Elevation 117 feet (Photo taken on 10/30/2007).

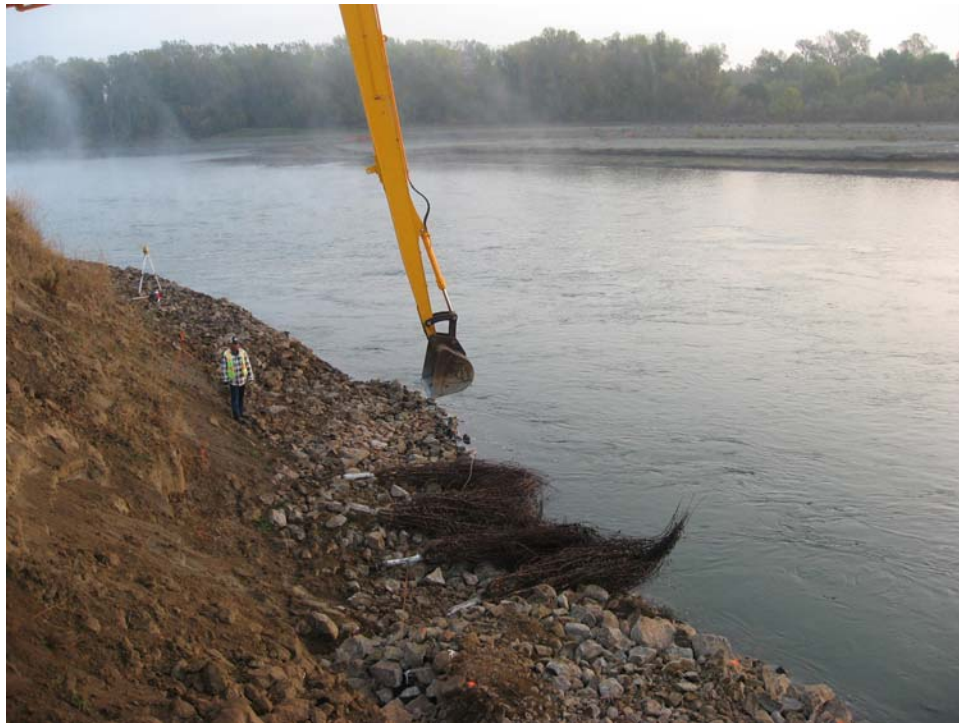
Figure 9. View of woody material being placed on the top of the revetment at about Elevation 119 feet during construction of the revetment (Photo taken on 10/30/2007).

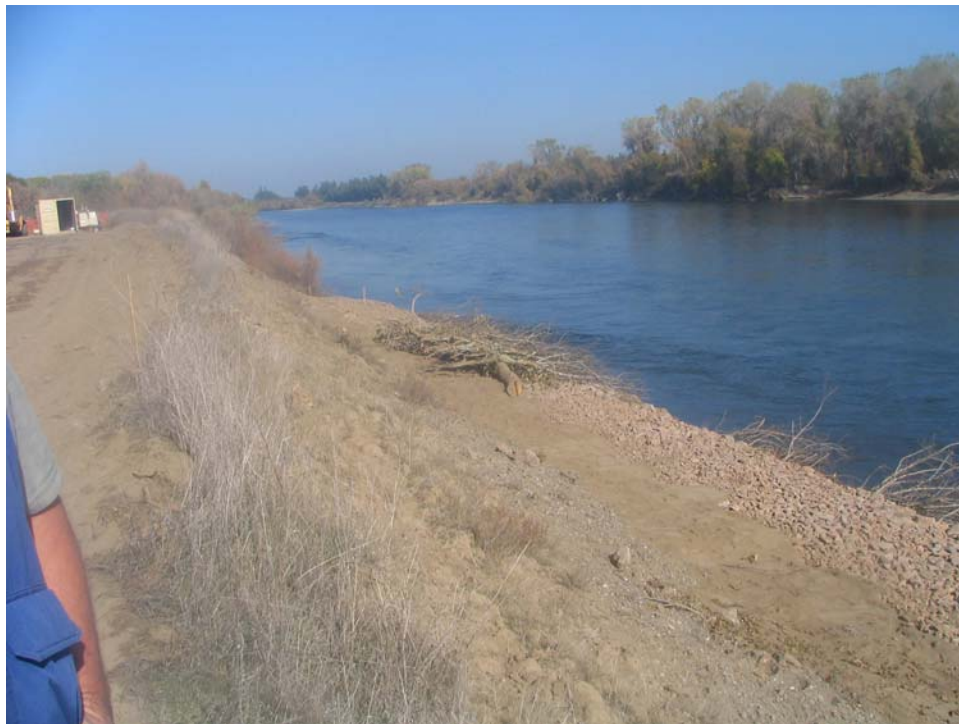
Figure 10. View upstream of backfill in place between the rock revetment and the bank slope during construction (Photo taken 10/30/2007).

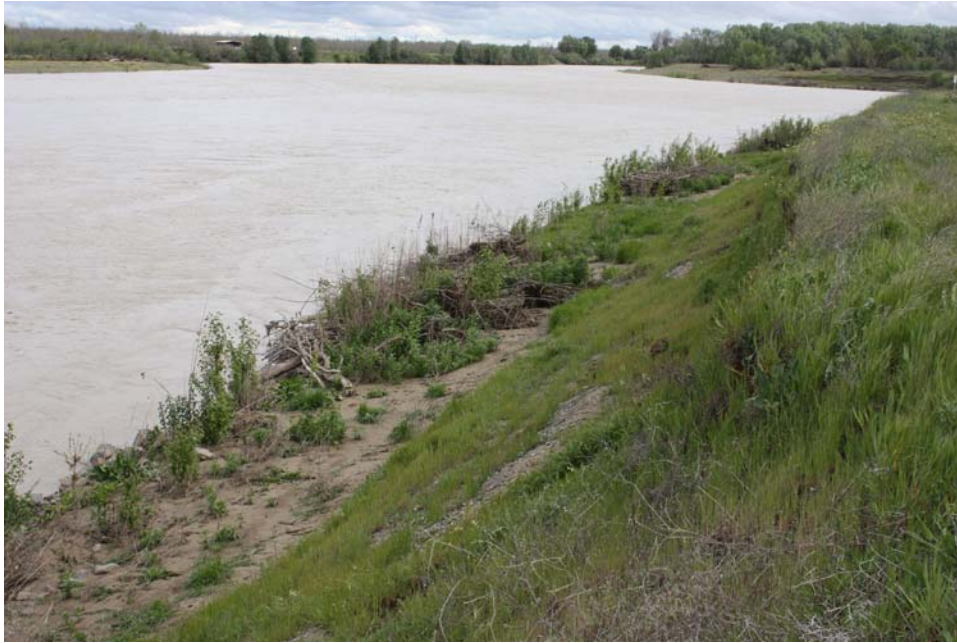
Figure 18. View downstream of the top of the revetment showing the woody debris piles that were placed and cabled onto the revetment. Flow in the river was about 11,000 cfs (Photo taken on 04/12/2010).
