TO: Jim Well, Ducks Unlimited

FROM: Mike Harvey, Ph.D., P.G.

SUBJECT: **June 7-9, 2011 Resurvey of M&T/Llano Seco Pumping Plant and City of Chico Outfall Reach of the Sacramento River**

DATE: July 11, 2011

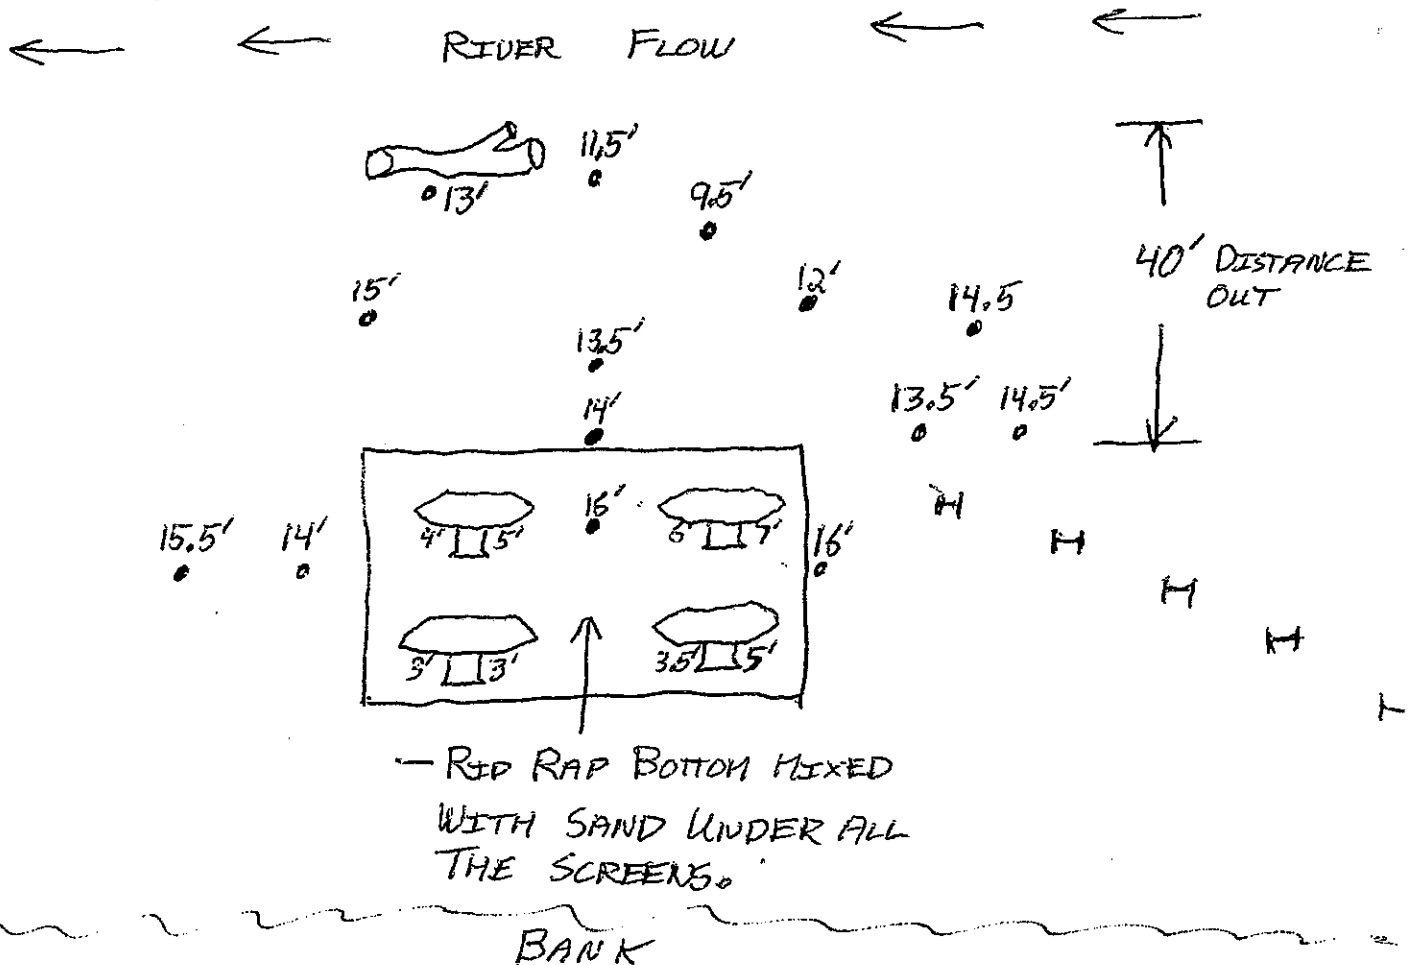
Readings taken on 4-9-09

- 1 – No major winter damage was found. Screens and surrounding protective structures were found to be in tact. No holes were found and screen integrity was found to be intact.
- 2 – Screen #1 average clearance 4' to gravel and rip-rap bottom.
Screen #2 average clearance 3' to gravel bottom.
Screen #3 average clearance 5.5' to 6' to rip-rap bottom.
Screen #4 average clearance 5' to gravel and rip-rap bottom.
- 3 – Diver traveled West from fish screen structure. The encroaching gravel bar began a slight downward gradient continuing to the West. The bottom leveled off 20' West of the structure and about 1.5' lower than the screen structure bottom elevation. Diver reported that the bottom appeared to continue flat to the West.

5 – Fasteners were checked and no loose hardware was found.

6 - Both buoys need to be replaced this year.
