TO: Jim Well, Ducks Unlimited

SUBJECT: **June 26, 2012 Resurvey of M&T/Llano Seco Pumping Plant and City of Chico Outfall Reach of the Sacramento River**

DATE: July 16, 2012

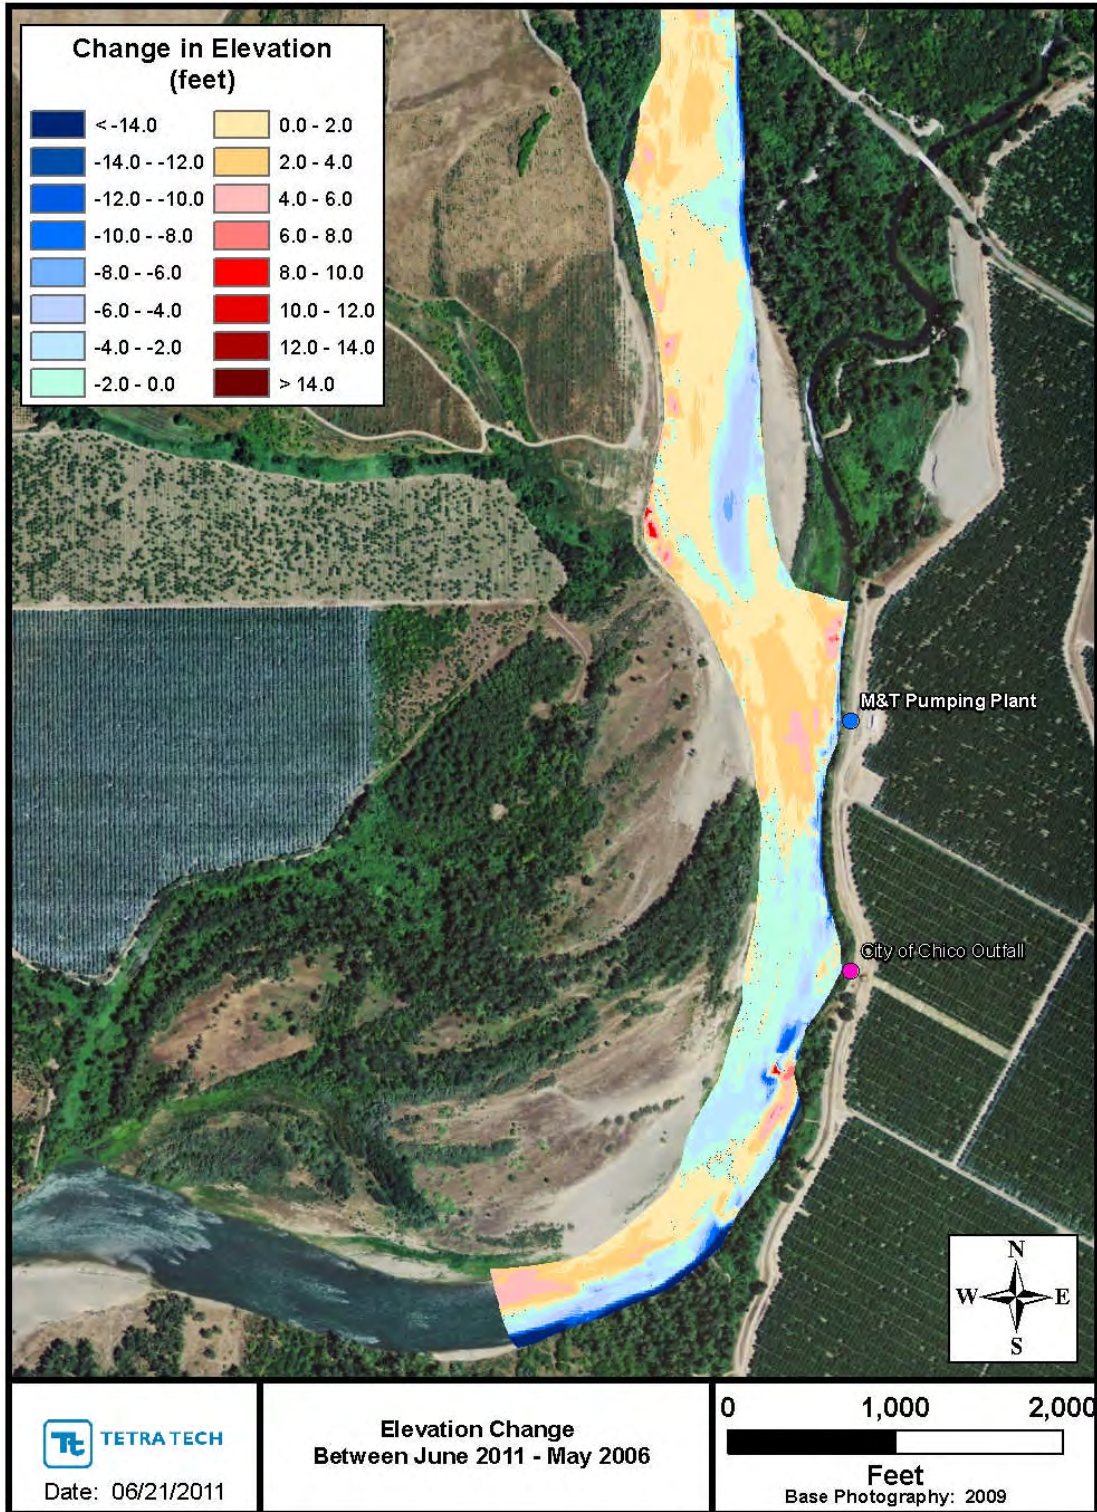
Figure 2 presents the changes in elevation of the bed of the river within the M&T/Llano Seco reach between the 2010 and 2006 surveys. The comparison indicates that there had been significant aggradation (4 to 10 feet) in the vicinity of the pumps which was supported by observations of the river under low-flow conditions. The location of the 2007 gravel removal is clearly visible (-4 to -6 feet) along the left (east) bank of the river upstream of the pumping plant and adjacent to Bidwell State Park. **Figure 3** presents the changes in bed elevation between the 2011 survey and the 2006 survey. It is apparent that the amount of deposition in the vicinity of the pumping plant was reduced following the high flows in early 2011 (peak flow at Hamilton City was about 102,500 cfs), but there is still some aggradation when compared to the 2006 survey. **Figure 4** presents the differences in elevation of the bed of the river between the 2010 and 2011 surveys.

Figure 3. Elevation changes in the M&T/Llano Seco reach between the June 2011 and May 2006 surveys.

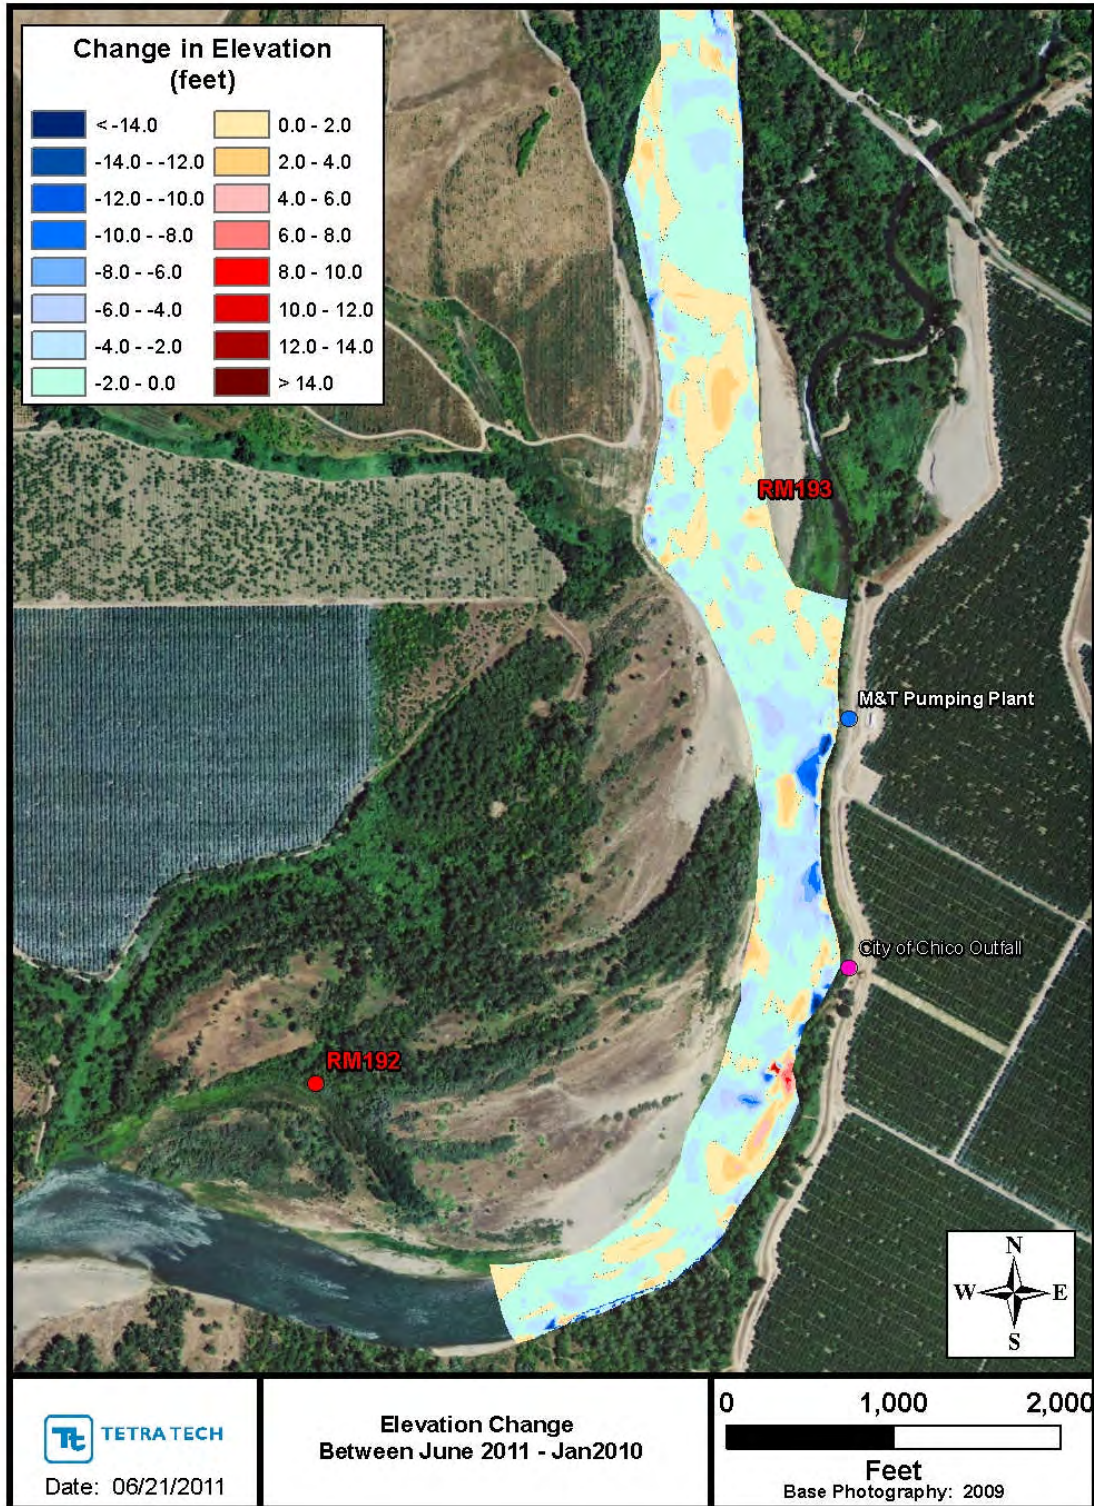
Figure 4. Elevation changes in the M&T/Llano Seco reach between the June 2011 and January 2010 surveys.

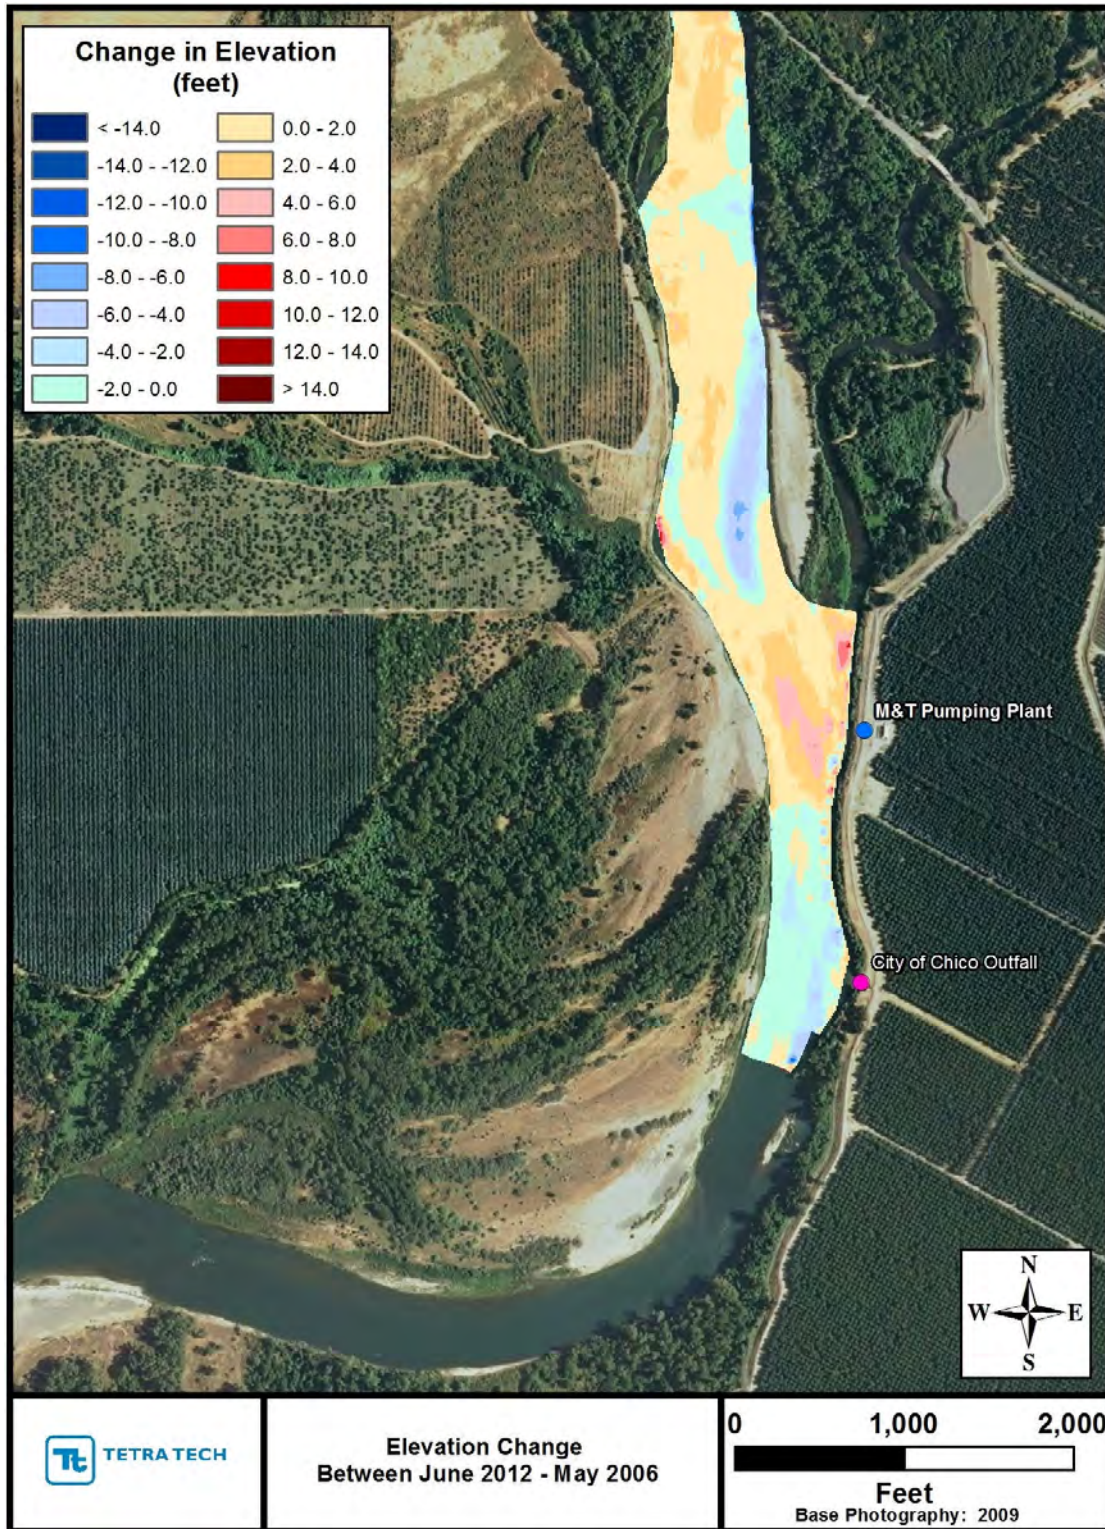
Figure 5 presents the changes in bed elevation between the 2011 survey and the 2012 surveys. The data indicate that there has been some additional aggradation in the vicinity of the pump intake as compared to the 2011 survey, which is likely due to the lack of significant peak flows during the 2012 spring runoff period (peak flow at Hamilton City was about 44,000 cfs). **Figure 6** presents the differences in elevation of the bed of the river between the 2012 and 2006 surveys, and demonstrates that the site is still net aggradational.

Figure 6. Elevation changes in the M&T/Llano Seco reach between the June 2012 and May 2006 surveys.

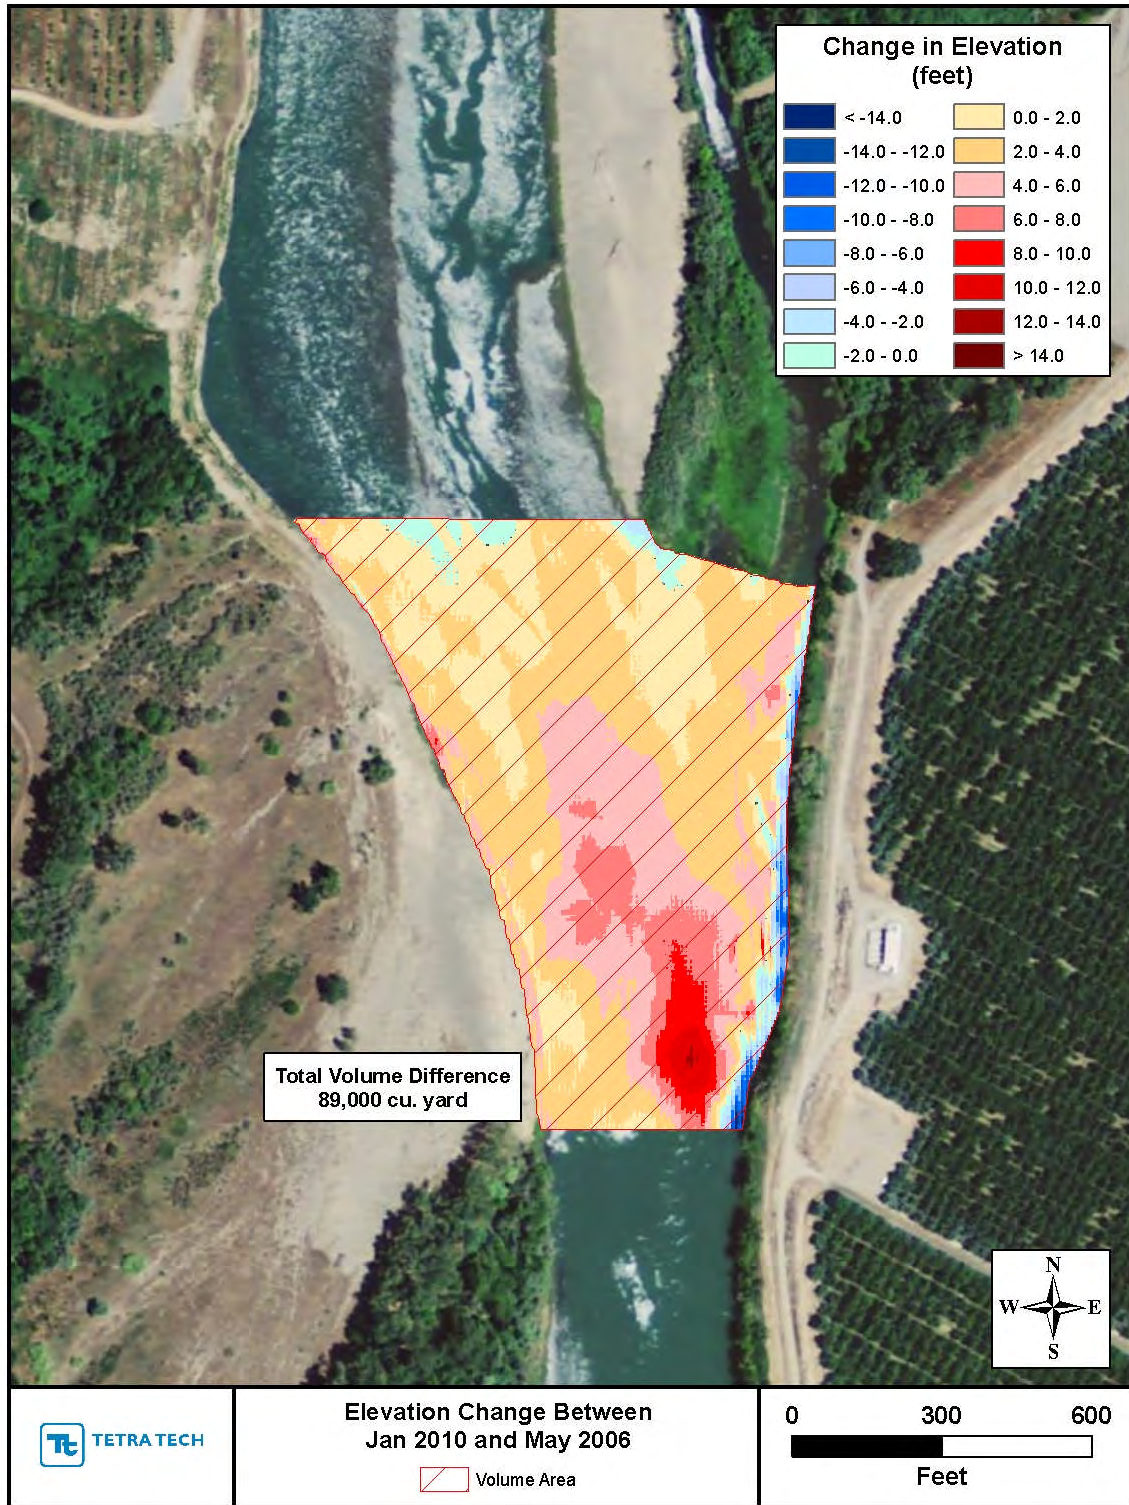
Figure 7. Volumetric calculation of the deposition in the 600- by 1,200-foot segment in the vicinity of the fish screens and pump inlets between the January 2010 and May 2006 surveys.

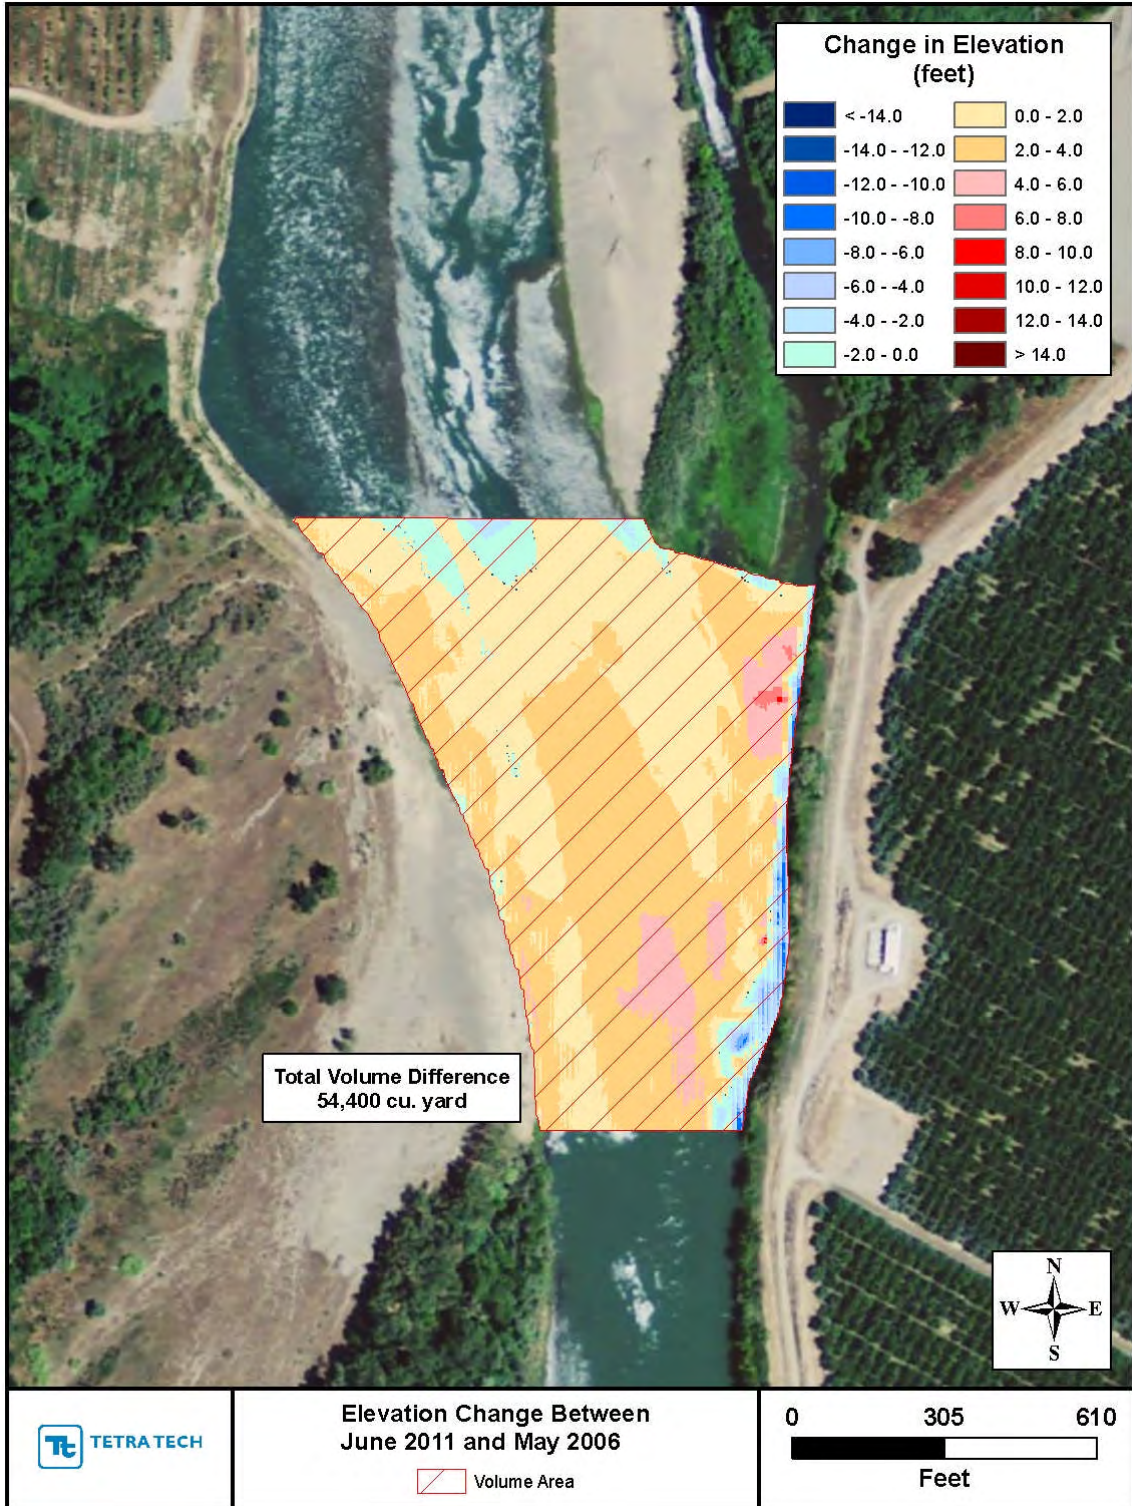
Figure 8. Volumetric calculation of the deposition in the 600- by 1,200-foot segment in the vicinity of the fish screens and pump inlets between the June 2011 and May 2006 surveys.

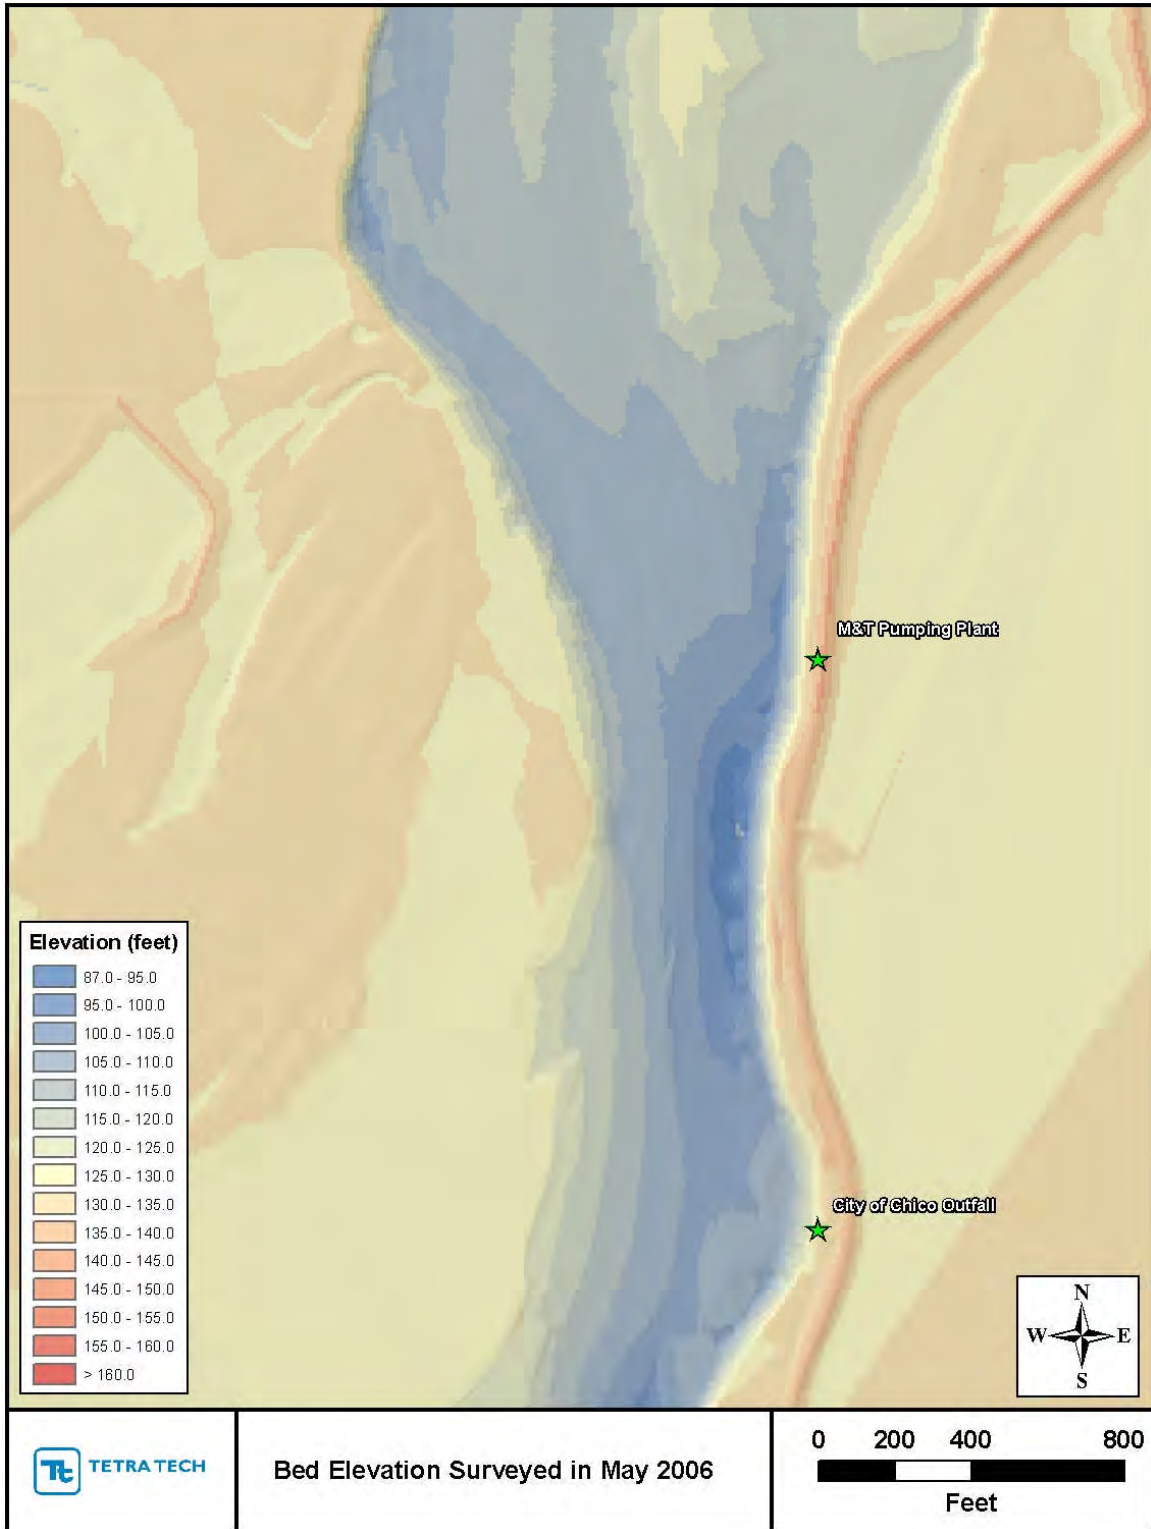
Figure 12. Color gradient plot showing the bed topography in the vicinity of the M&T/Llano Seco Pumping Plant and the relocated City of Chico Outfall in May 2006.

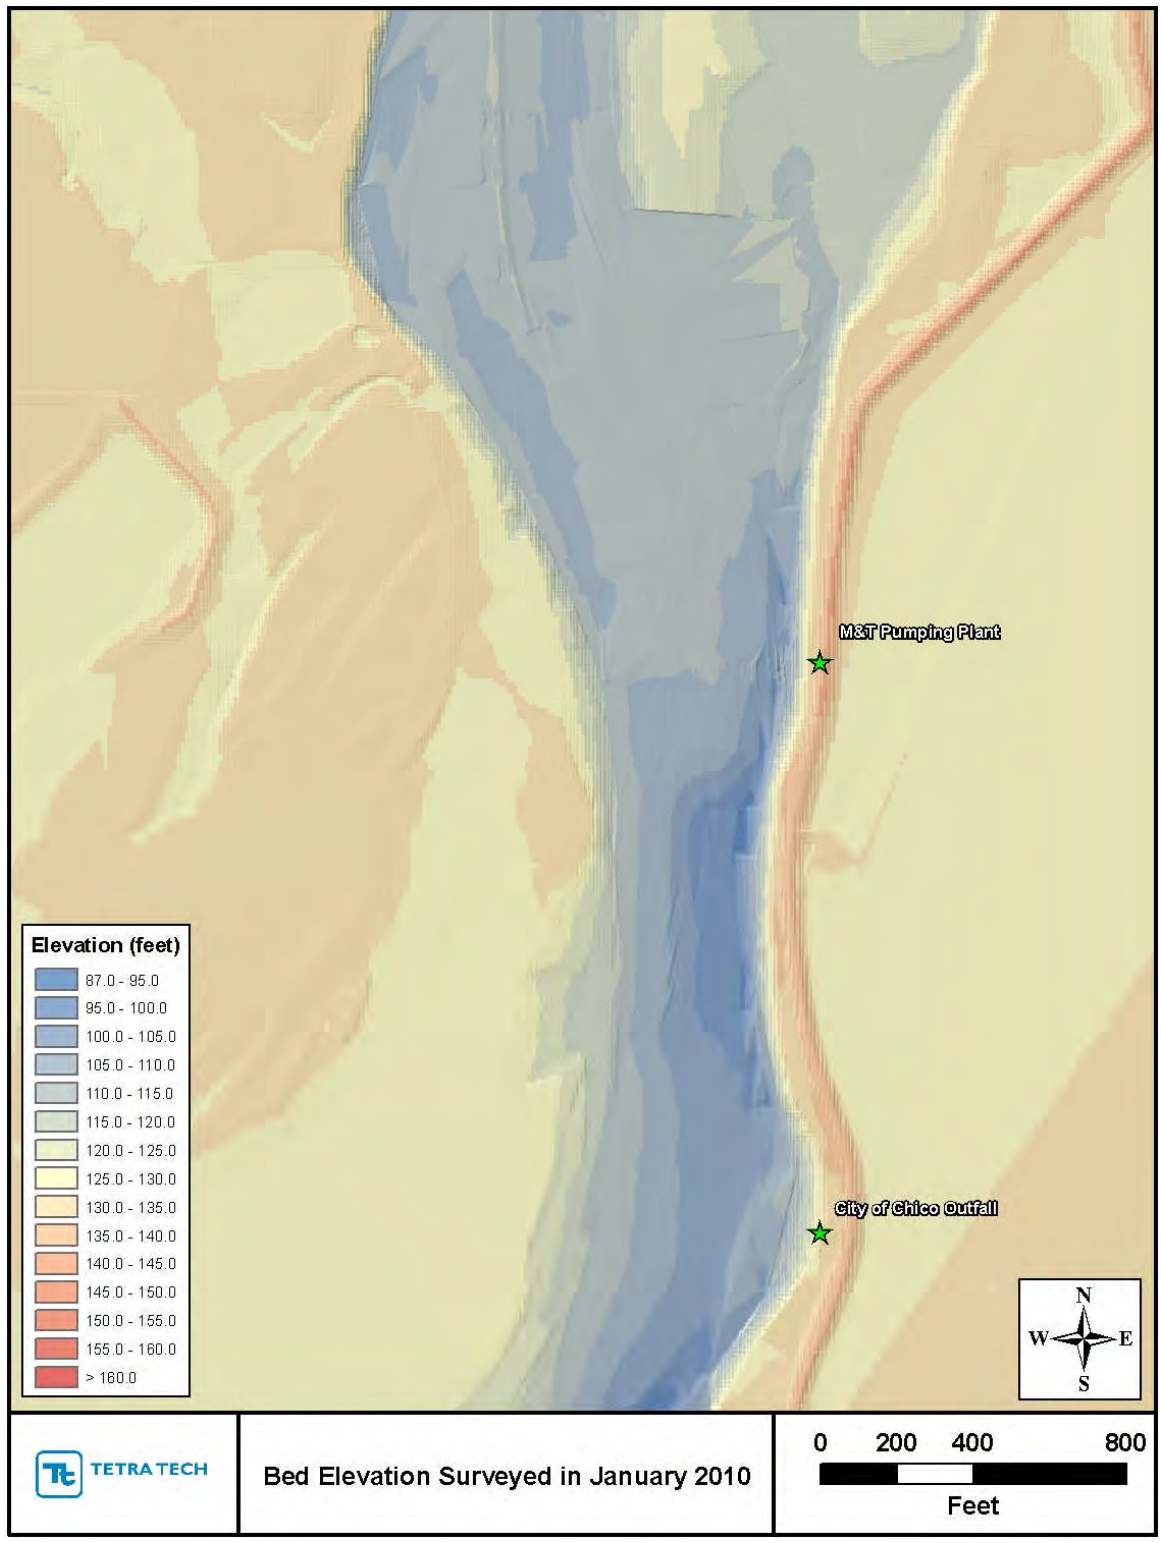
Figure 13. Color gradient plot showing the bed topography in the vicinity of the M&T/Llano Seco Pumping Plant and the relocated City of Chico Outfall in January 2010.

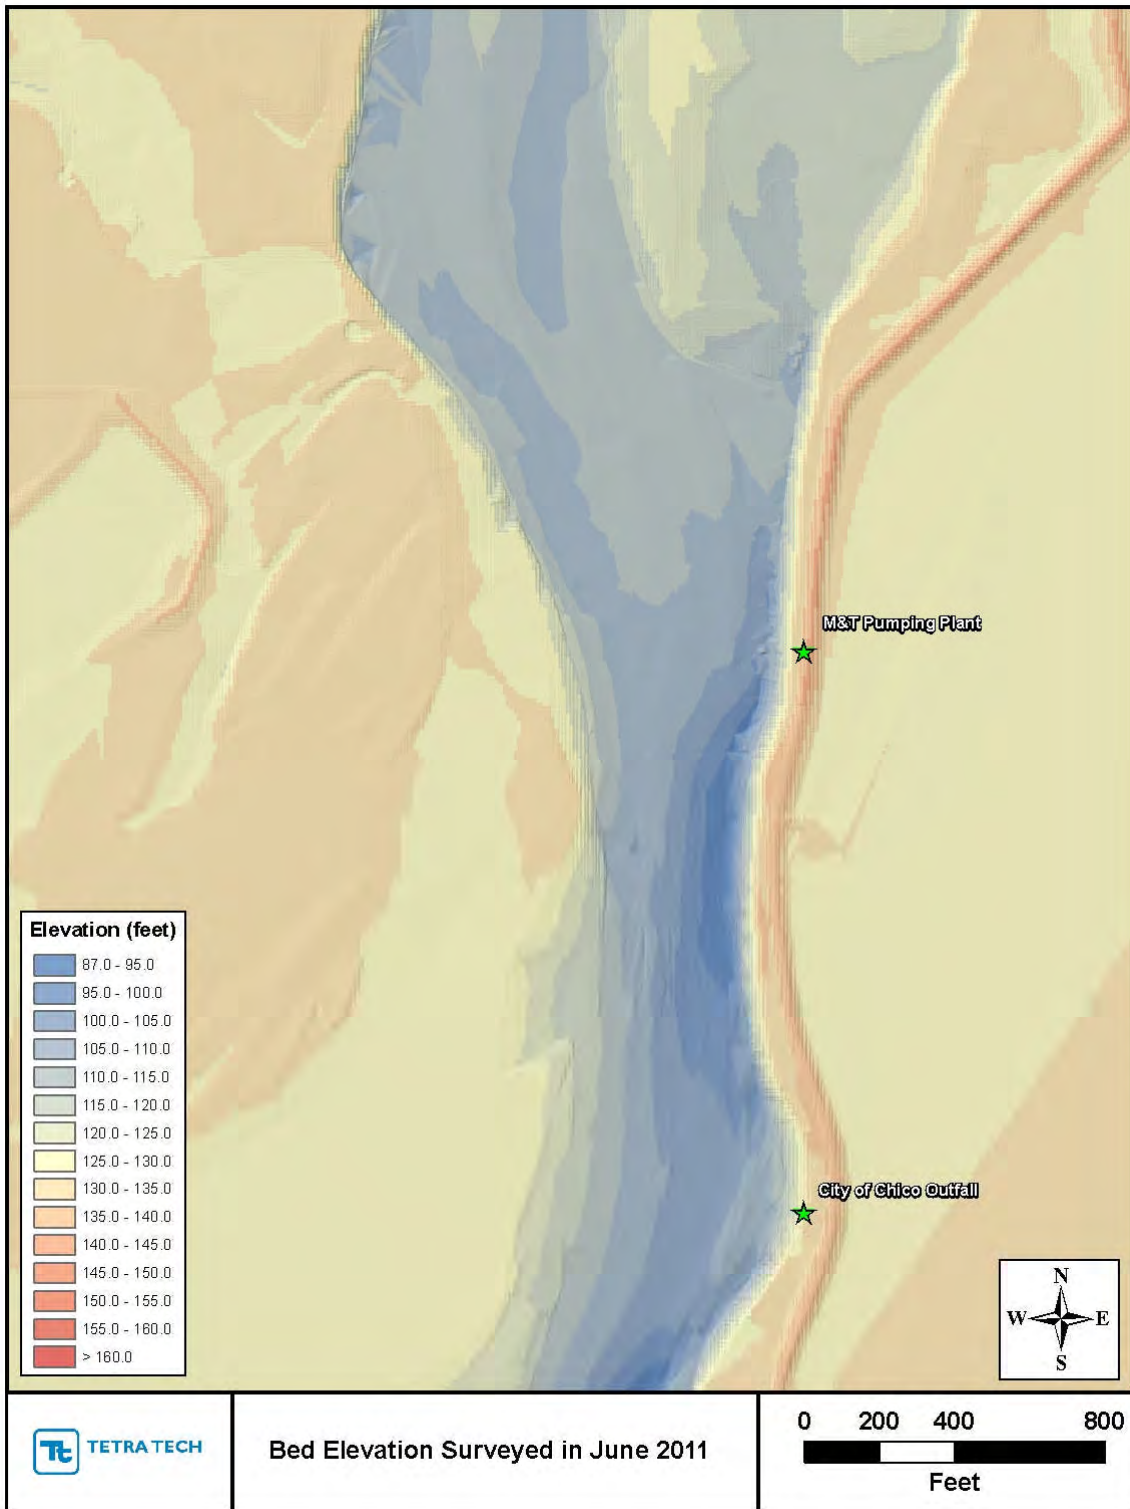
Figure 14. Color gradient plot showing the bed topography in the vicinity of the M&T/Llano Seco Pumping Plant and the relocated City of Chico Outfall in June 2011.

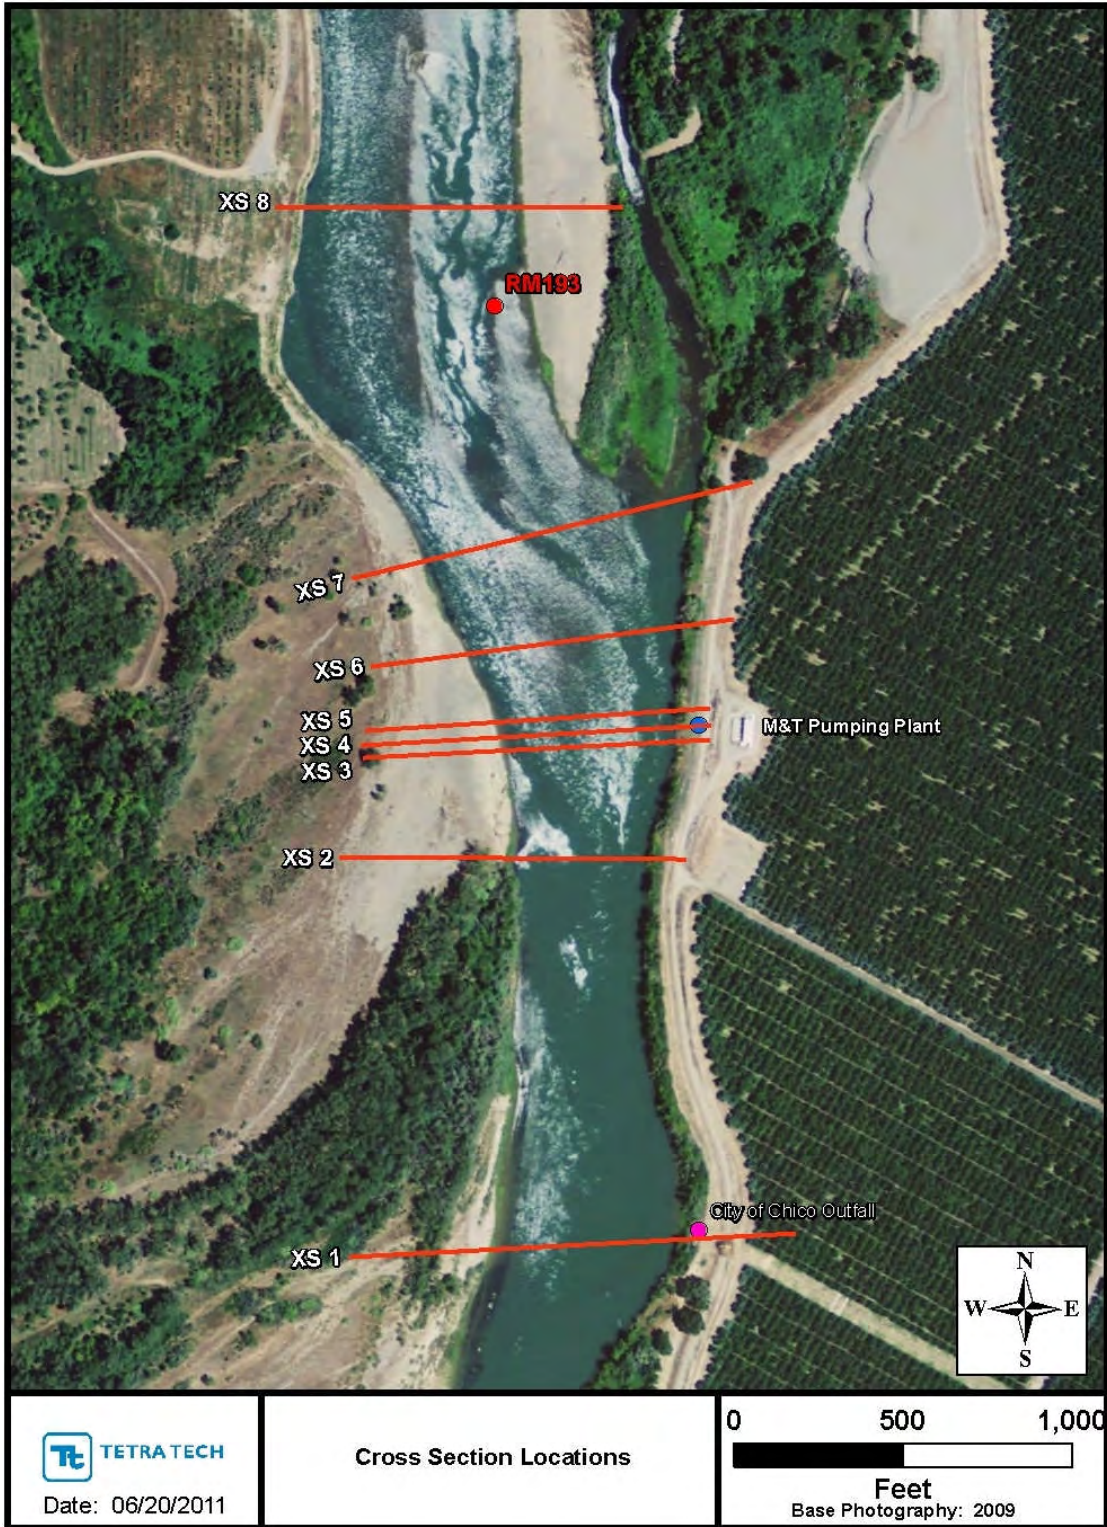
Figure 16. Locations of comparative cross sections discussed in the text.

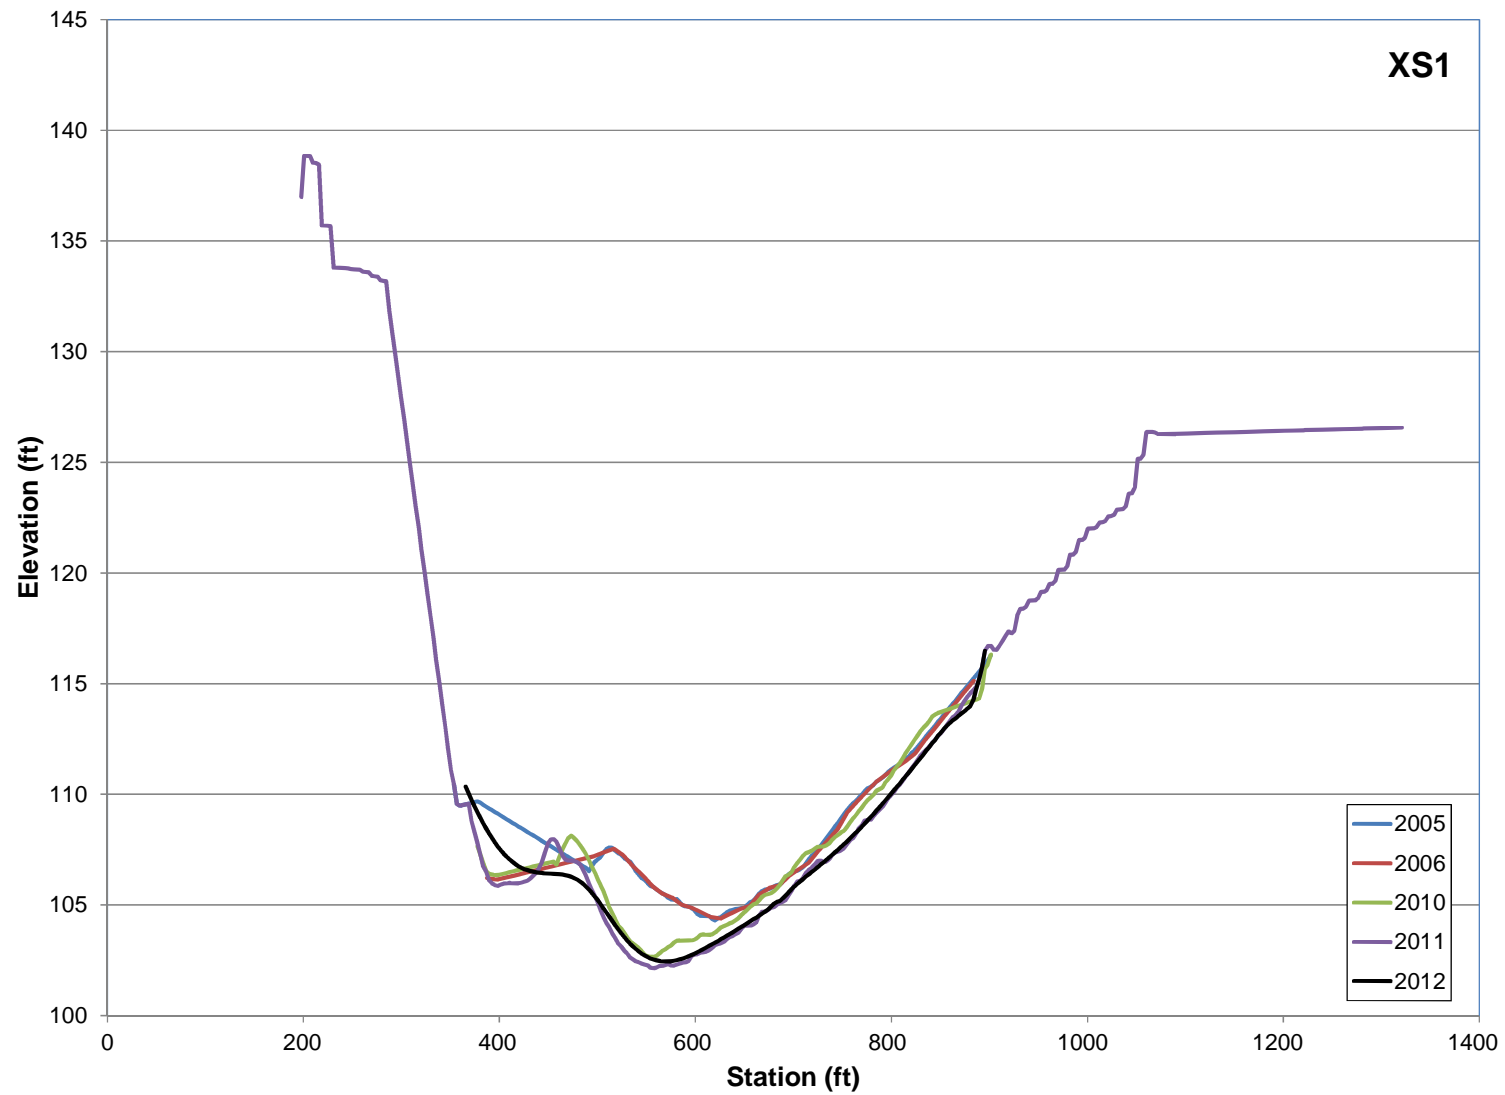
Figure 17. Comparative cross-section plots, 2005 to 2012 at the relocated City of Chico outfall.

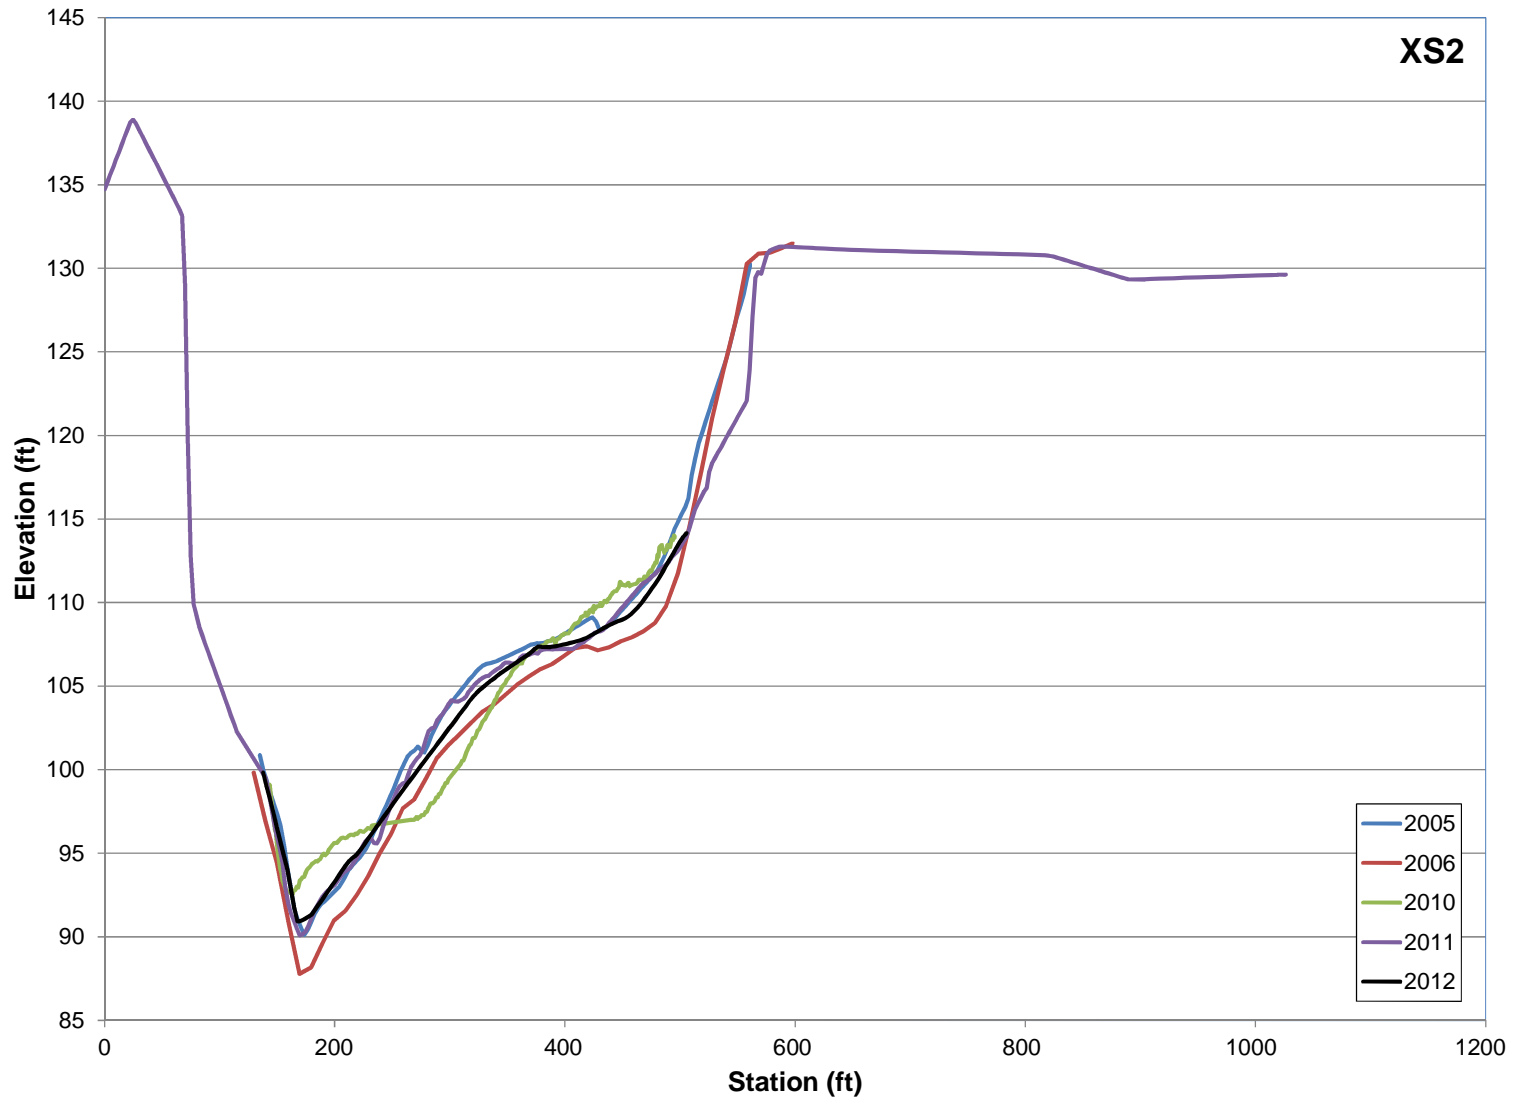
Figure 18. Comparative cross-section plots, 2005 to 2012 at the original City of Chico outfall.

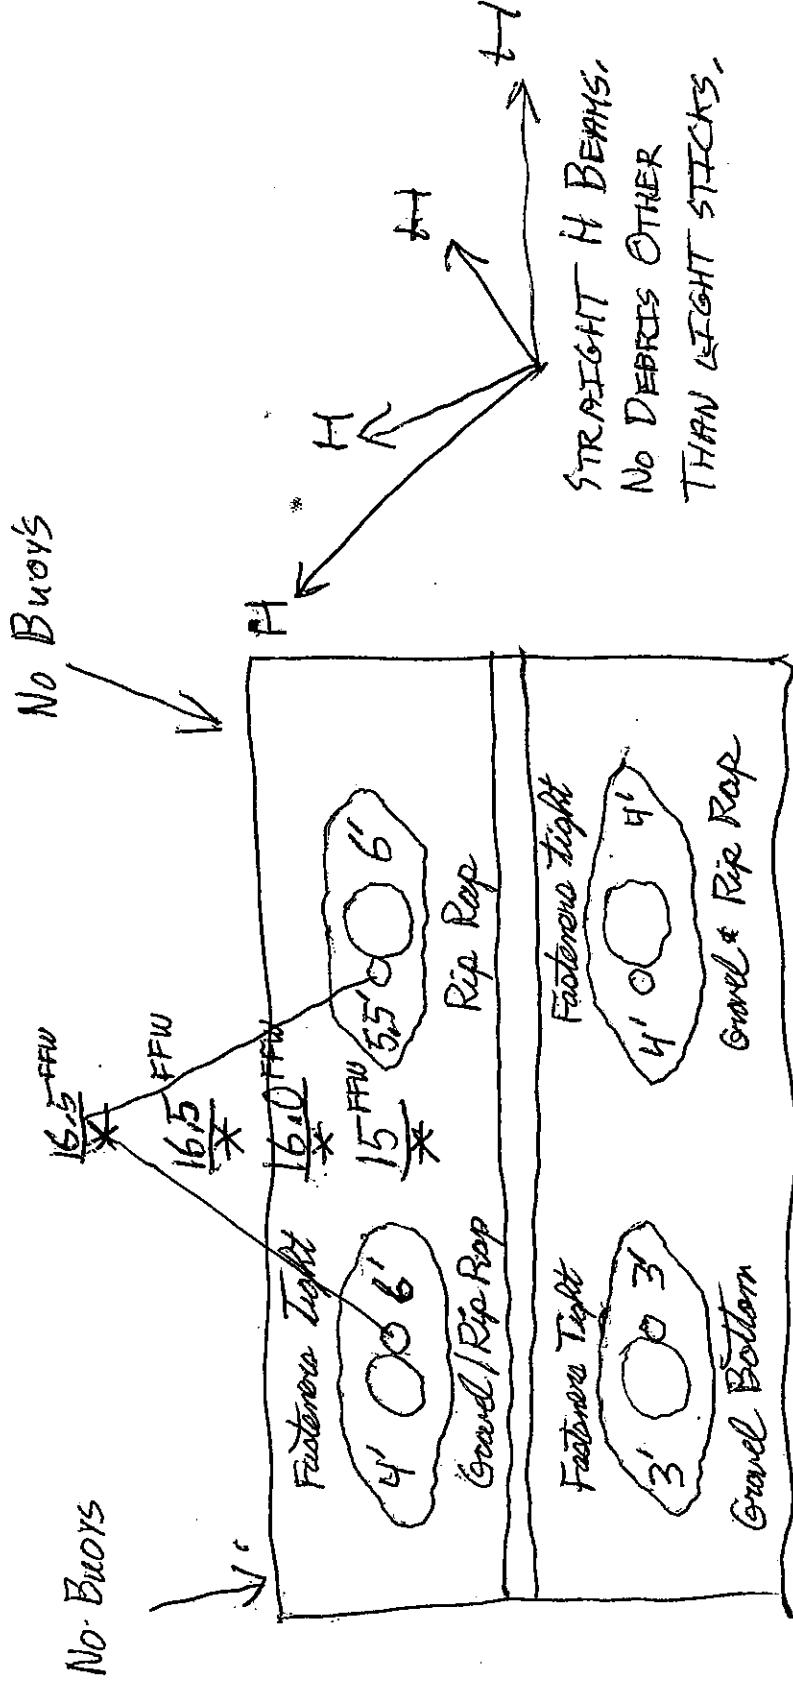
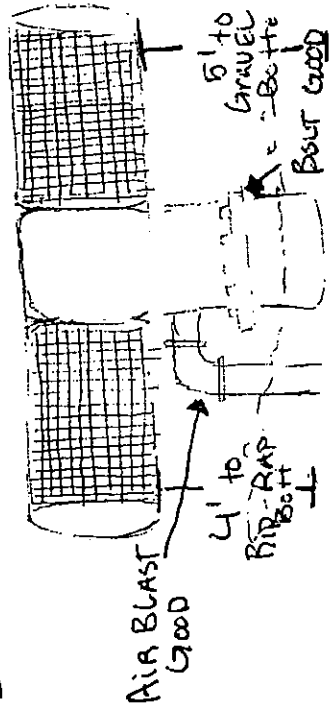
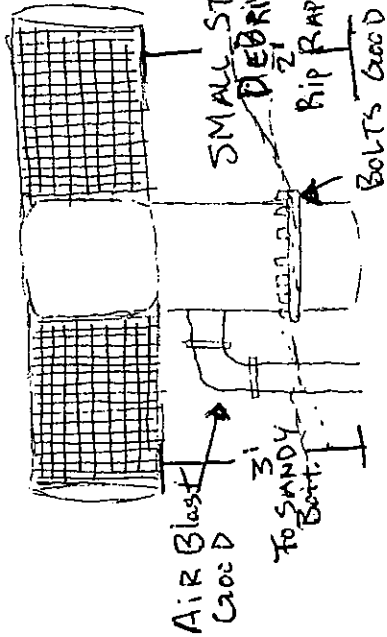
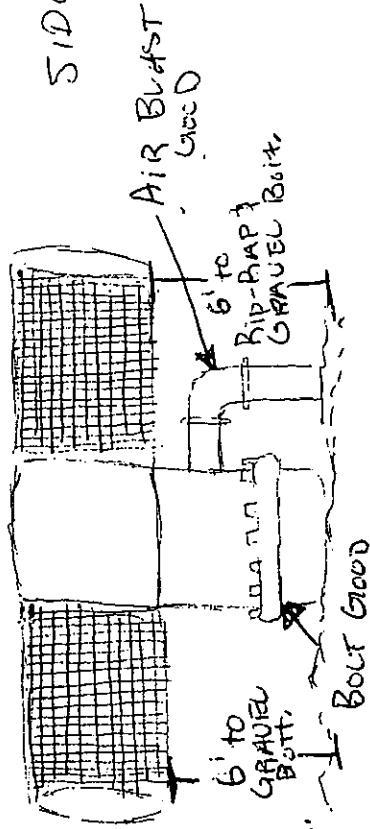
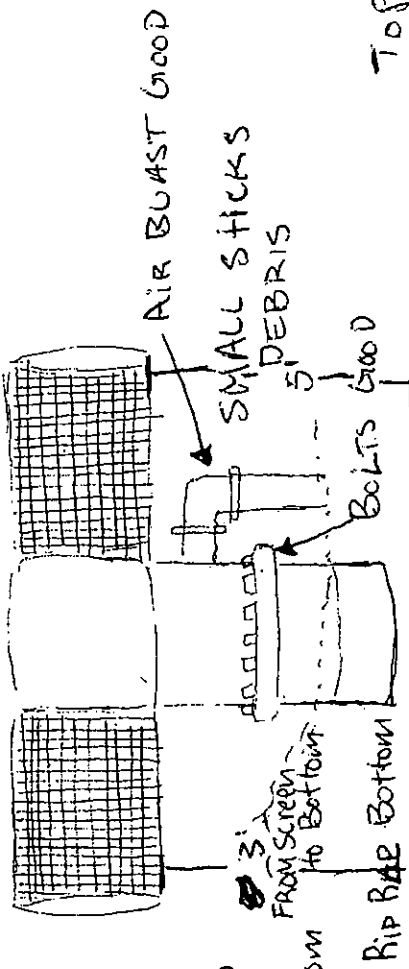
4/14/08
INSPECTION

- NOTES:
- UPST. 3' FROM SCREEN TO Bottom
 - DOWN 2' TO Rip-Rap Bottom
 - UPSTREAM-INNER 5' FROM SCREEN TO Bottom
 - Rip-Rap Bottom
 - BOLTS GOOD/AIR BLAST GOOD
 - UPST. 2' TO Rip-Rap Bottom
 - DOWN 3' TO SANDY Bottom
 - BOLTS GOOD/AIR BLAST GOOD
 - UPST. 5' TO GRAVEL Bottom
 - DOWN 4' TO Rip-Rap Bottom
 - BOLTS GOOD/AIR BLAST GOOD
 - UPST. 6' TO Rip-Rap/Gravel Bottom
 - DOWN 6' TO GRAVEL Bottom
 - BOLTS GOOD/AIR BLAST GOOD

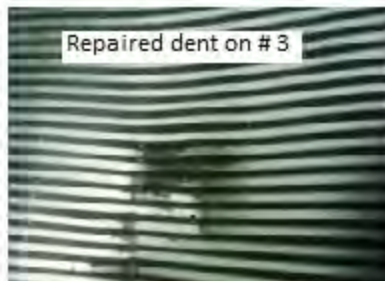
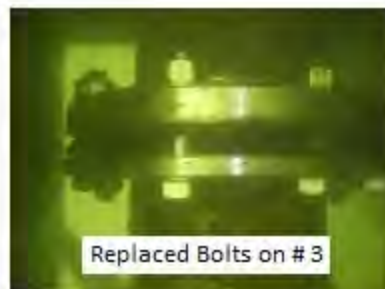
Ord Ferry 5-17-12 River Stage 97.75

- Screen #1 - Flanges and bolts tight. Air test = No leaks. Screen cleaned. No dents.
 6' from bottom of screen to sandy bottom.
- Screen #2 - Flanges and bolts tight. Air test = No leaks. Screen cleaned. No dents.
 5' From bottom of screen to sandy bottom.
- Screen #3 - Flanges and bolts checked. 2 Galled Stainless Steel bolts found. Bolts removed and replaced. Bolts tightened. Air test = Small leak at beginning of air burst. Determined leak is workable and not to be repaired but will monitor. Screen cleaned. Two dents found. Diver able to rebend wedge wire back to operational status and closed up small gap. 4' From bottom of screen to sandy bottom.
- Screen #4 - Flanges and bolts tight. Air test = No leaks. Screen cleaned. No dents.
 3' From bottom of screens to sandy bottom.
